Conservation & Management Plan

Mary Immaculate College, Limerick

Client: Mary Immaculate College

Date: April 2020

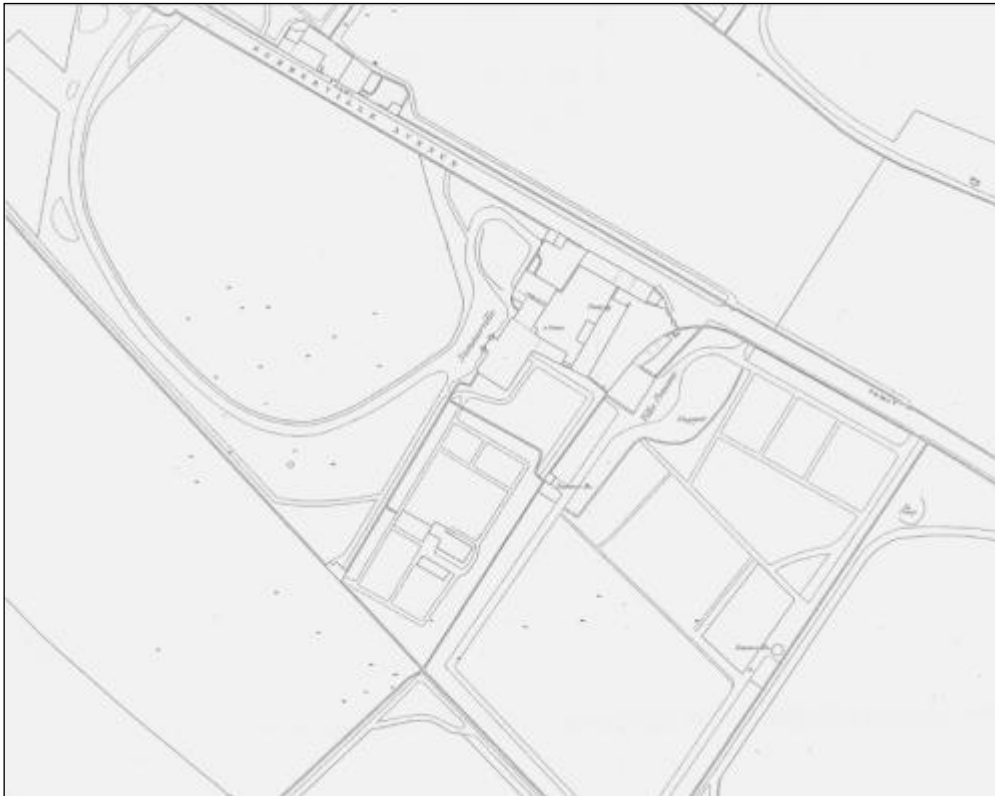
Figure 2 Summerville House, 1870

Extract of Ordnance Survey Town Plan for Limerick, 1870, showing Summerville House expansion and the associated landscape design.

There were some significant design developments made to each of the 'villa' landscapes by 1870. While some gate lodges were evident in 1840, all houses are seen to contain one by 1870. The gate lodge to Ashbourne House marks the entrance for a new sweeping drive across towards the house. There is a new entrance to Summerville House by 1870 and this is denoted with a gate lodge further west along Summerville Avenue and away from the house so that it accommodates a sweeping drive around a curved parkland to the front of the house. The house is also expanded by this time as the footprint shows extensions to the house and garden buildings, perhaps to accommodate the leasing of the premises in the 1850s.⁵

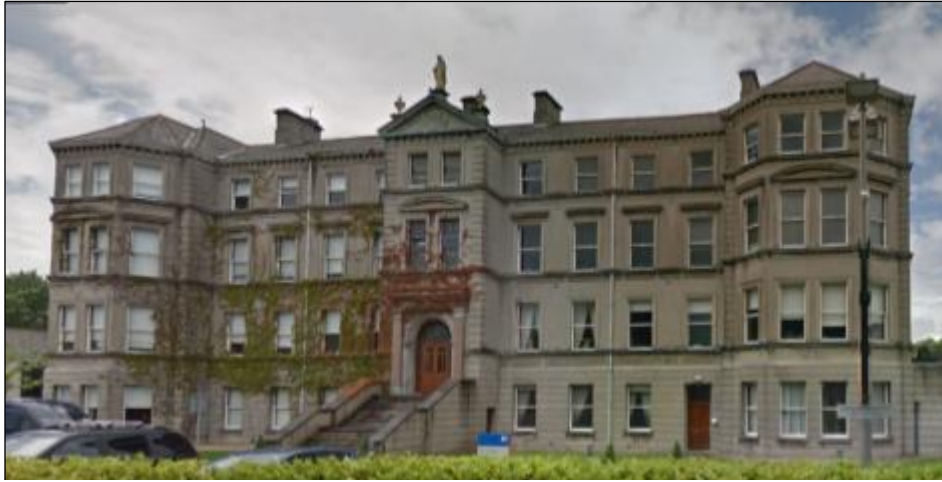
Photograph 3 Foundation Building Front Elevation

The Foundation building was the first building developed for the original teacher training College in the 1900s. It is an eleven bay four story purpose built College with a rendered finish and built in an Italianate style. The entrance to the building was originally on what is now the first floor, and the ground floor was referred to as the basement level. The entrance is via several stone steps up to an arched door opening and enters into a large porch area that is enclosed by large timber doors. This building has been added to over the years with numerous alterations and additions; however the main front façade presents itself much the same as it was originally built. For a more detailed description of the building please refer to sections below.

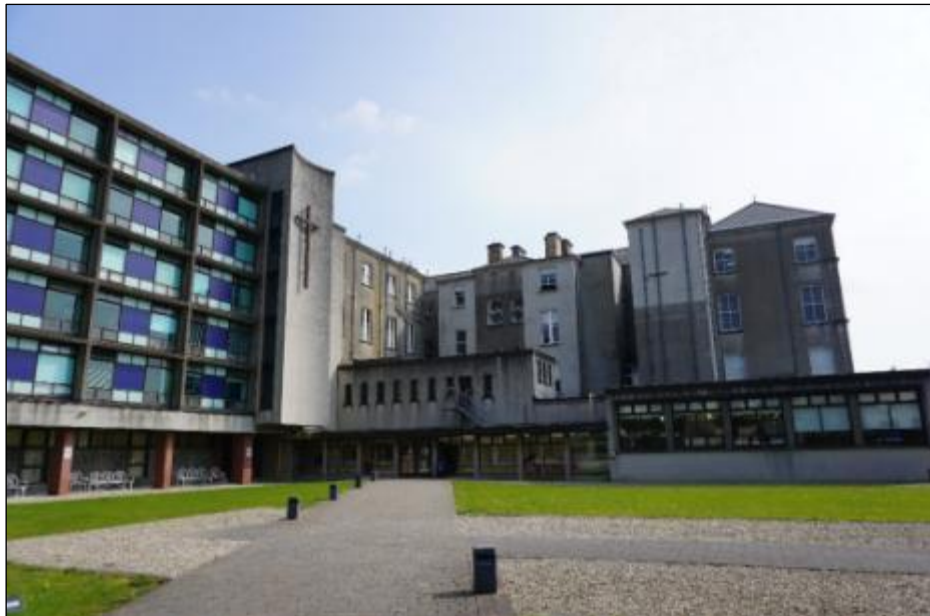
Photograph 4 Rear Elevation of Foundation Building showing additions

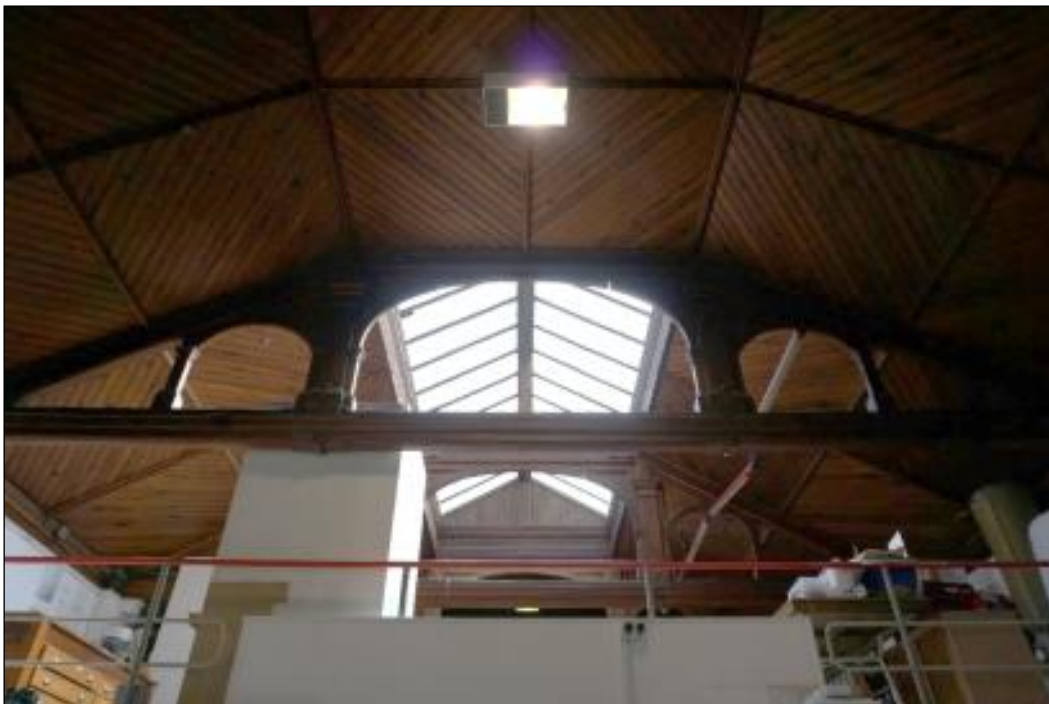
Photograph 6 Interior View of Recreation Hall - View to paneled ceiling

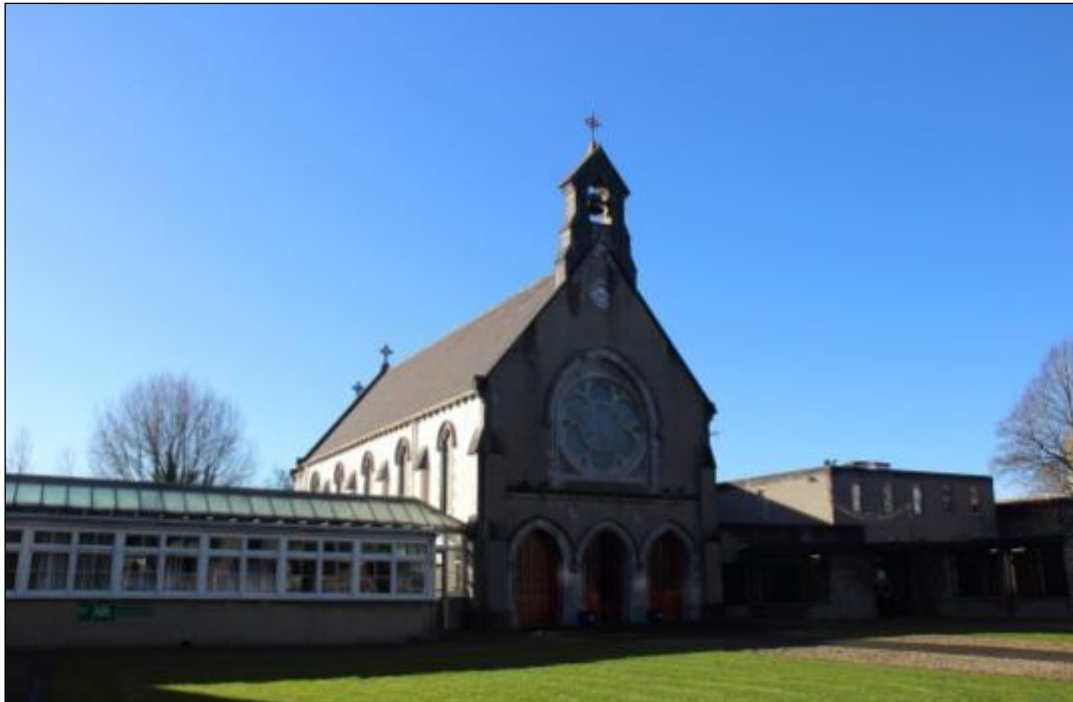
Photograph 7 Mary Immaculate College Chapel and St Cecilia's Corridor

St. Cecelia's corridor links the main building with the chapel, built in 1906. The chapel has a gabled front elevation with a triple arch entrance and rose window above. There is a limestone ashlar belfry at the apex of the pitched natural slate roof. For a more detailed description of Mary Immaculate College Chapel refer to the following sections.

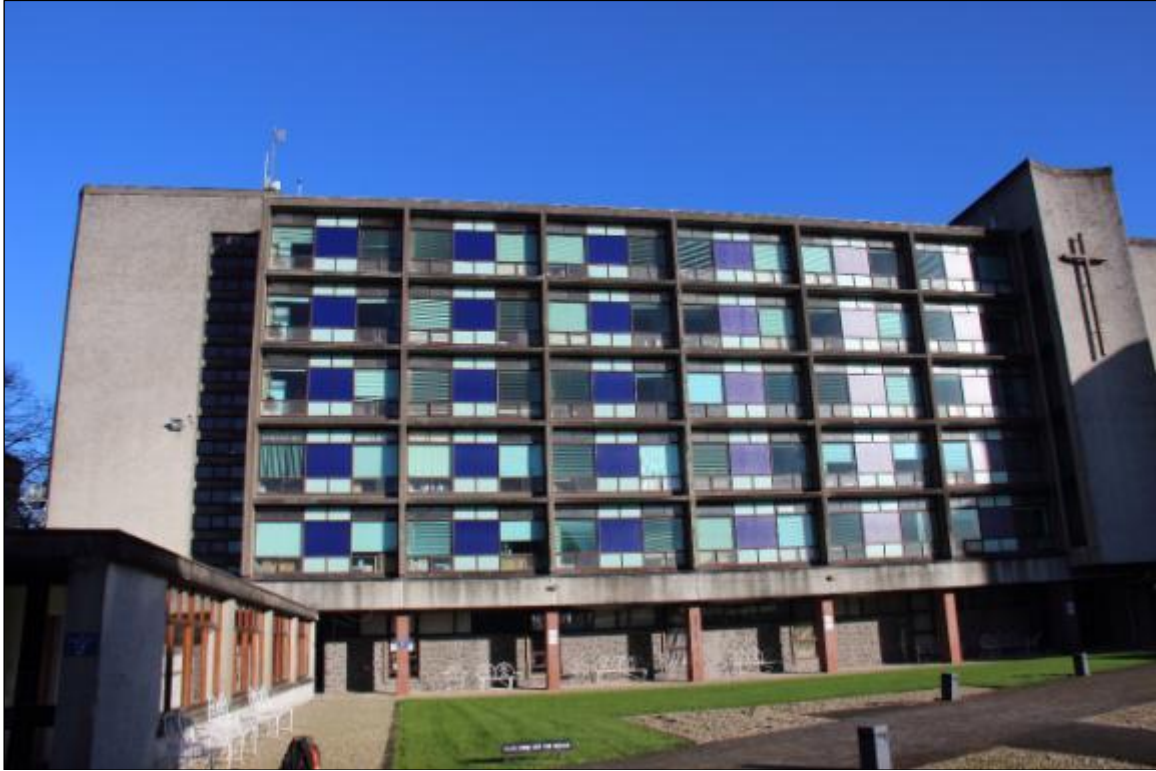
Photograph 9 Residential Block

Directly opposite the front elevation of the chapel is the residential building designed by Andrew Devane of Robinson Keefe Devane in 1955. He made numerous alterations and additions to the College. The building is differentiated from the main building by its 20th century architectural style with a rock faced ground floor and modular facades on the north and south elevations made up of a reinforced concrete grid and timber framed casement windows with distinguished coloured panels. This six-storey building creates one of the boundaries to the recently designed courtyard space at the rear of the foundation building. The final boundary of the courtyard is formed by two single storey flat roof structures

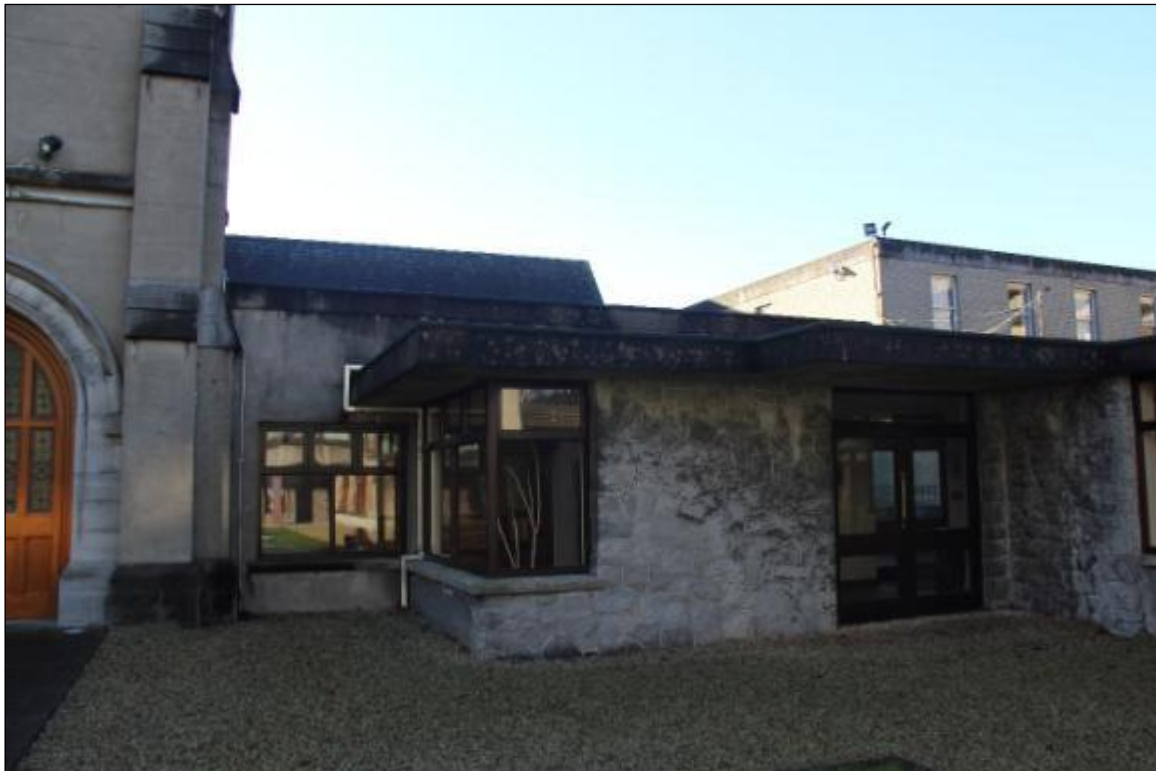
Photograph 10 Single Storey addition next to Chapel

designed by Andrew Devane. The structure nearest the chapel is finished in masonry. The other has a rendered finish and is made up of a modular pattern similar to the resident block. There is an opening between these buildings with large timber gates which allows access to the building and green spaces behind. For a more detailed description refer to the following sections.

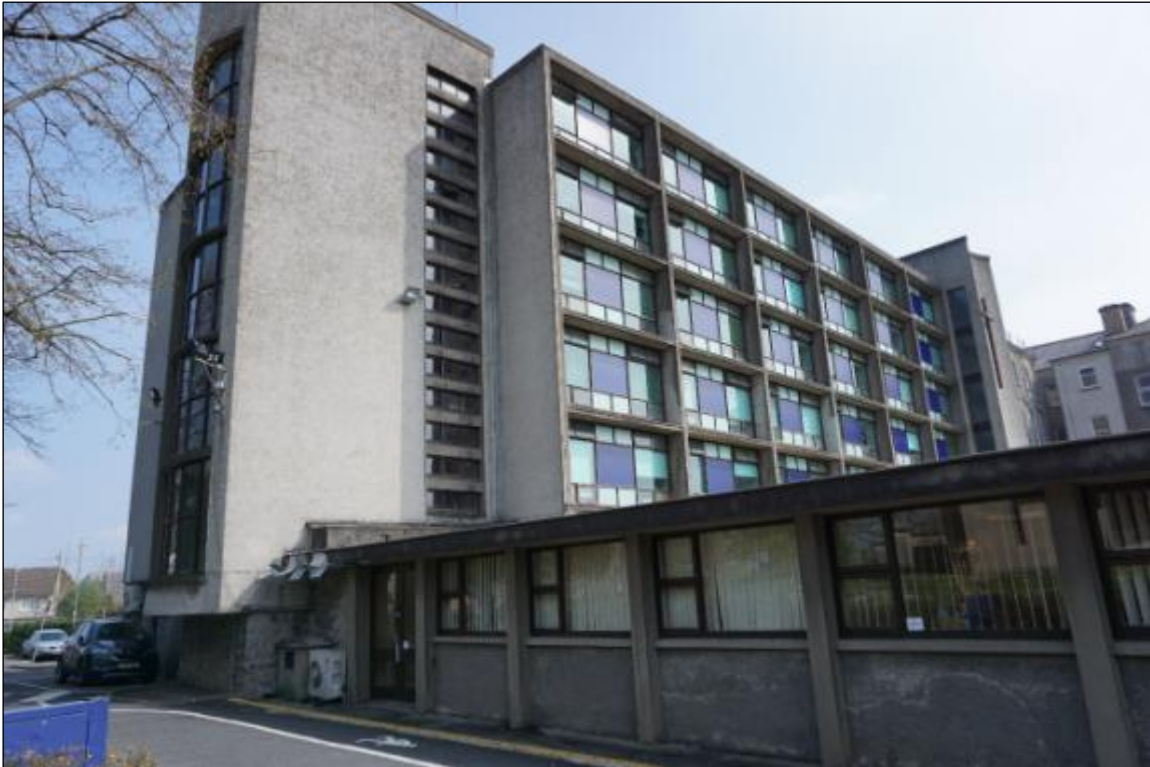
Photograph 11 Single Storey addition next to Residential Block

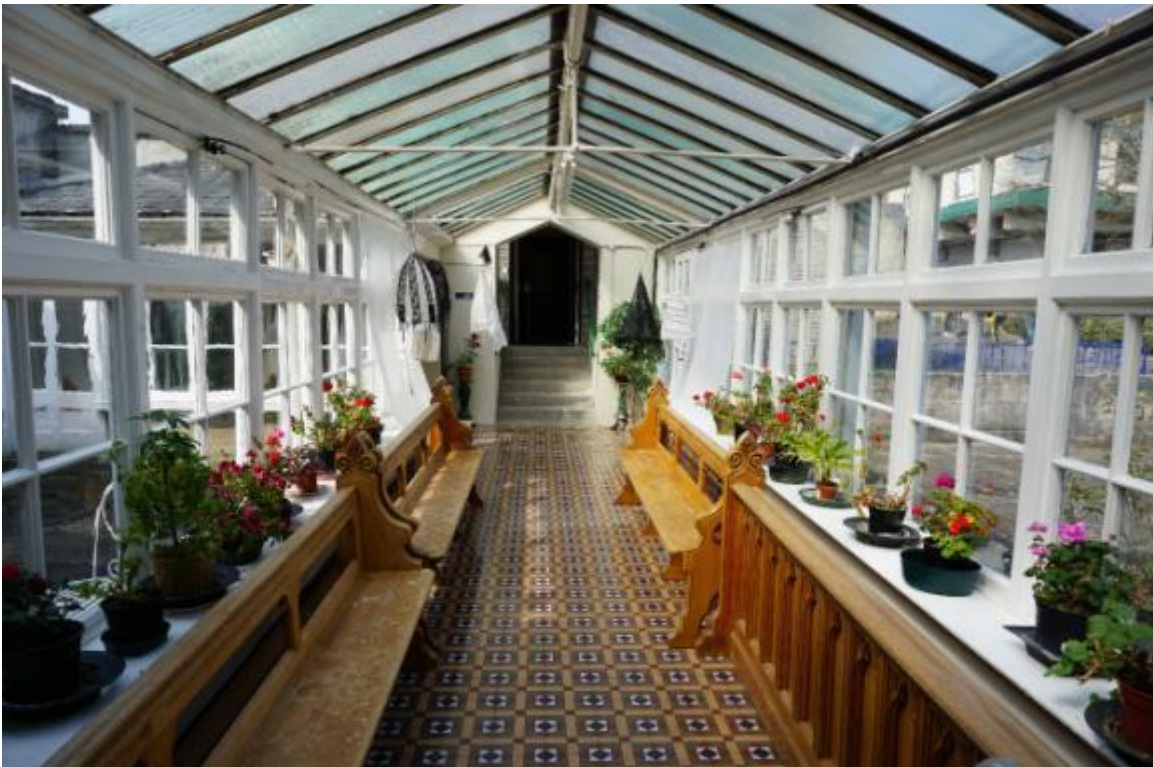
Photograph 12 St. Cecelia's Corridor Link to Former Convent Building

St. Cecelia's corridor adjoins the chapel and links to a former convent brick building. This building has a rectangular layout and has a brick façade finish. To the rear of the chapel are several flat roofed buildings that extend from beside the recreational hall down past the rear of the chapel and then to the former convent building.

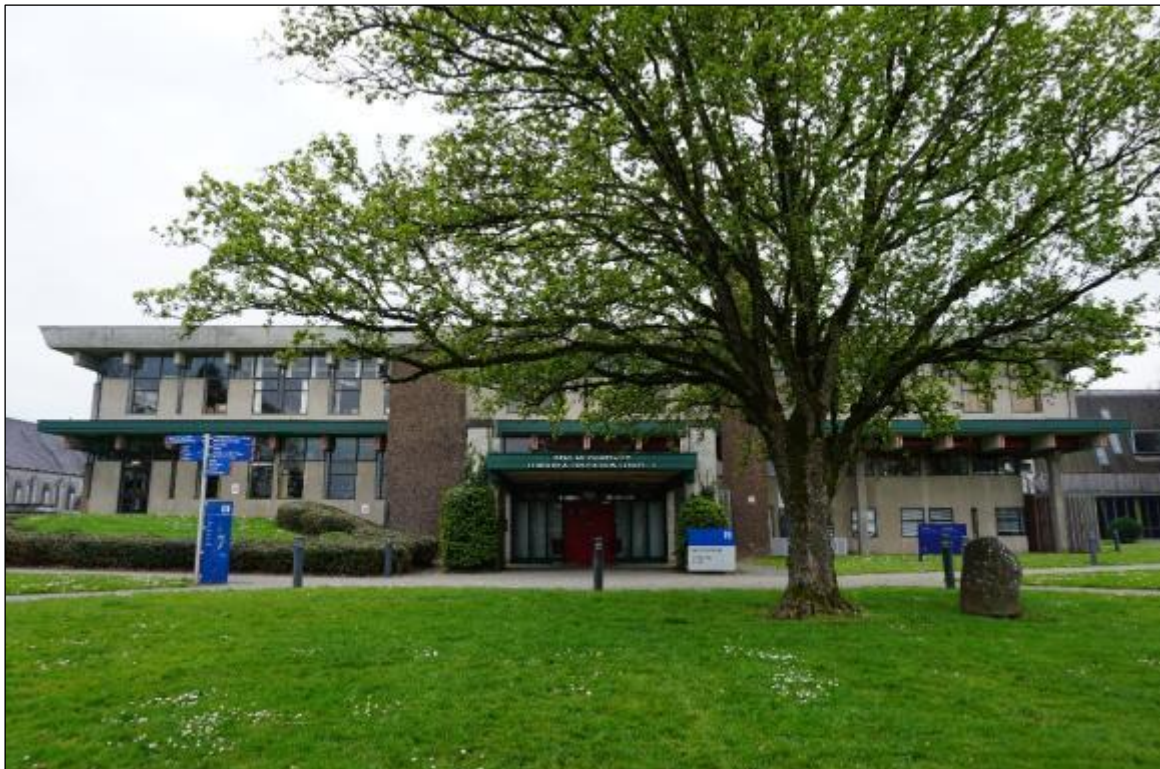
Photograph 13 Library front elevation

Towards the north of convent is the library building built in 1980. This building is a two storey, flat roof with a rendered finish on the walls and exposed concrete beams projecting from the building. This was the first major addition to the College in over 30 years since the residence block.

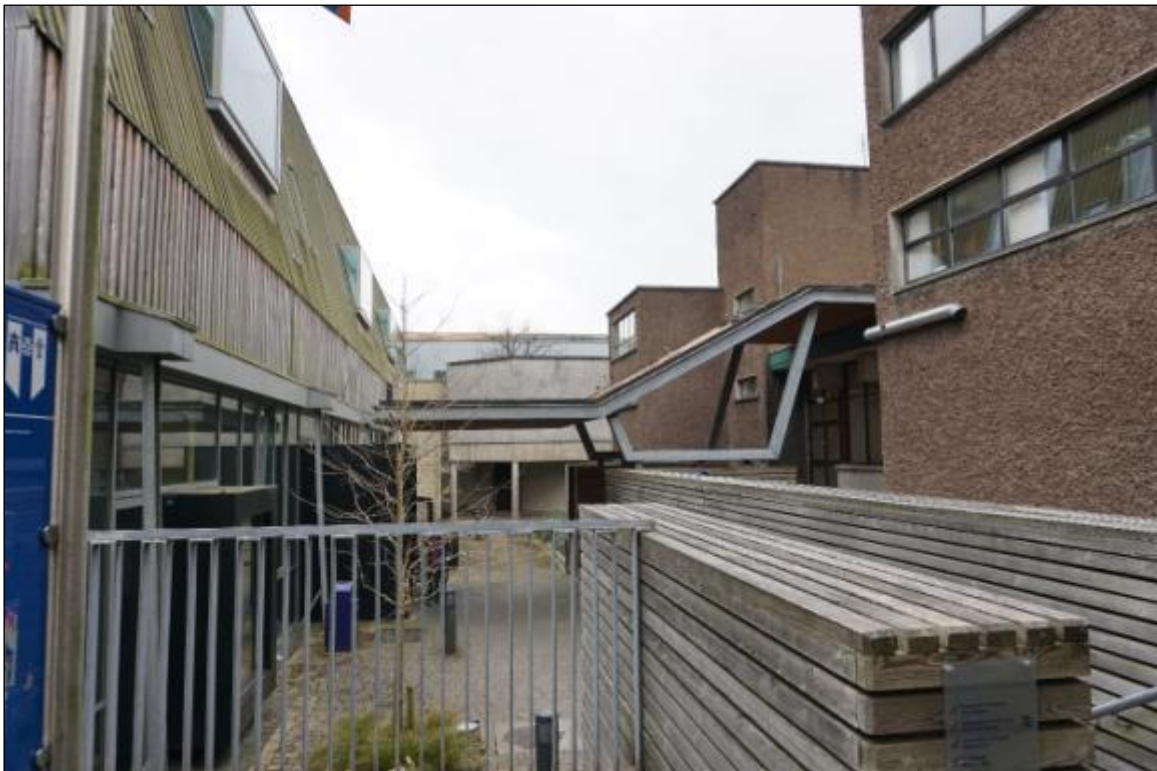
Photograph 15 Canopy connecting Library with TARA building

Towards the rear of the library there is an octagonal section of the building which houses a lecture hall. The building is then connected to the TARA building via a canopy within a small courtyard area. This area then links back toward the convent and into the main building. Next to the octagon there is a large open space which divides the library with part of the TARA building.

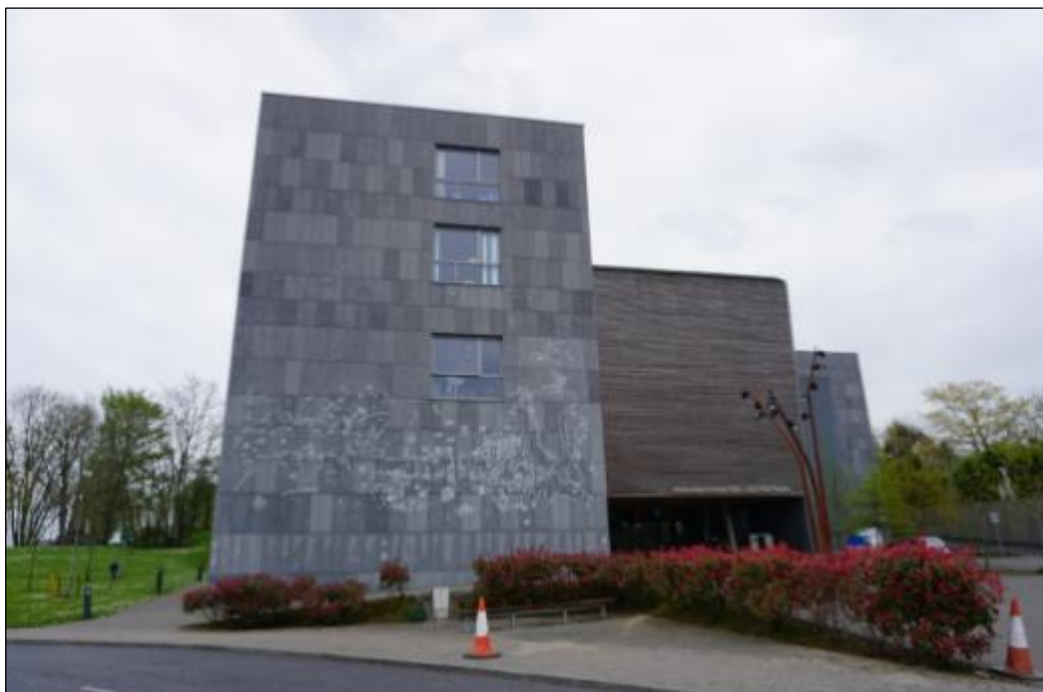
Photograph 17 TARA Building and Lime Tree Theatre Entrance

TARA Building (Teaching, Recreational and Auditorium space) was officially opened in 2011 and is a four storey building that houses many of the College's facilities including the 510-seat Lime Tree Theatre and Student Union. The structure has part timber clad finish with a cut stone façade section to the front of the building and rendered finish in another section. The front entrance to the lime tree theatre is timber clad with the section adjoining this made up of stone cladding with a detailed carving of Limerick on the cladding.

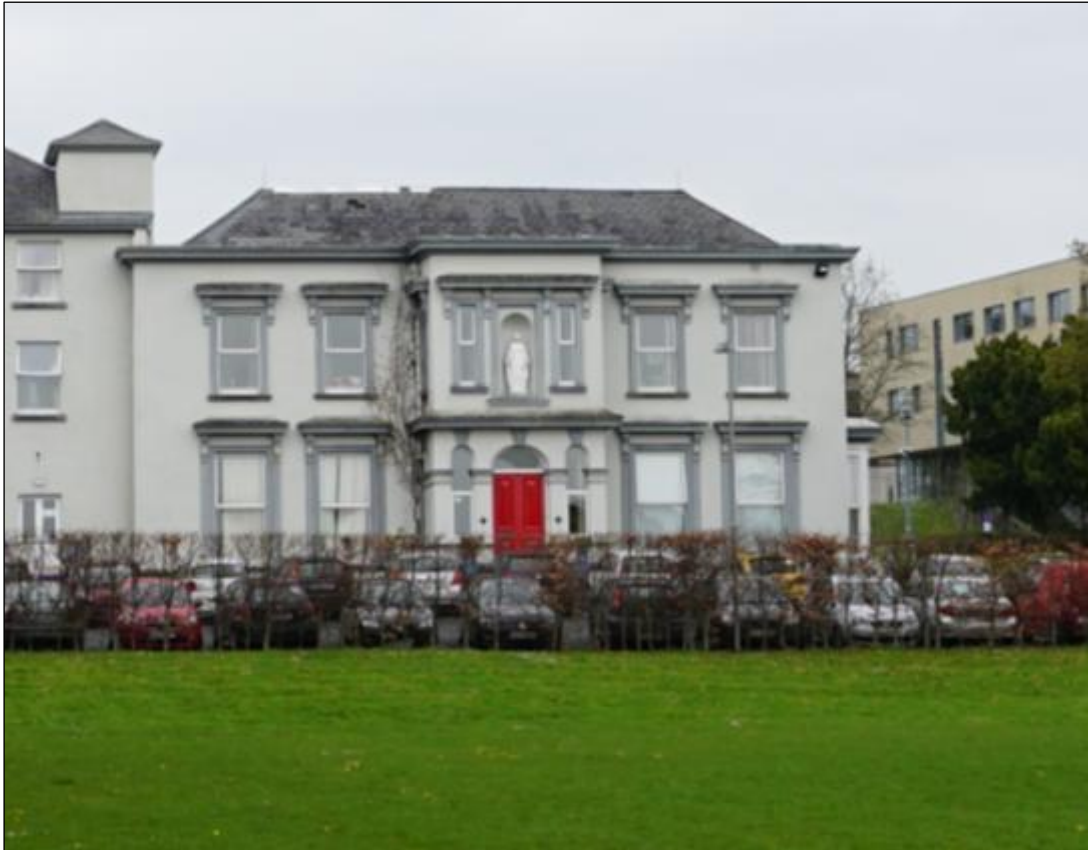
Photograph 18 Summerville House Front Elevation

Summerville House is one of the oldest buildings on the site and is a key building within the overall campus. The house is rectangular shaped while the main section of the building is two storey with three-storey sections in the side extensions towards the rear and side elevations. The building is accessed from the rear which faces the main campus buildings. Next to the house facing toward the Tailteann building is a small car park area and open amenity space. There is also access from Summerville Avenue to a courtyard area and car park to the rear of Summerville house.

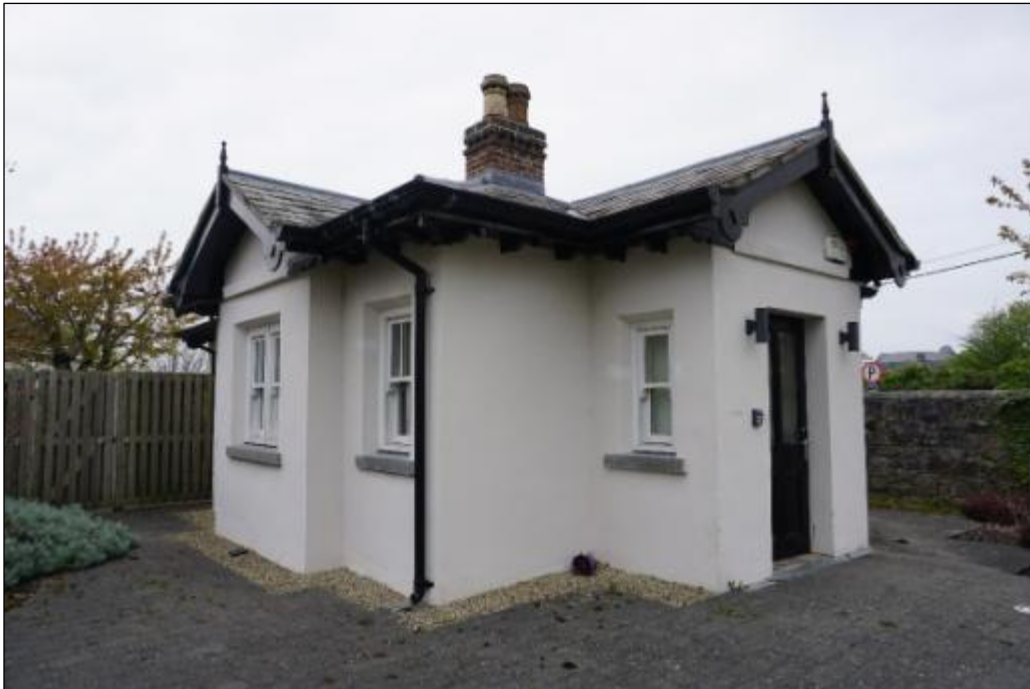
Photograph 22 Summerville Gate Lodge Front Elevation

Summerville gate lodge is located directly across from Summerville House. This gate lodge has been refurbished in recent years and now functions as a Franco-German Language Centre. The lodge has a cruciform shaped and natural slate roof with replacement timber sash windows. For further detail on the Gate Lodge please refer to the appendices.

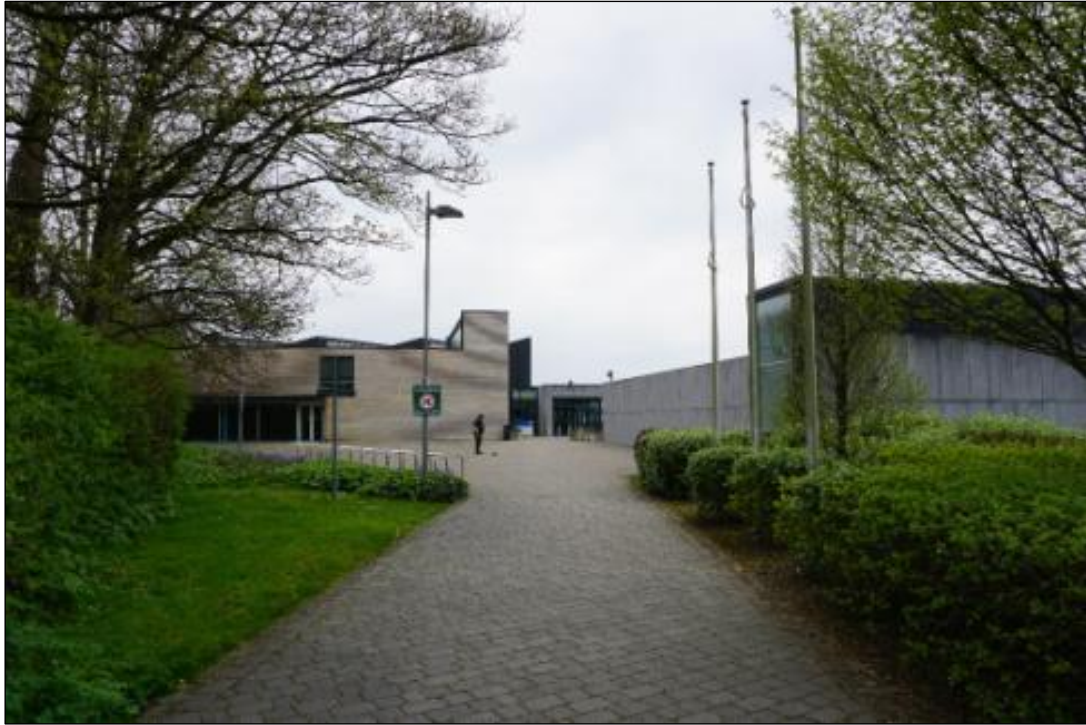
Photograph 24 Tailteann Building

Tailteann building is one of the more modern buildings on the campus. This sports facility was completed in 2007 and is located opposite Summerville House and next to the TARA building. The building itself is a two-storey building with timber and stone cladding on the exterior. The building is accessed on the first floor and the ground floor opens directly out onto the sports pitch located in front of it. This multipurpose facility contains three large halls which provide key functions within the overall usage of the College.

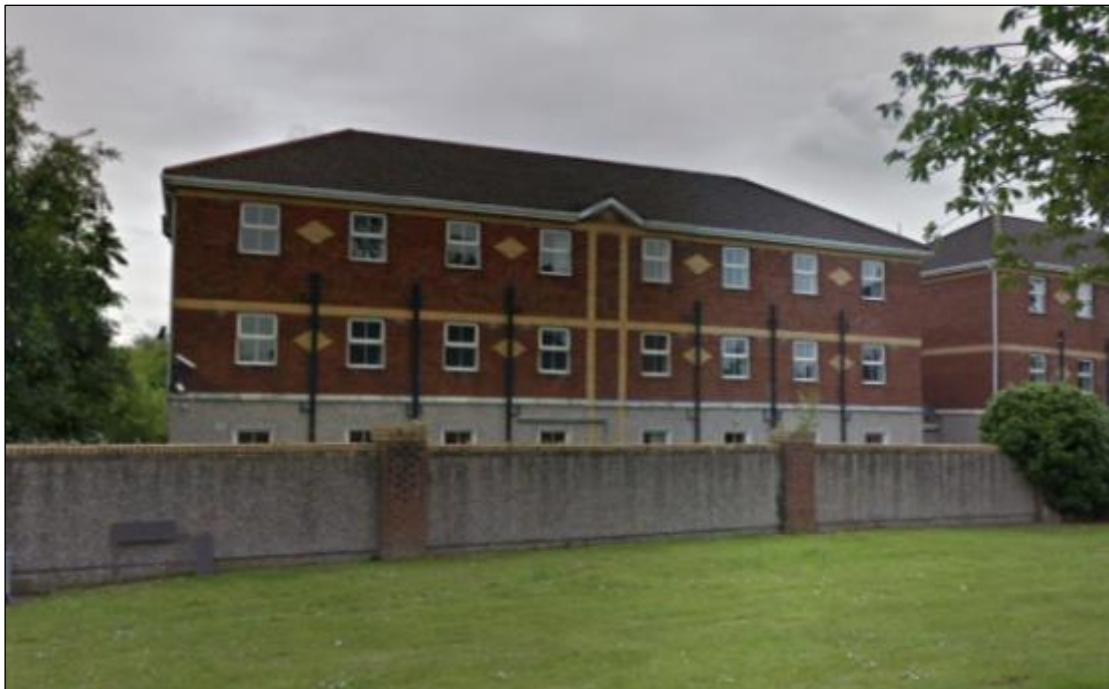
Photograph 25 Courtbrack Accommodation

Courtbrack accommodation is located at the end of the campus along the Dock Road and comprises of 3 storey brick finished rectangular structures with pitched roofs. Courtbrack is located on the site of Ashbourne house (which has since been demolished) and historic demesne.

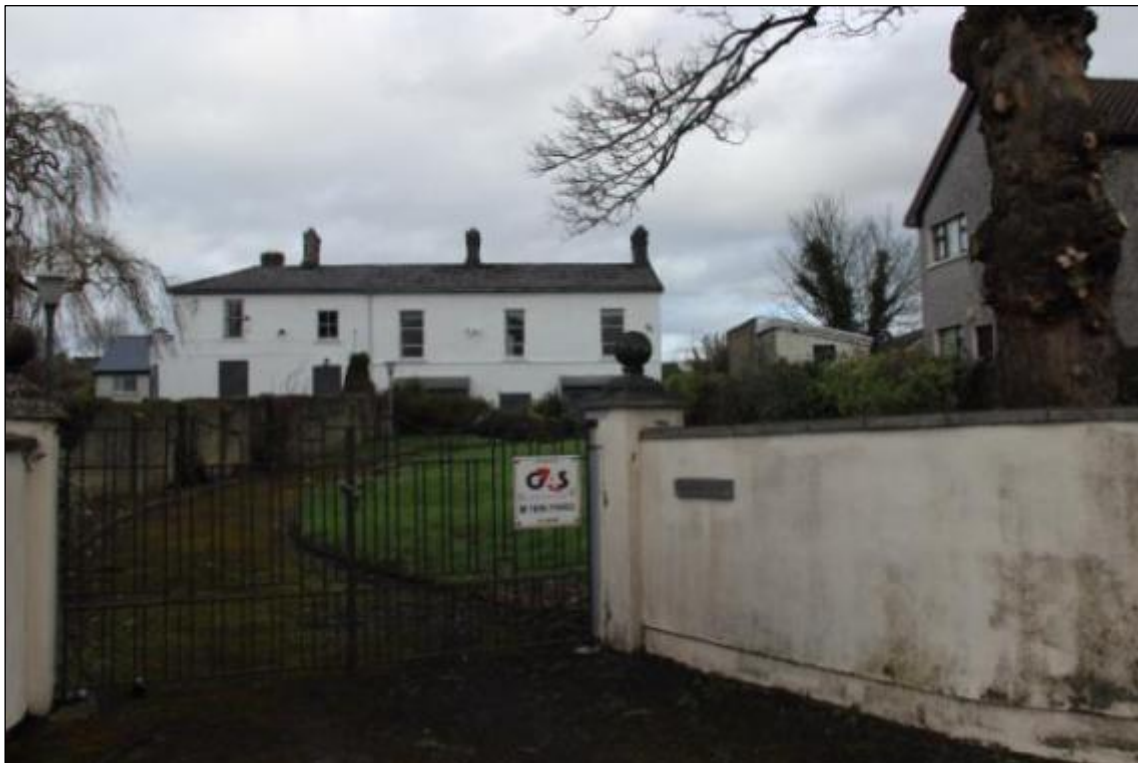
Photograph 26 Richmond and Hillsborough House(s)

Richmond House & Hillsborough House were formed when the original 18th or early 19th century Richmond House was spilt. The houses are two storeys with a pitched roof. The Richmond side of the original house has a curved side to the building which is made up of a

large living room and has a flat roof section on it. Both sides of the house have remained disused for the past number of years.

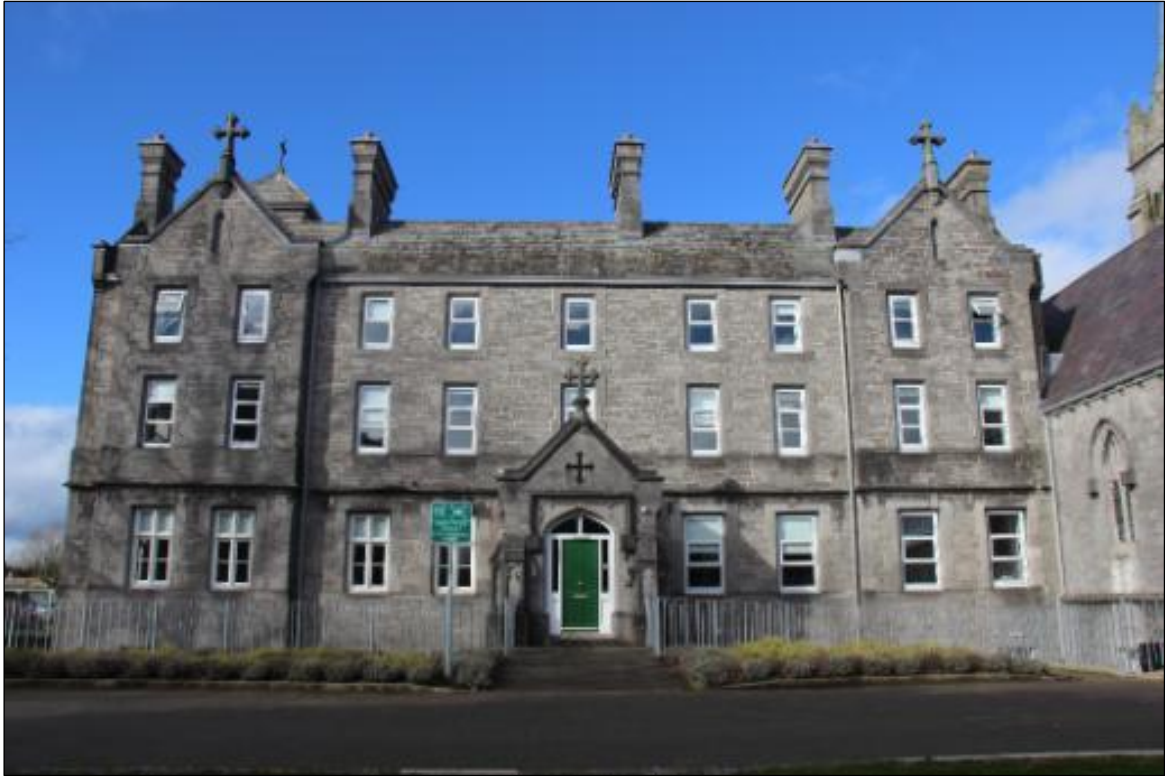
Photograph 29 Mount St. Vincent Front Elevation

Mount St. Vincent building is a nine bay three storey over basement building with a cut stone finish and natural slate M-profile roof. This building is perpendicular to the convent building. These two sections are linked by a six-stage square plan campanile. Refer to the following sections for further detail.

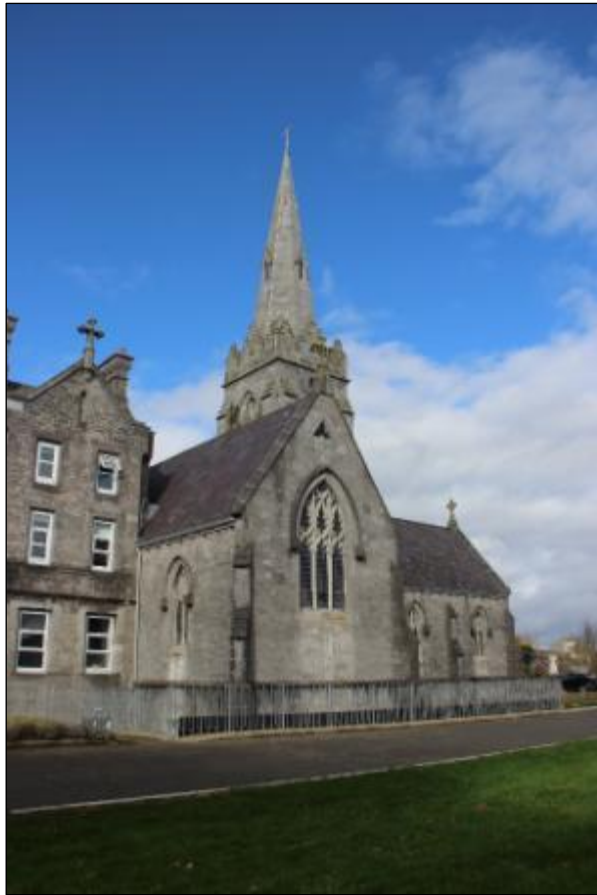
Photograph 31 Mount St. Vincent Chapel

Mount St Vincent's Chapel adjoins Mount St Vincent's Convent on the northeastern side of the building. This chapel has a similar cut stone finish and natural slate roof. The chapel has a T-shaped plan with a three-stage tower. Refer to the following sections for further information on the chapel.

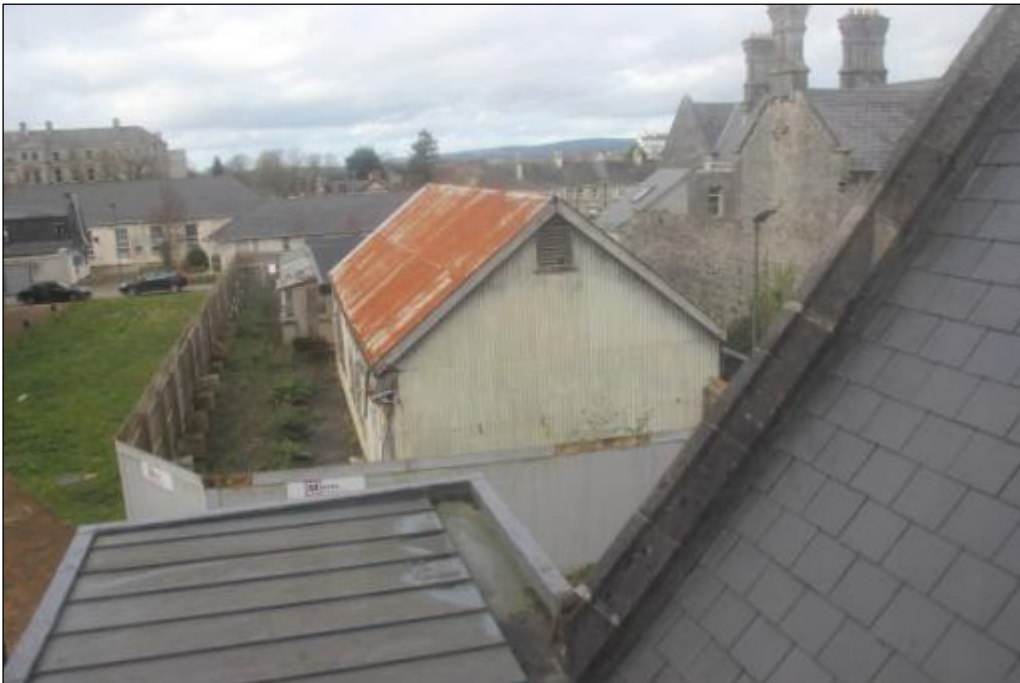
Photograph 34 Mount St. Vincent Hall.

Mount St. Vincent Hall is located to the rear of Mount St Vincent's chapel and convent. It is a single-storey corrugated iron building and was placed as a separate unit on the gardens of Mount St. Vincent Convent. For further details on Mount St Vincent Hall refer to the following sections.

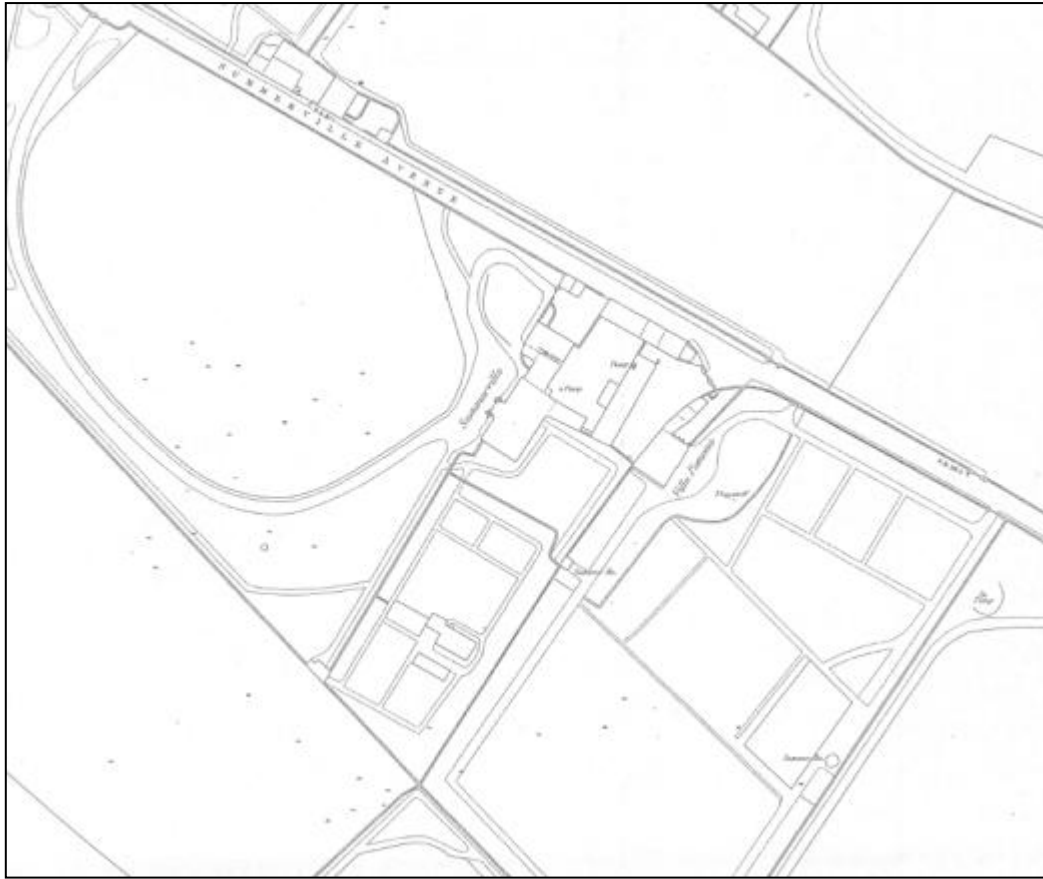
There is a new entrance to Summerville House by 1870 and this is denoted with a gate lodge further west along Summerville Avenue and away from the house so that it accommodates a sweeping drive around a curved parkland to the front of the house. There were extensive walled gardens to the side and rear of the house and figure 27 shows a number of summer houses and a flagstall. Interestingly, the gardens were given the title ‘Villa Pomona’, which may point to the cultural influence of Italian villa landscape architecture or a desire to reference this cultural link.

Figure 27 Extract of Ordnance Survey Town Plan for Limerick, 1870, showing Summerville House landscape design.

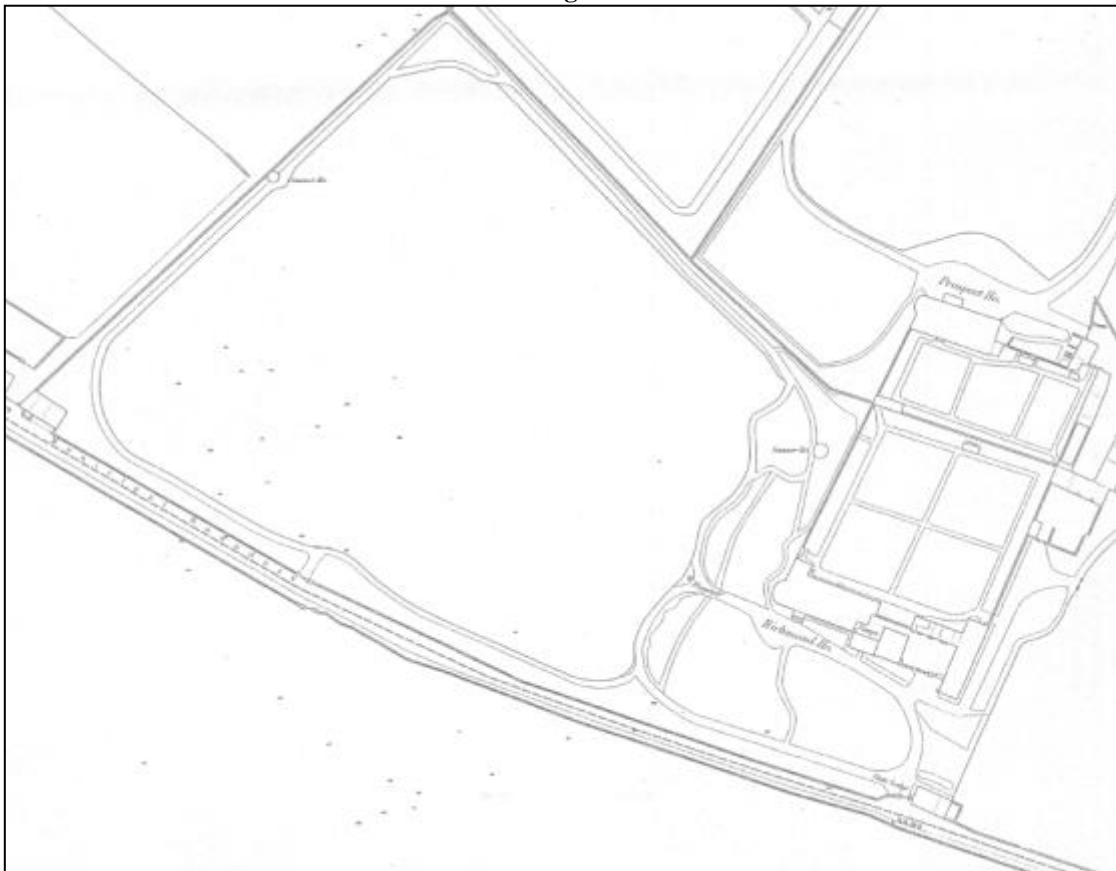
Richmond House remained accessed from Courtbrack Avenue and like the other houses; it too had a gate lodge by 1870 with a number of drives on approach to the house. Access the parkland followed these drives, which also shows a perimeter access route to Courtbrack Avenue further to its west. There are summerhouses on the parkland grounds and an arrangement of meandering walks and drives up and around the house, while the rear garden wall abuts Prospect House and its layout and form remains similar to the 1840s design.

Figure 30 Extract of Ordnance Survey Town Plan for Limerick, 1870, showing Richmond House landscape design.

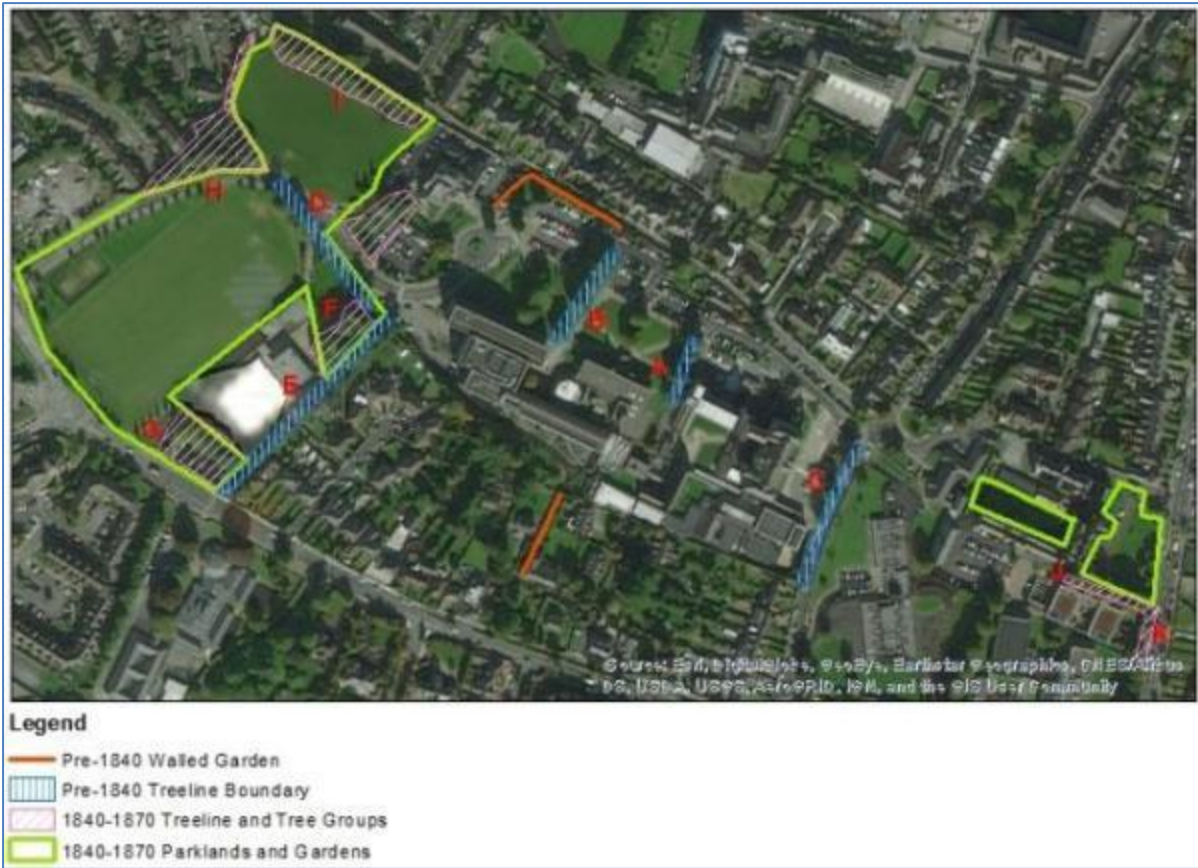
Figure 38 Map identifying important historic landscape elements on MIC campus (letters to be used as reference for trees and tree groups in the text below).

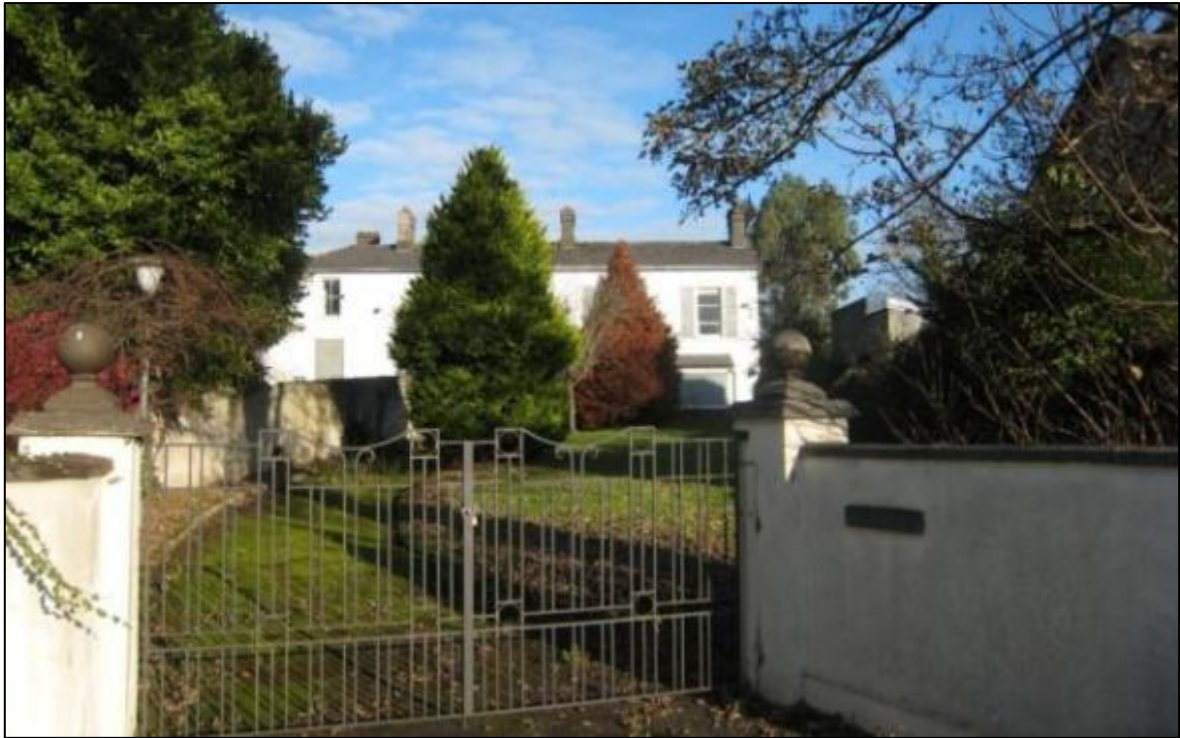
Richmond House remains as part of the campus, but the house and former rear walled garden have been divided into two residences. The parkland, as described above has been consumed by residential street and estate houses. There was a new entrance introduced, which most likely coincided with the division of the property into two units. The former access remains, but this area to the front of the house has been divided for residences on the street. A gate that led to the service and stables of Richmond House remains as does the cobbled yard. The western boundary walls of the rear walled garden remains, but the northern was inaccessible on the day of survey.

Photograph 37 Richmond House - entrance to the eastern property and the dividing wall is visible.
