Conservation & Management Plan

Mary Immaculate College, Limerick

Client: Mary Immaculate College

Date: April 2020

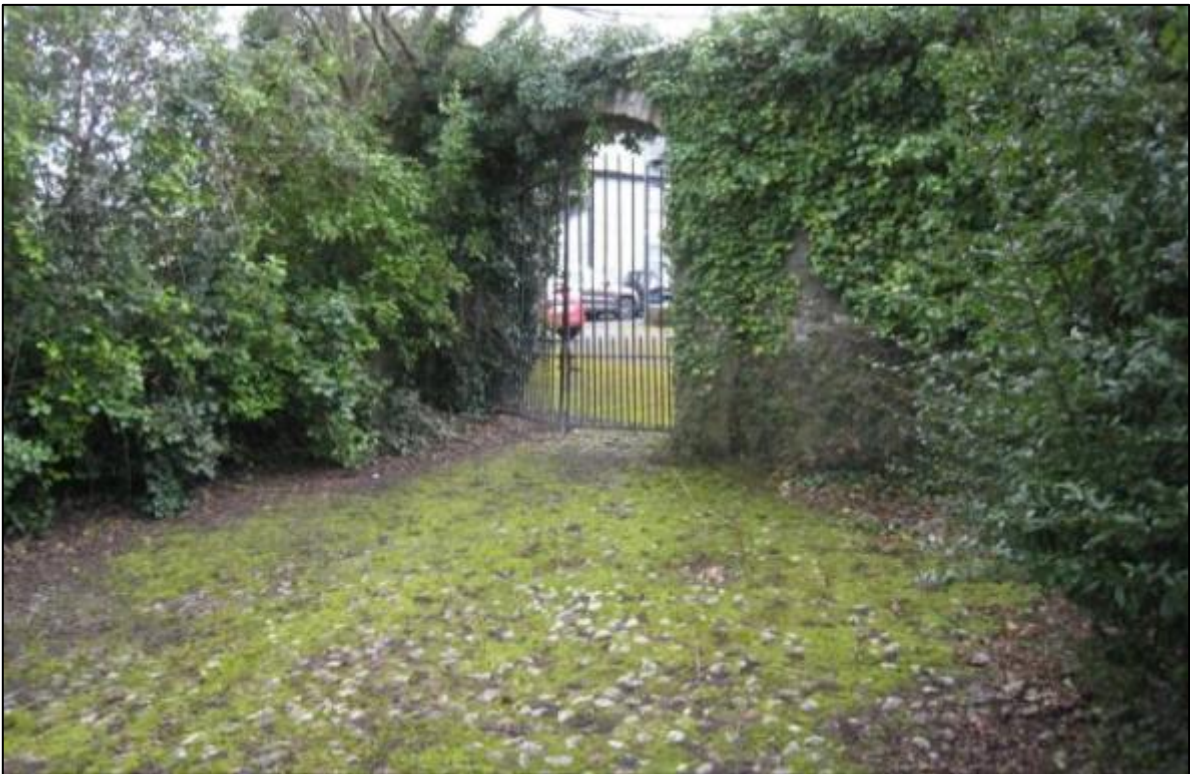
Photograph 38 Former Stable Entrance to Richmond House with cobbled yard.

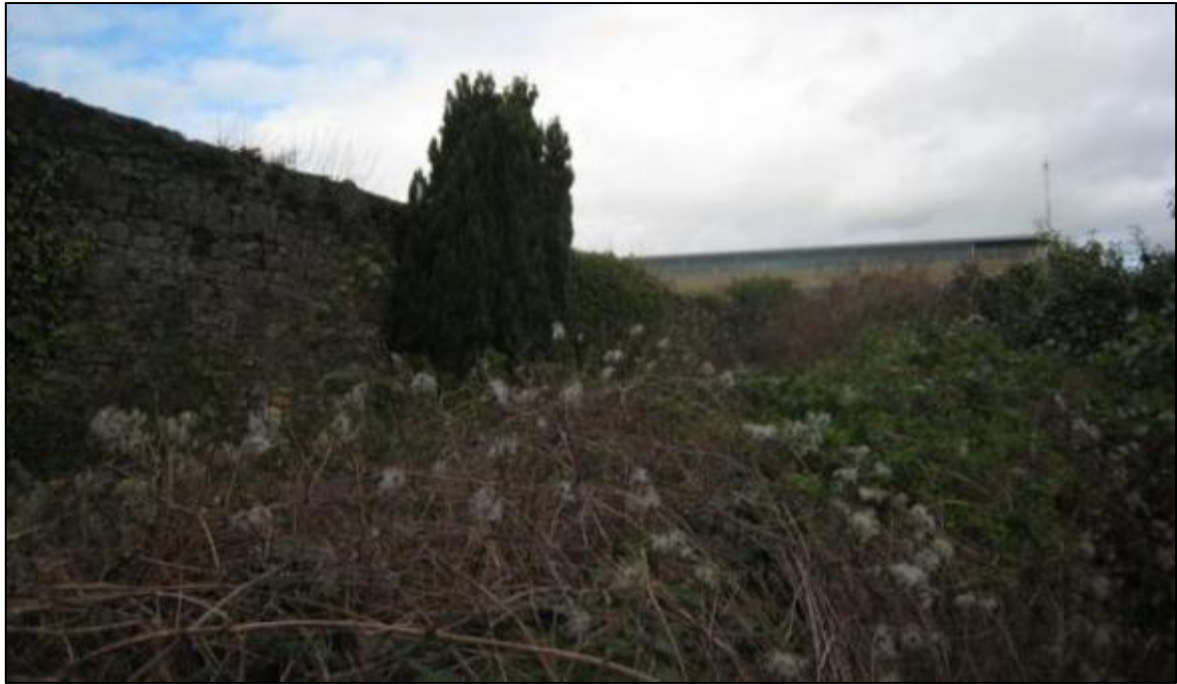
Photograph 39 Western walled rear garden of Richmond House.

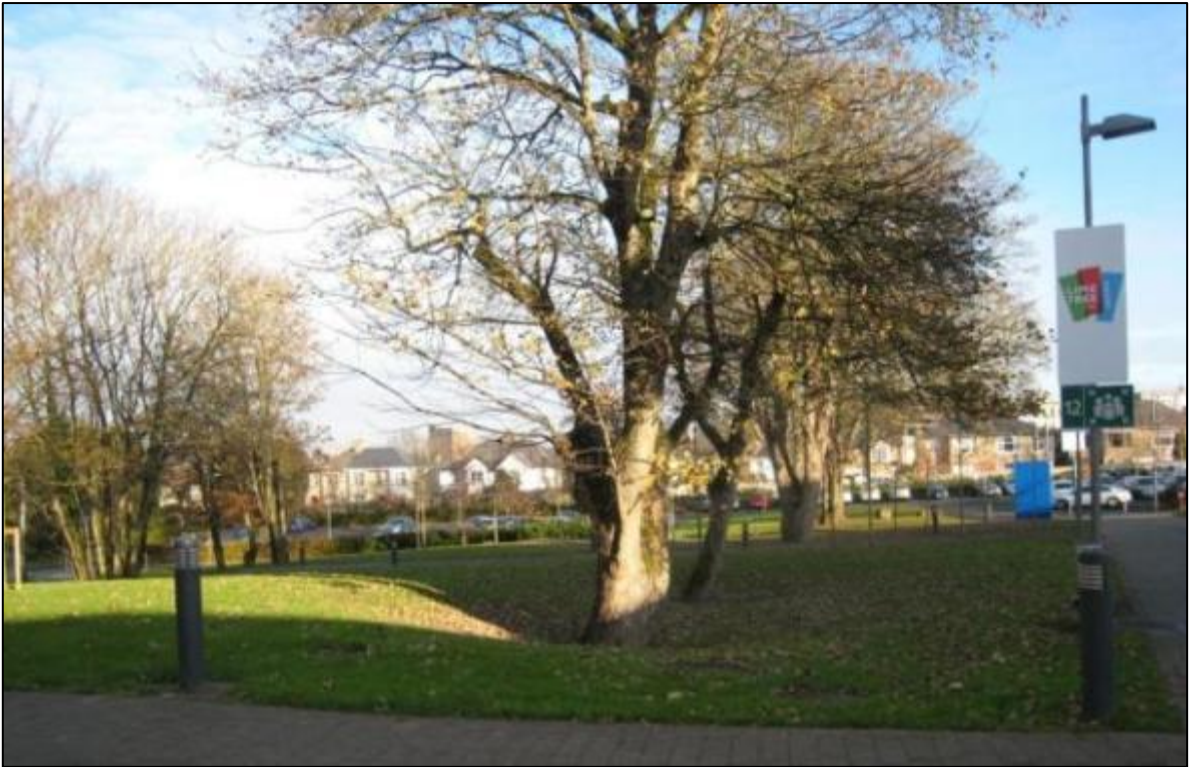
Photograph 40 Historic tree-lined boundary formerly between Prospect House and Summerville House (B on Figure 38).

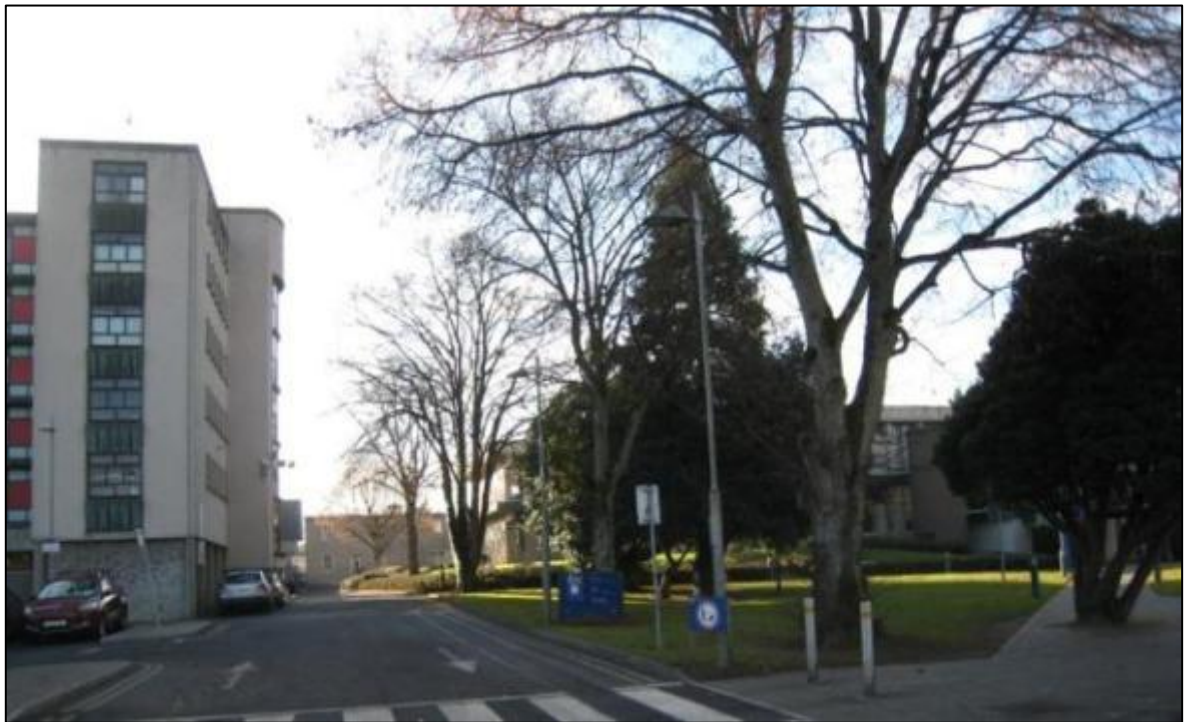
Photograph 41 Former field boundary of Prospect House landscape (A on Figure 38).

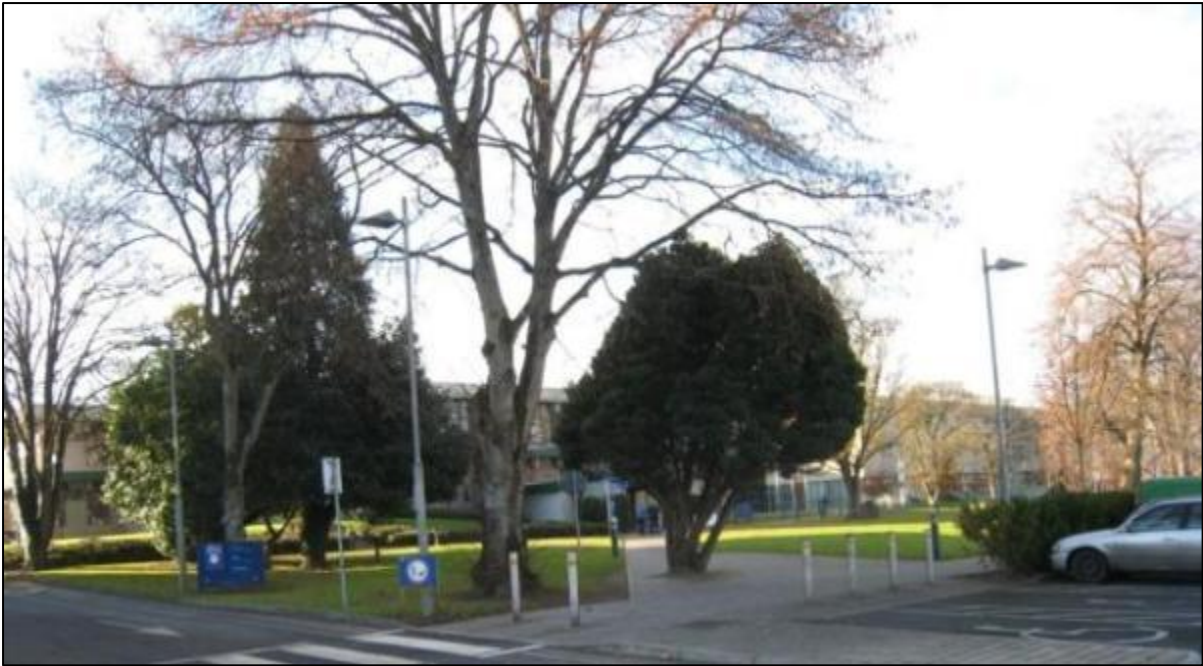
Photograph 42 Newly-designed green spaces and car park now replaces the former parkland to the front of Prospect House. The design accommodates the historic boundary (A on Figure 38).

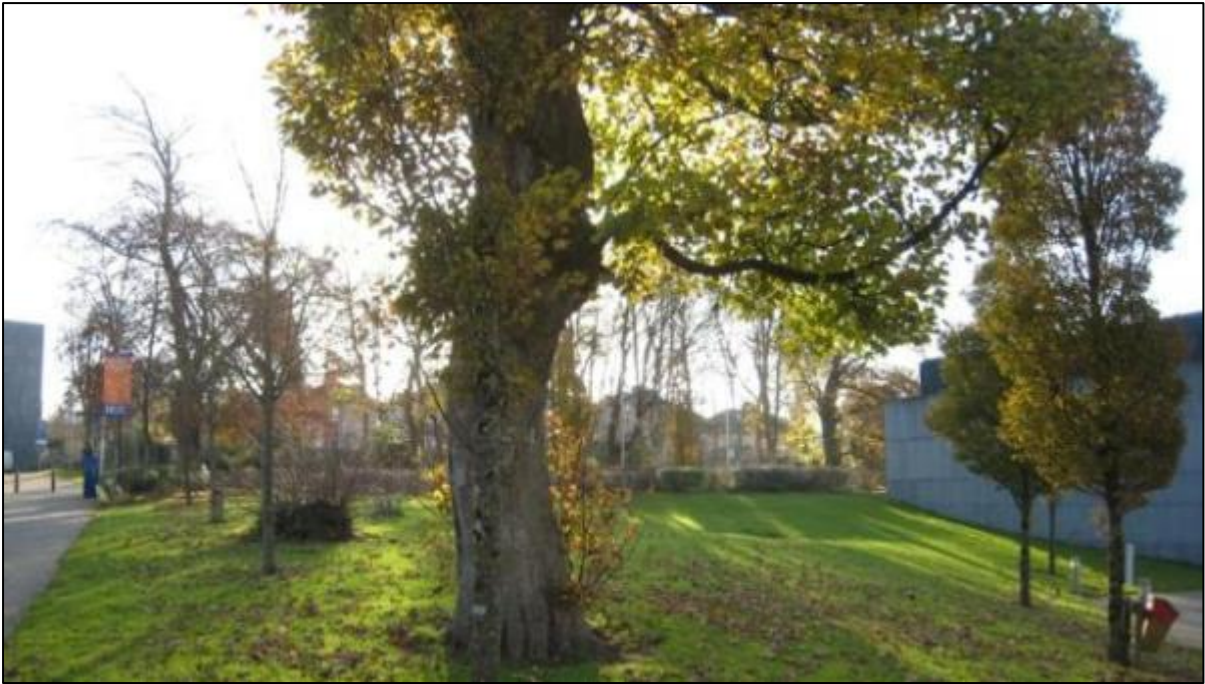
Photograph 46 Former boundary line between Ashbourne and Summerville Houses denoted by the larger trees in the foreground and background and continues in Photograph below (D on Figure 38)

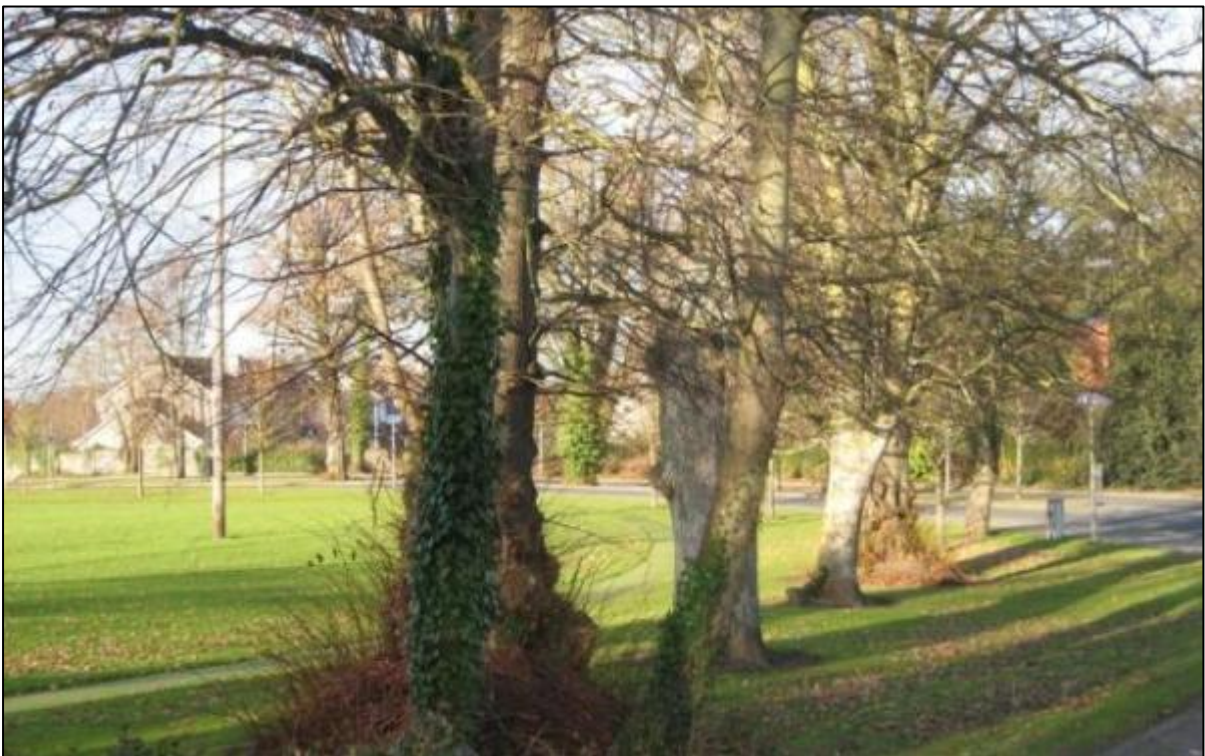
Photograph 47 Former boundary line between Ashbourne and Summerville Houses (D on Figure 38)

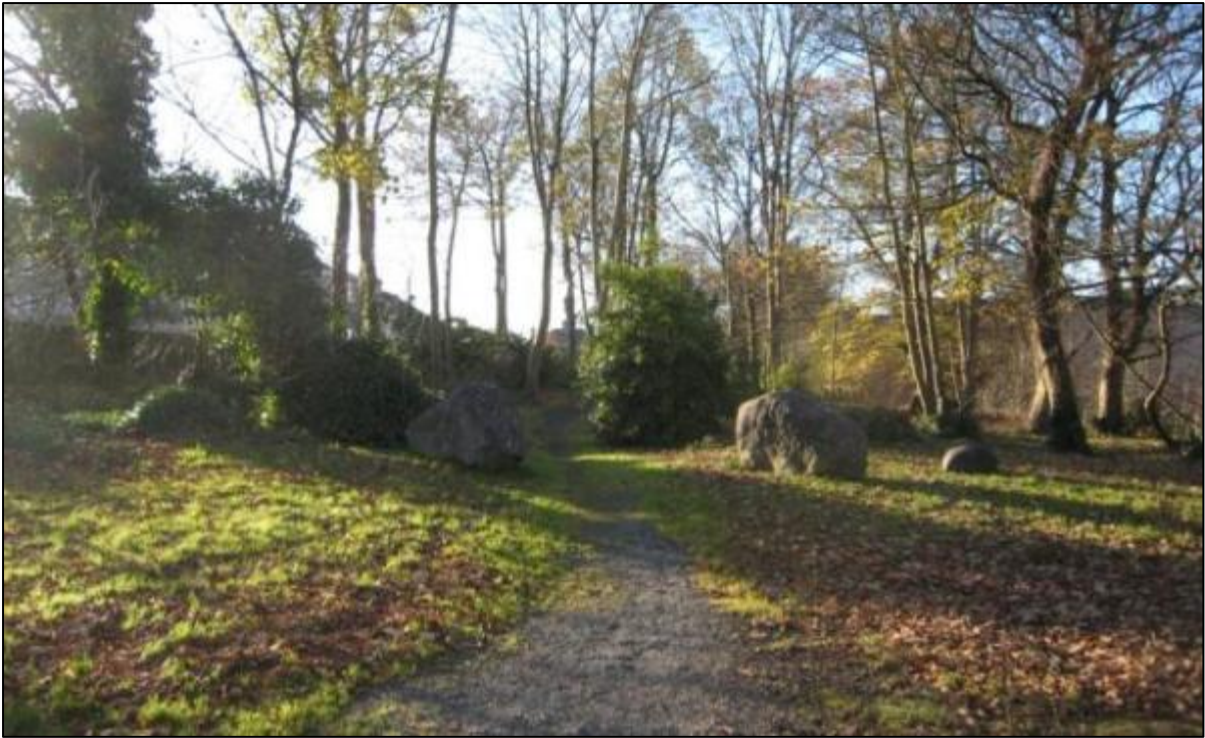
Photograph 48 North-eastern part of the wooded stand associated with Ashbourne House's parkland, 1840-1870 (F on Figure 38)

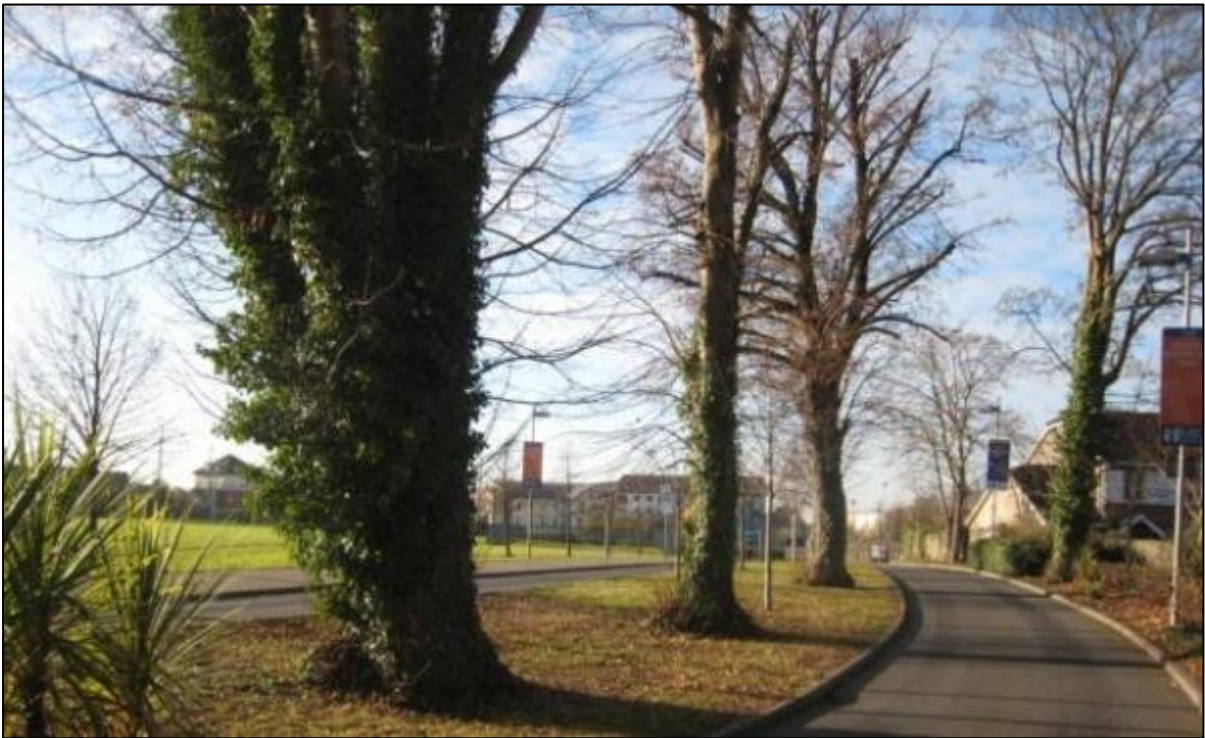
Photograph 49 North-western part of the wooded stand associated with Ashbourne House's parkland, 1840-1870 (H on Figure 38) Note:- New drive follows former wooded drive.

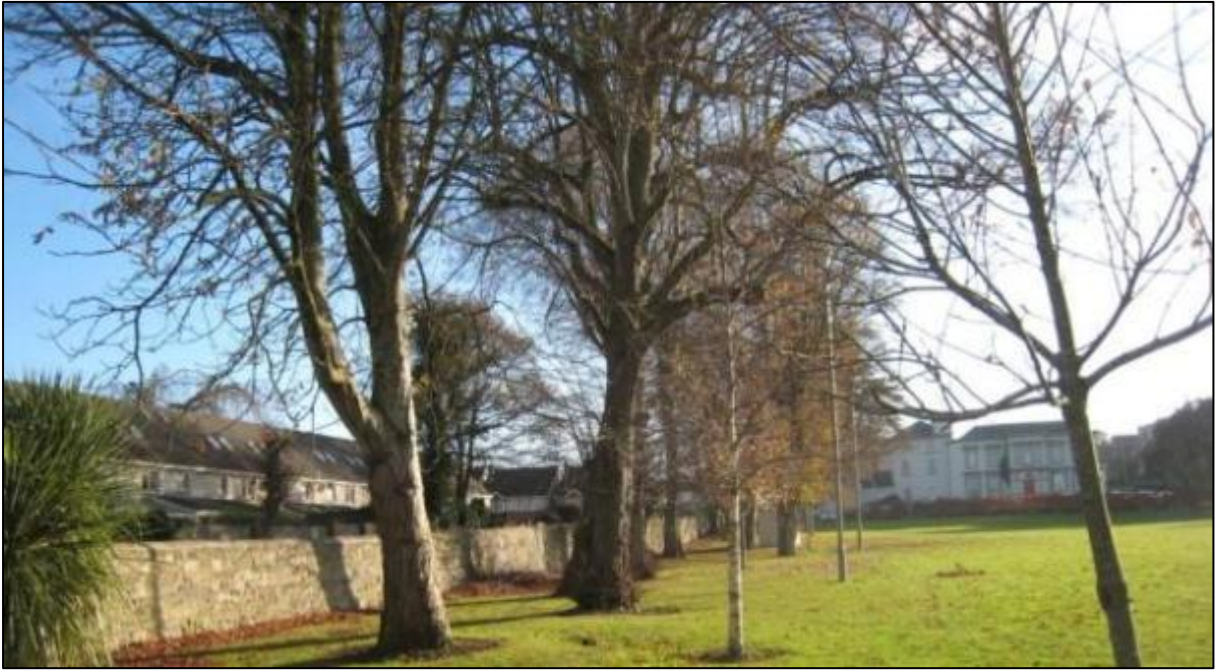
Photograph 52 Historic tree stand bounding Summerville House parklands with Summerville House in the background (I on Figure 38)

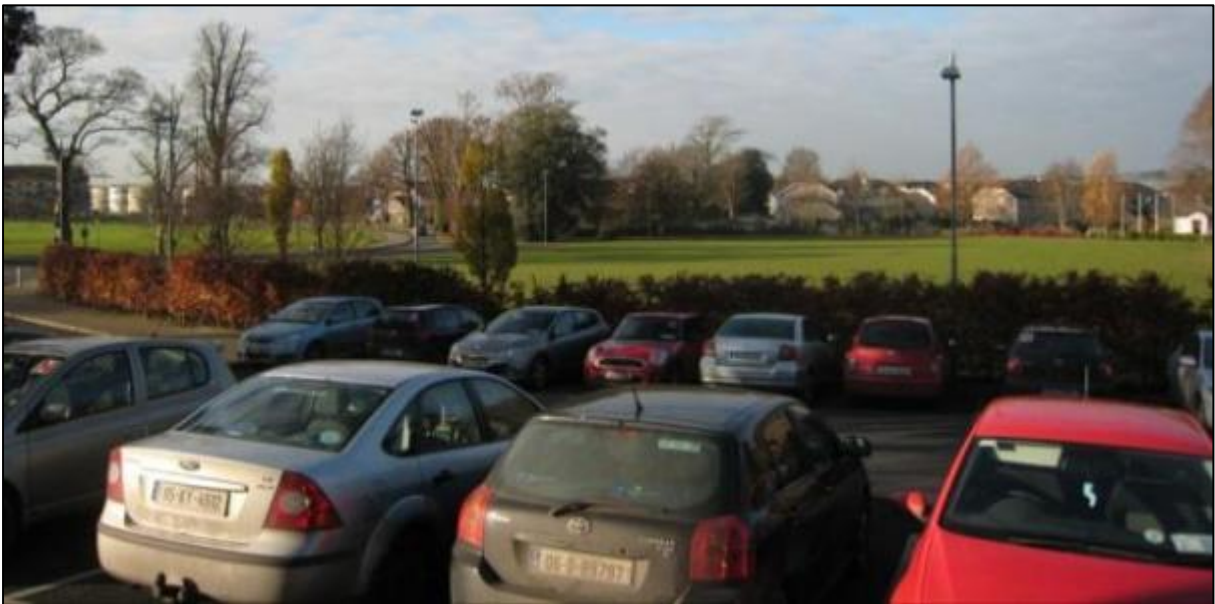
Photograph 53 Historic parklands in front of Summerville House with the former parkland of Ashbourne House to the left. Car park occupies the space immediately in front of Summerville House and severs it from its landscape.

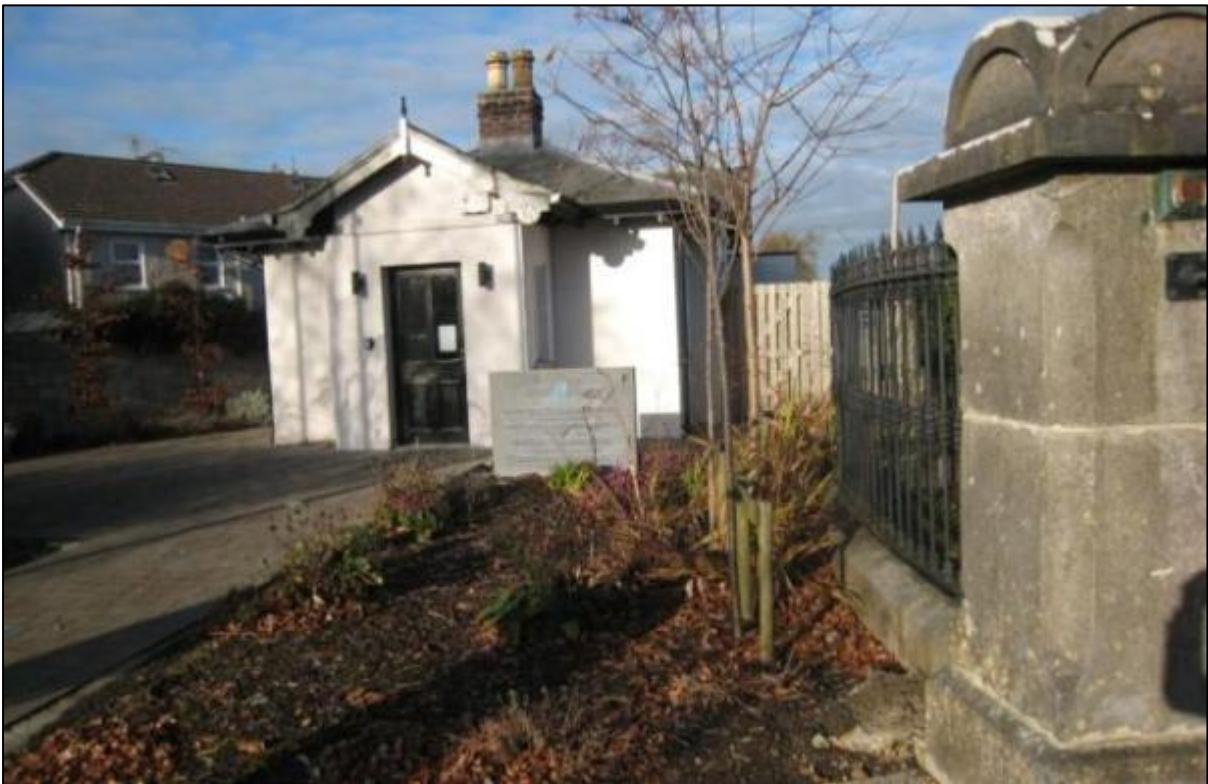
Photograph 55 Gate lodge and entrance to Summerville House 1840-1870. This accommodated a new sweeping drive to the house in the English parkland style.

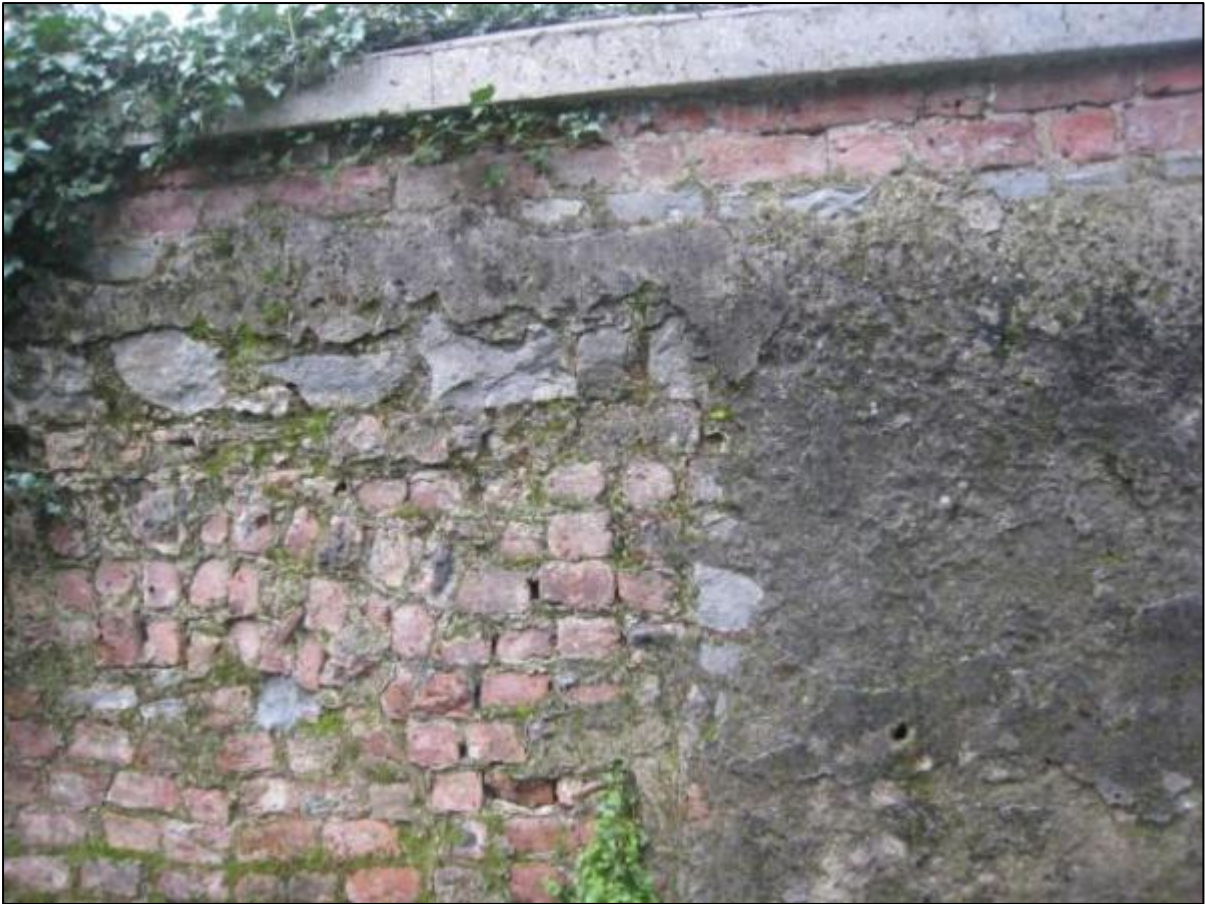
Photograph 56 Section of remaining pre-1840 boundary of the walled garden of Summerville House

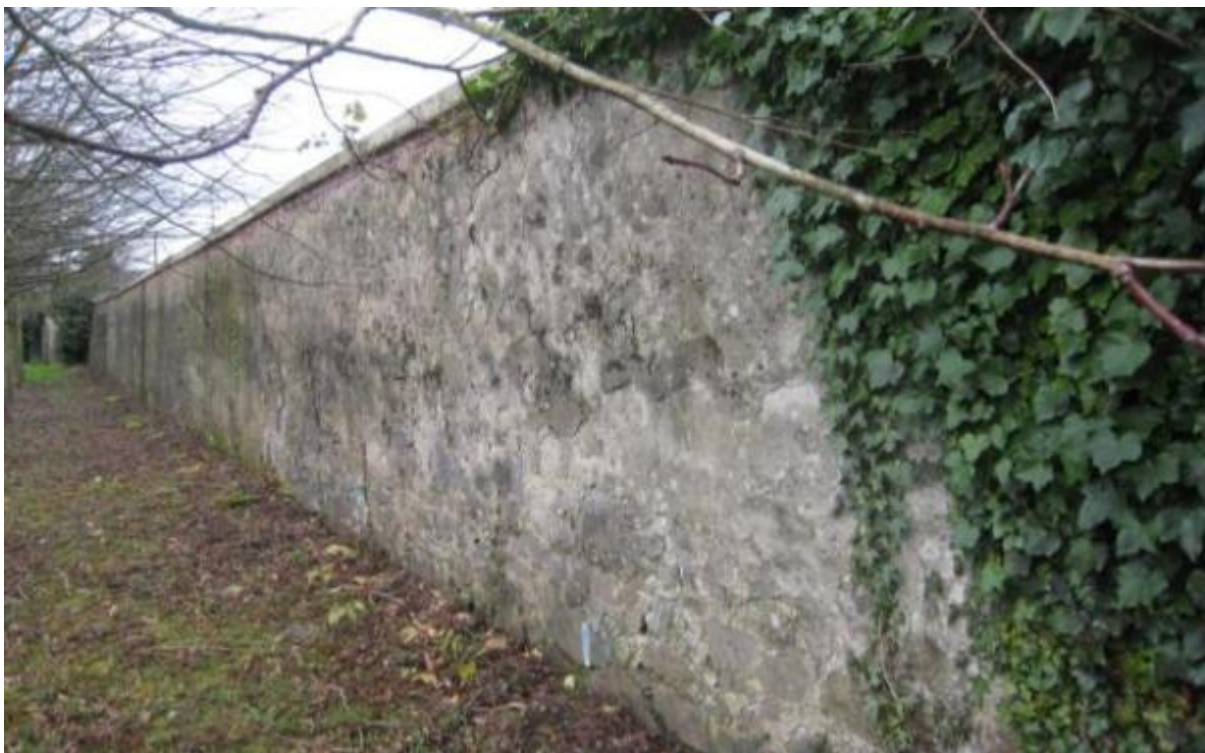
Photograph 57 Section of remaining pre-1840 boundary of the walled garden complex of Summerville House

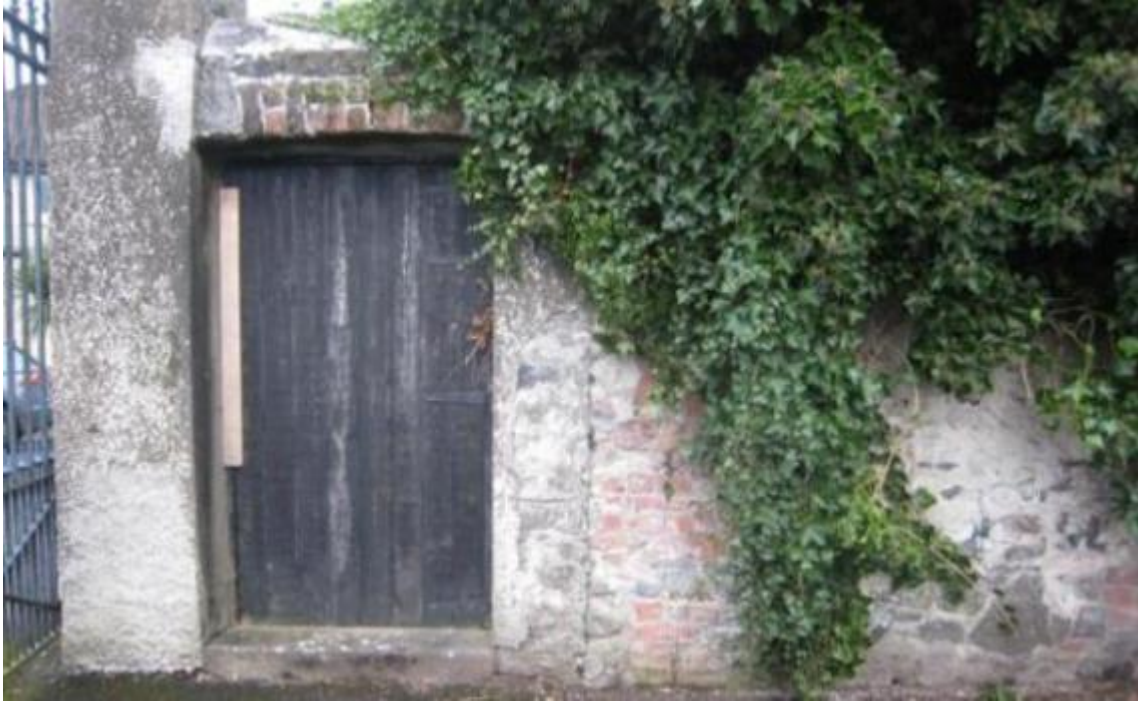
Photograph 58 Section of remaining 1840-1870 additions to the walled garden and entrance to Summerville House

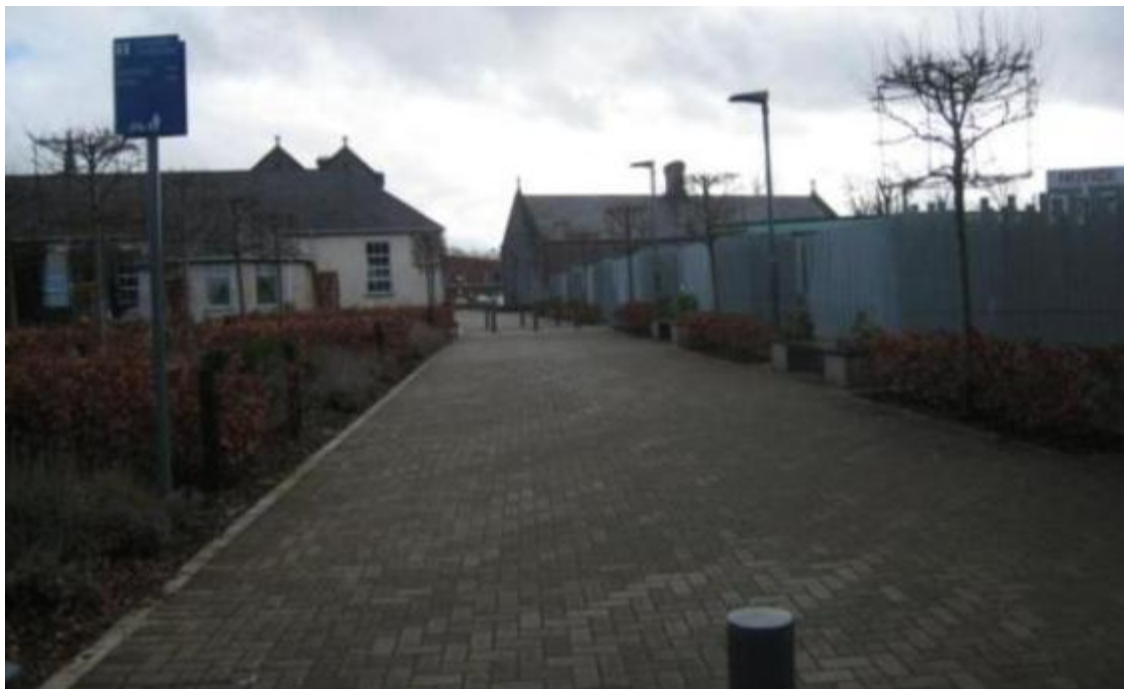
Photograph 59 New landscape scheme to the west (front entrance) of Mount St. Vincent.

Mount St. Vincent landscape has been altered with a newly designed scheme to the front of the former convent grounds – photograph below. The garden and lodge house to the west of the convent grounds remains largely as it was laid out in the 1870s map. New buildings have been constructed along the southern boundary, but the former tree lines remain. The central courtyard space associated with the original designed landscape has been built upon and only partly remains.

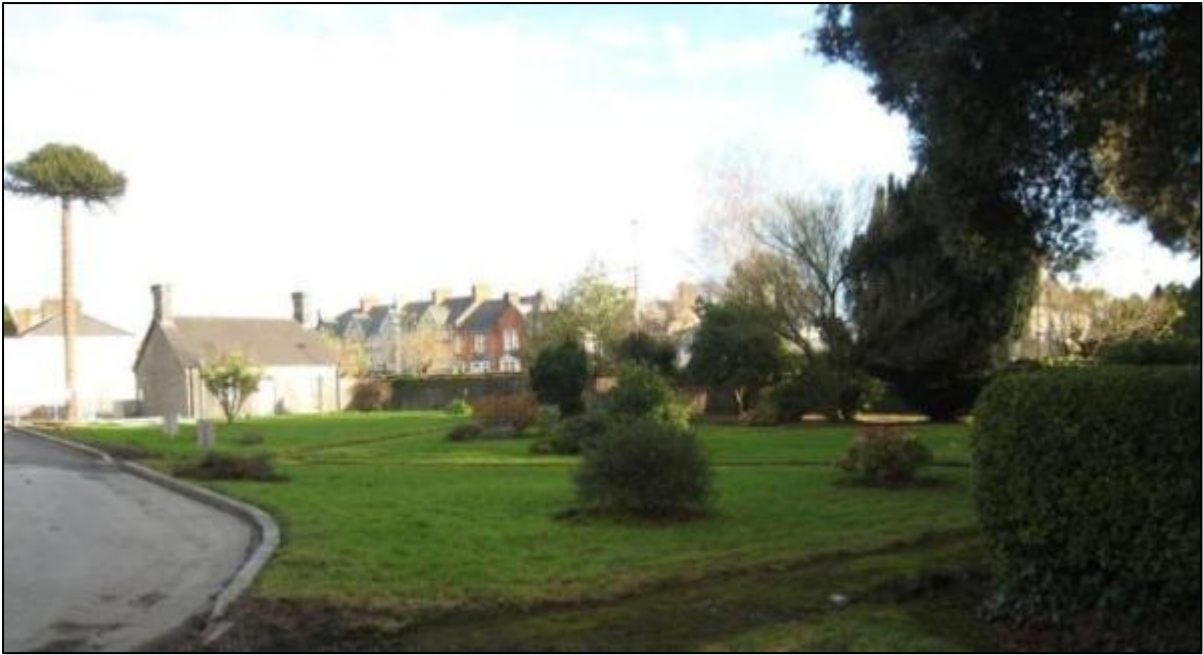
Photograph 60 Historic garden associated with original convent largely remains in structure, but layout has changed. Former lodge house remains

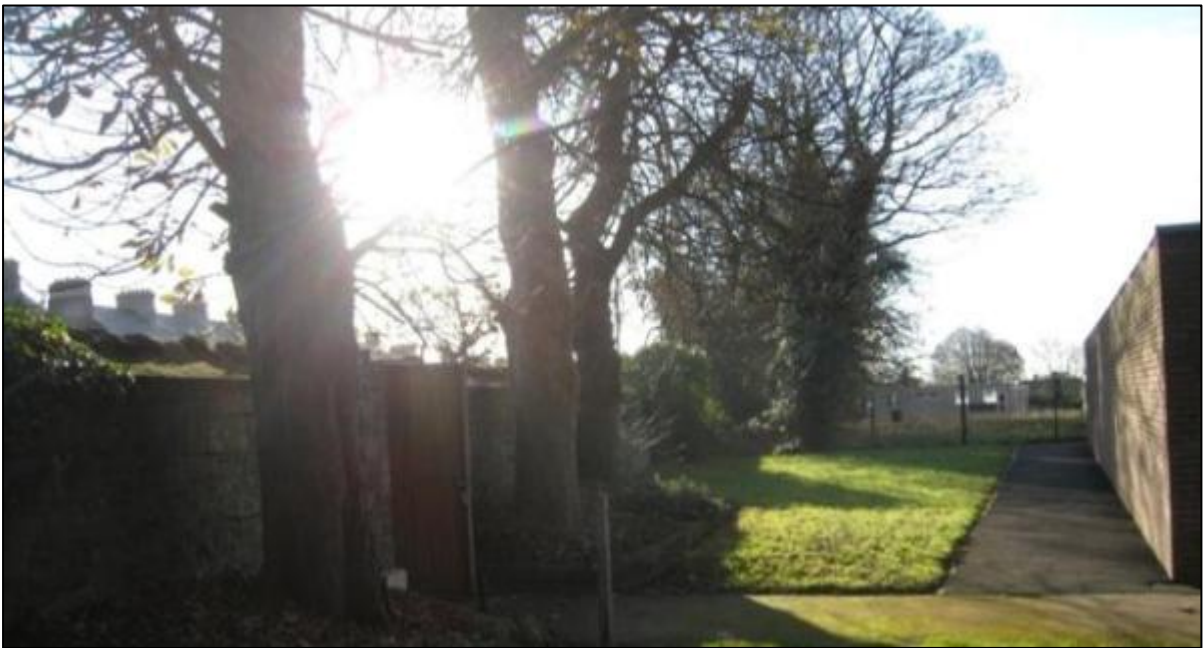
Photograph 61 Tree-lined eastern boundary of Mount St, Vincent (K on Figure 38)

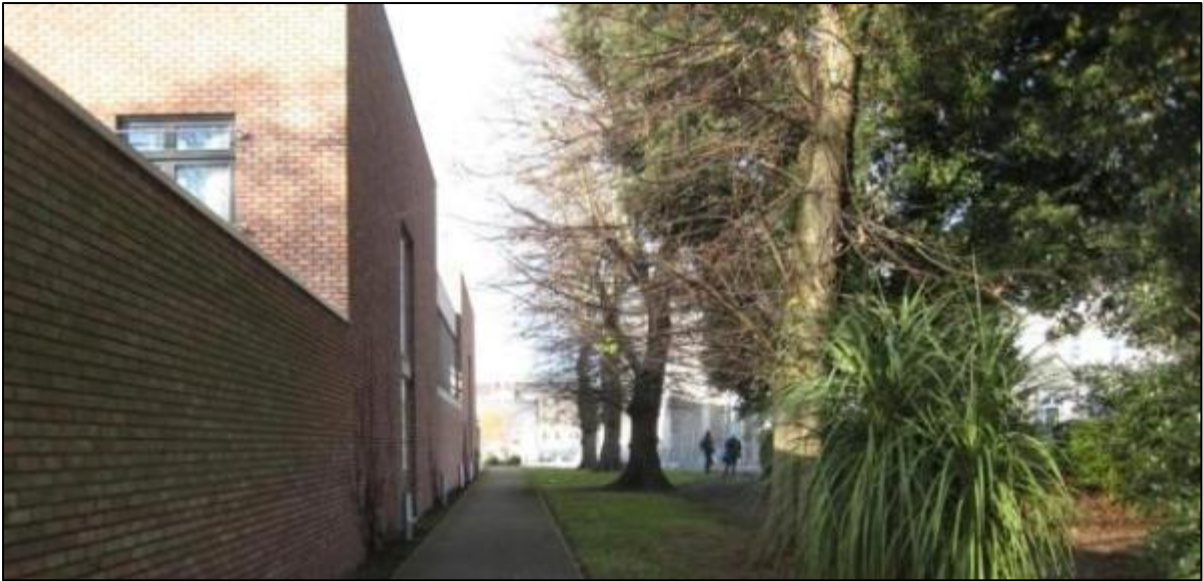
Photograph 62 Tree-lined edge to the historic garden at Mount St. Vincent's remains (J on Figure 38)

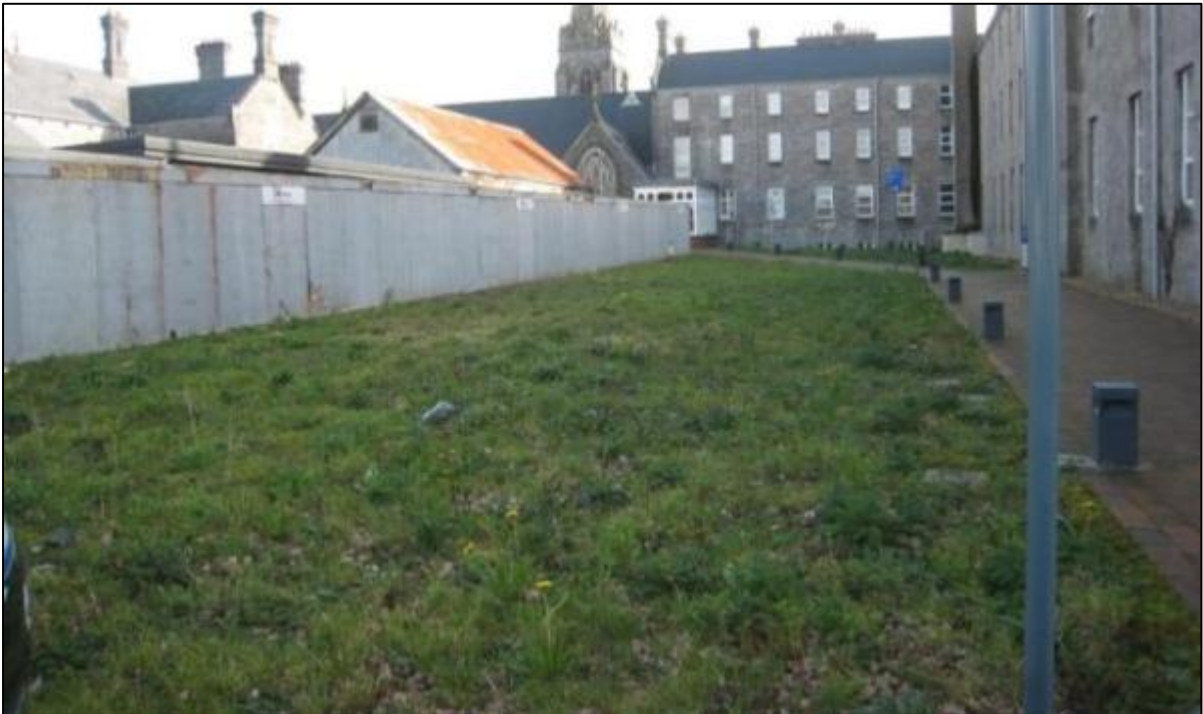
Photograph 63 Former courtyard space of Mount St. Vincent's has been built upon and its layout altered

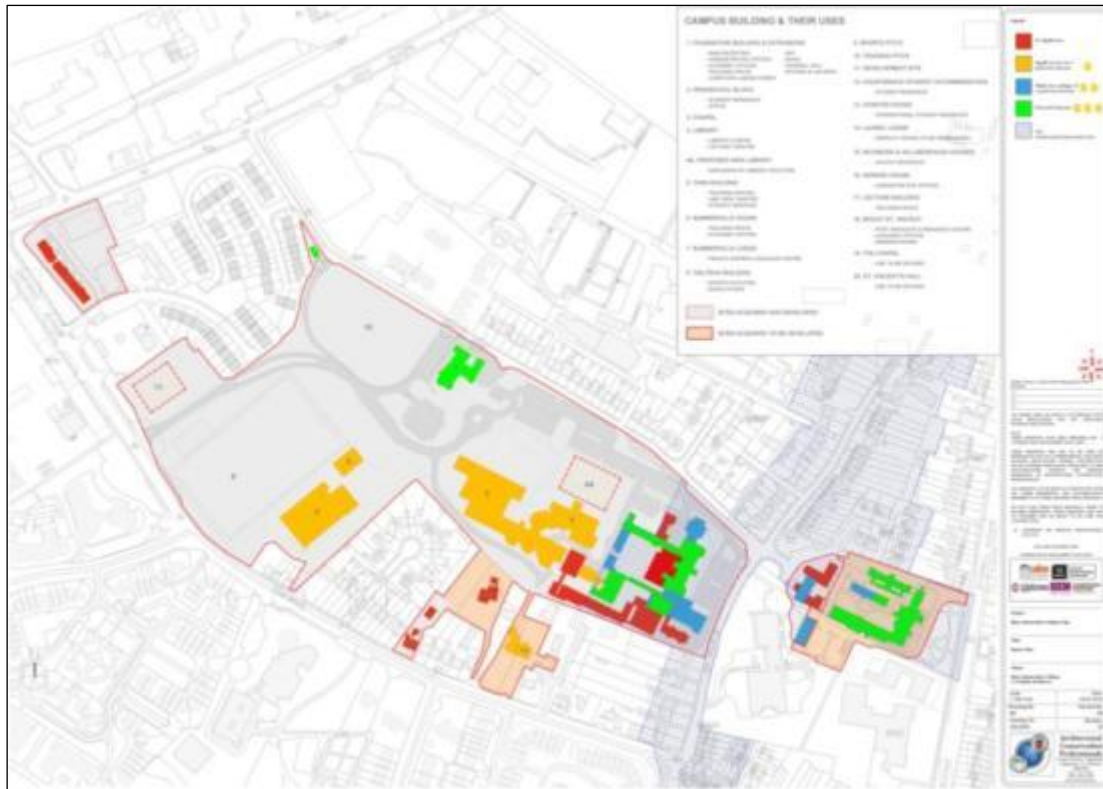
Figure 40 Masterplan showing location of buildings and significance ratings – Refer to Appendix B

Building Name	Master Plan No	Note	Significance
Foundation Building	1	Main Building	★ ★ ★
Foundation Building	1	Extension (restaurant), Halla and new entrance /reception	★ ★
Foundation Building	1	Modern flat roof extensions to west – courtyard side	
Recreation Hall	none	all	★ ★ ★
Residential Block	2	all	★ ★ ★
Single story buildings		Forming western part of courtyard enclosure	★ ★
Modern facility buildings to north of Residential Block			
MIC Chapel and St. Cecelia's Corridor	3		★ ★ ★
Part of corridor to west of recreation hall			★ ★
Modern buildings to the south of the Chapel		Including staff coffee lounge	
Library	4		★
Former Convent Building (Brick Structure)			★
Tara Building	5		★
Summerville House	6		★ ★ ★
Summerville Gate Lodge	7		★ ★ ★
Tailtean Building	8		★
Courtbrack Student Accomodation	12		
O'Dwyer House	13		
Laurel Lodge	14		
Richmond & Hillsborough Houses	15		★
Gerard House	16		★ ★
Modern building extensions to Gerard House

Lecture Building	17		★ ★
Mount St. Vincent convent	18		★ ★ ★
Mount St. Vincent chapel	19		★ ★ ★
Mount St. Vincent Hall	20		★ ★ ★
Modern buildings adjacent to Mount St. Vincent Hall			★ ★
Widows Home			★ ★ ★

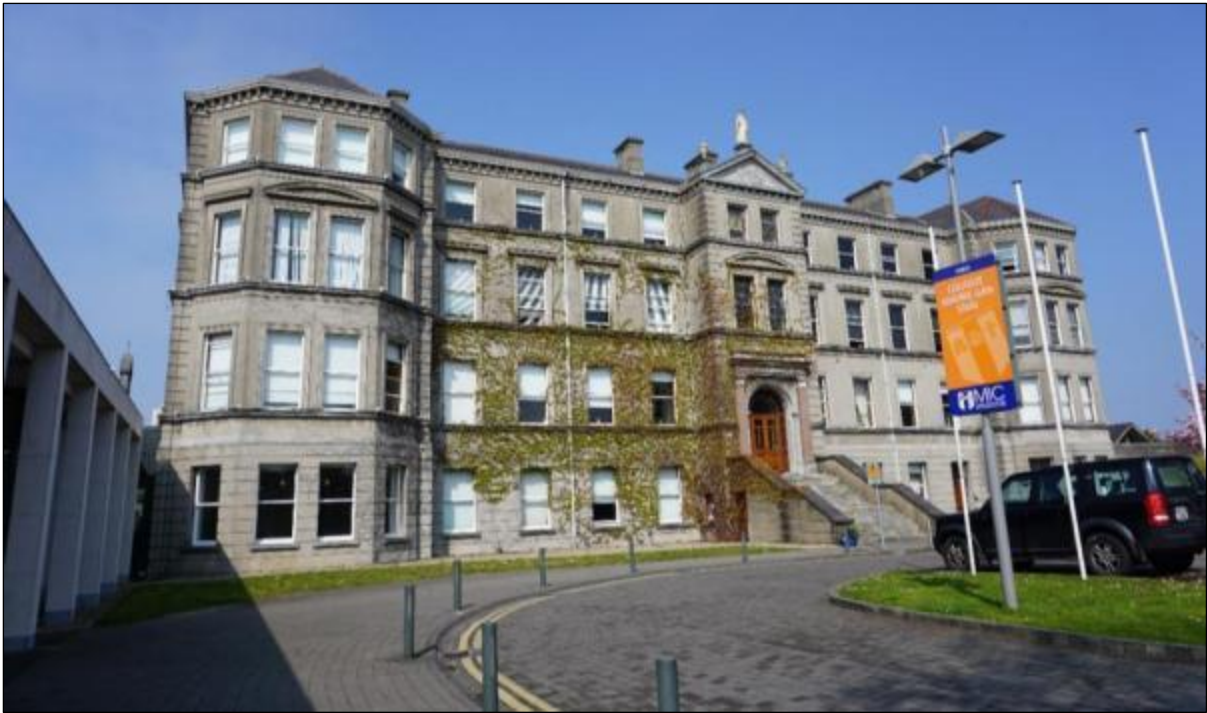
Photograph 64 Mary Immaculate College Foundation Building Front Elevation

The foundation building from the front façade remains much as it was originally designed. While it is surrounded by numerous extensions the overall standing of the building remains as was initially intended. However, to the rear there are several additions that diminish the original building form.

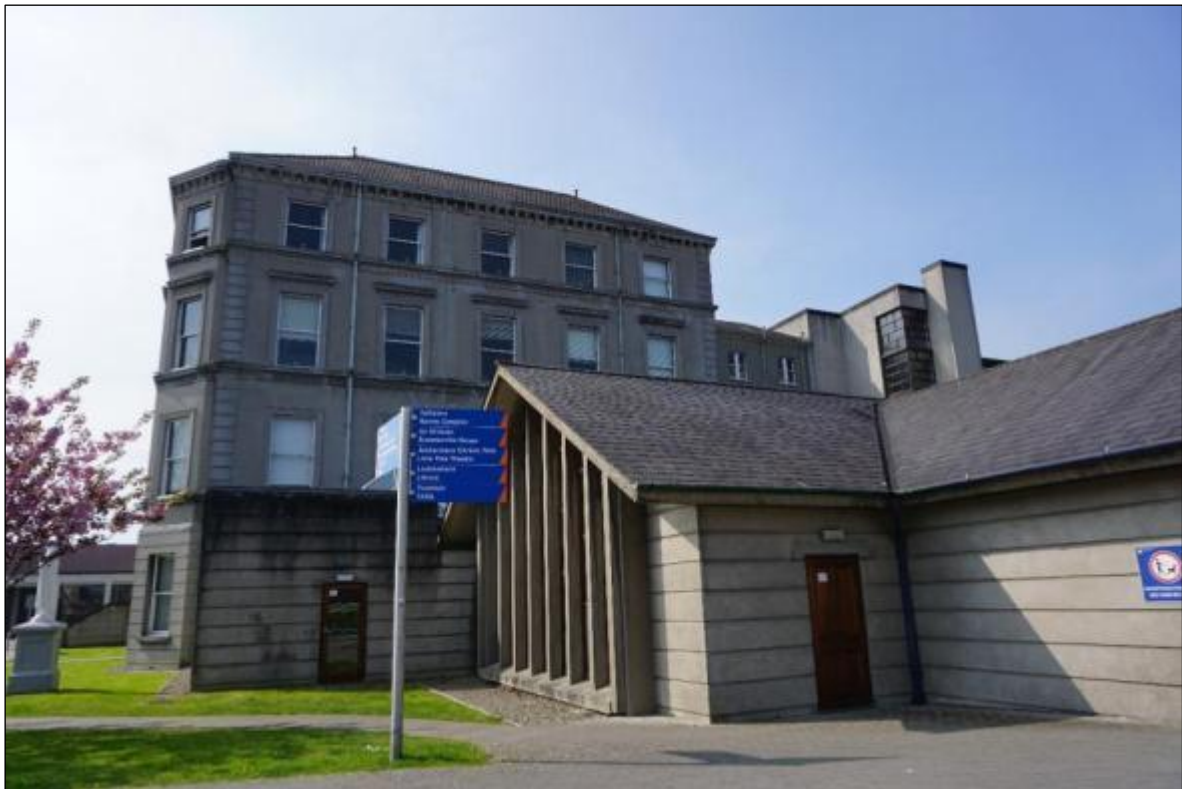
Photograph 65 Mary I Foundation Building Side Elevation

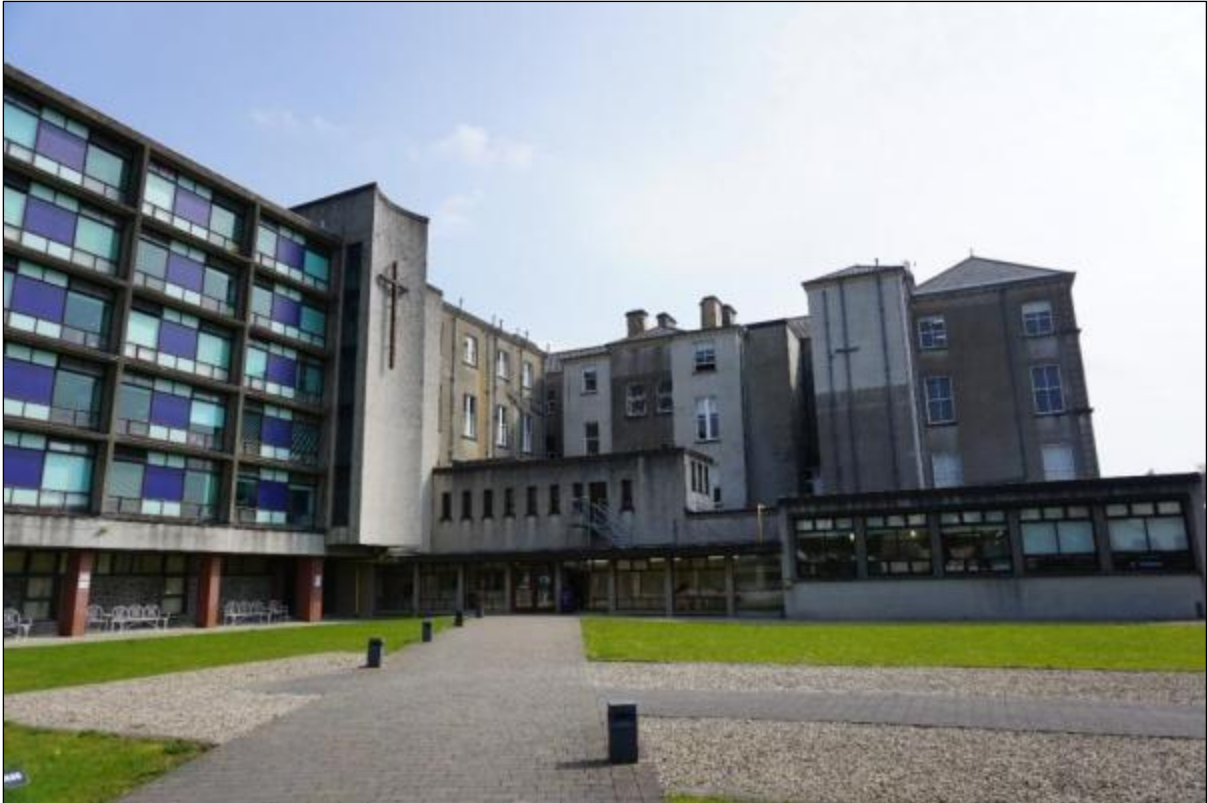
Photograph 66 Mary I Foundation Building Rear Elevation

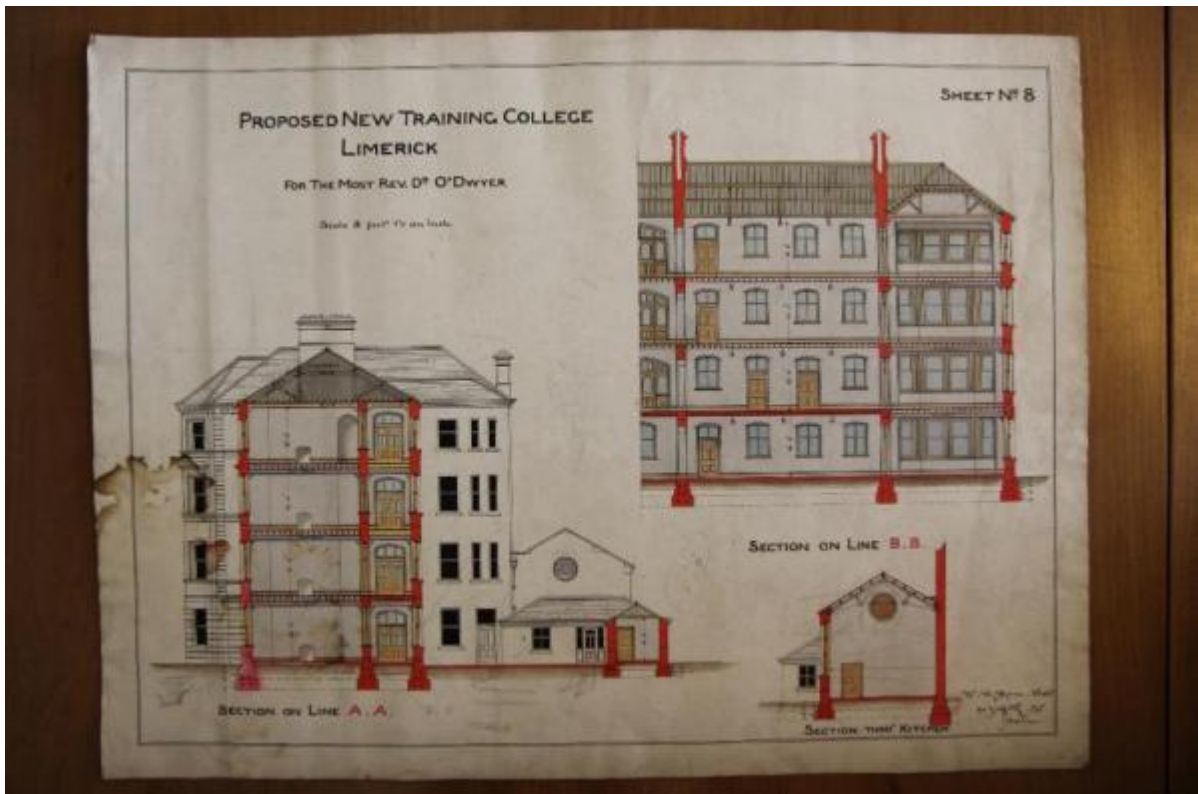
Figure 47 Mary Immaculate College Section Drawings - Irish Architectural Archive
