Conservation & Management Plan

Mary Immaculate College, Limerick

Client: Mary Immaculate College

Date: April 2020

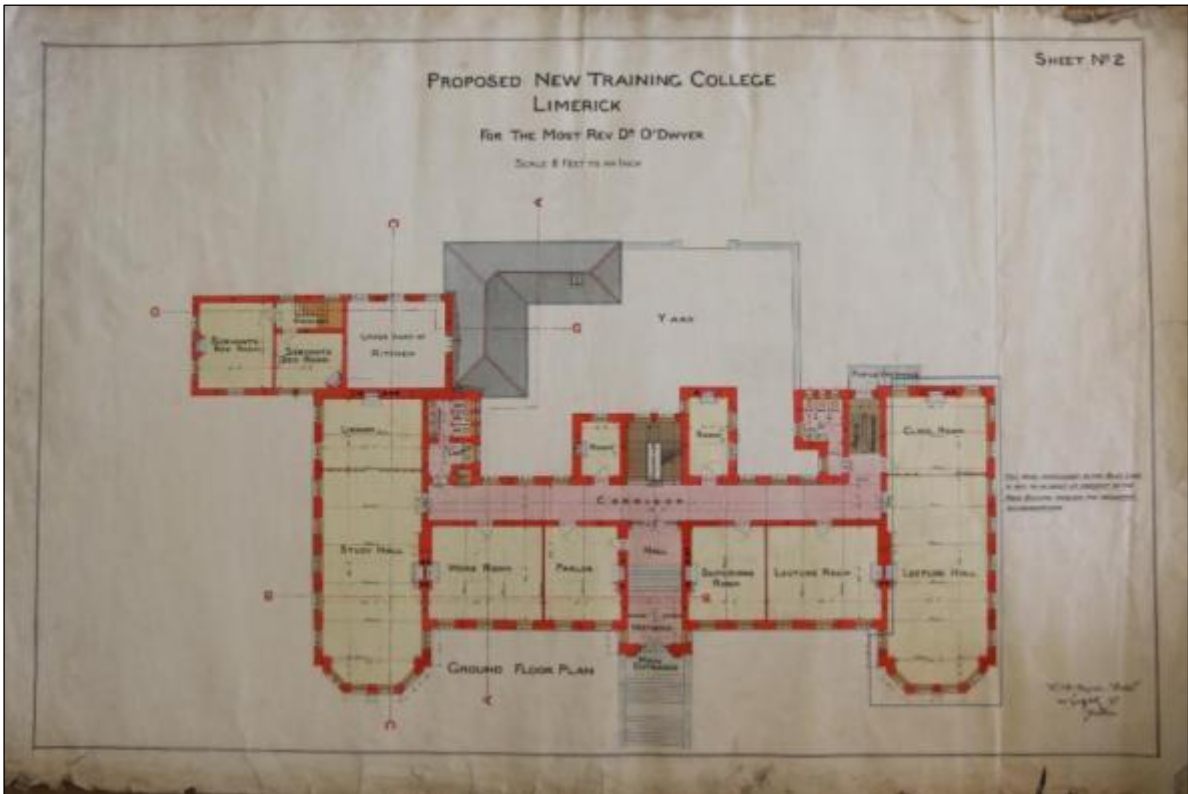
Figure 49 Mary Immaculate College Ground Floor Plan - Irish Architectural Archive Irish Archive

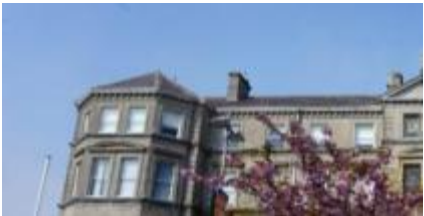
Roof	Pitched natural slate roof with crested terracotta ridge tiles; with interlocking secondary pitched natural slate roof structures.

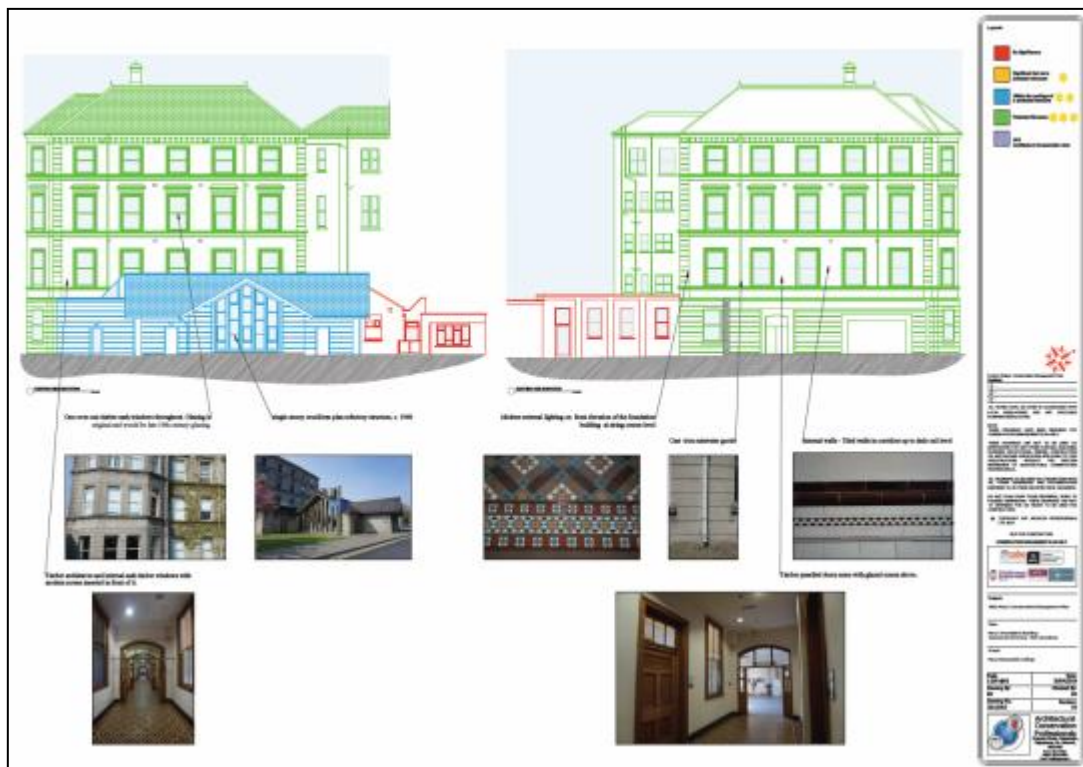
Figure 54 Foundation Building Assessment Drawing– Refer to Appendix B

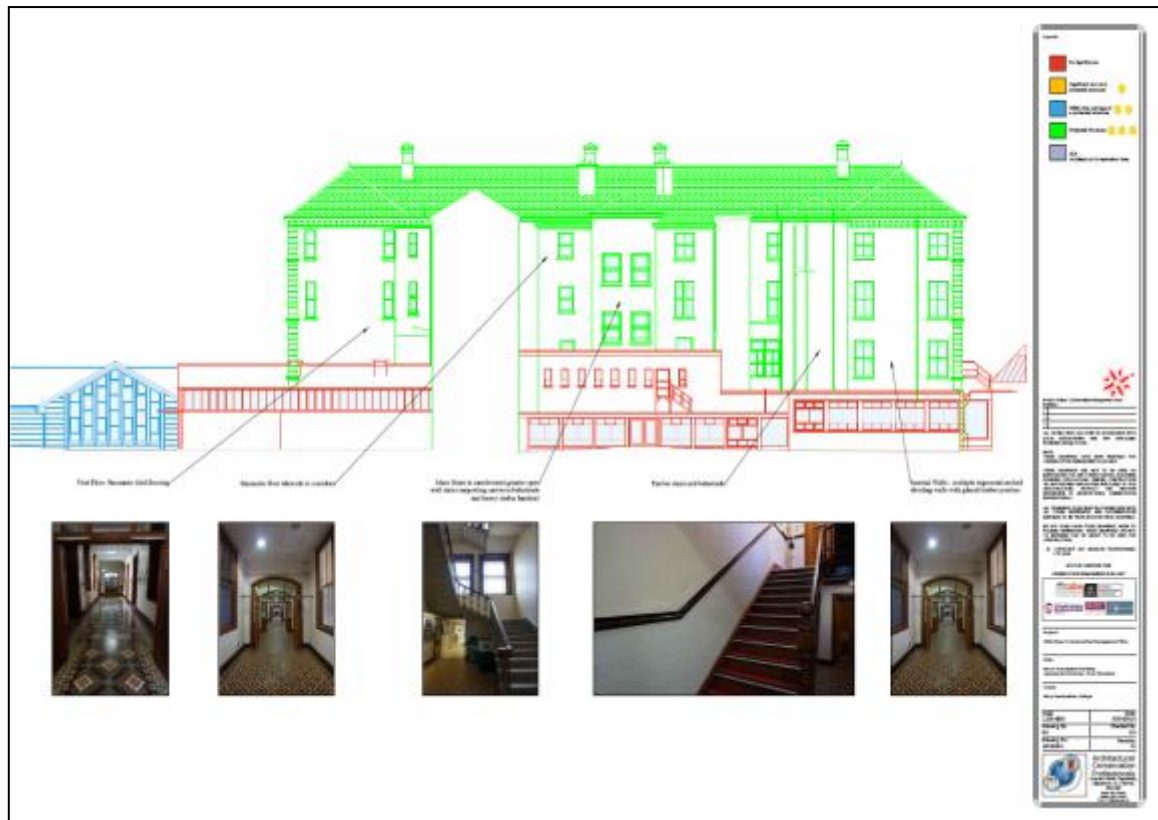
Figure 55 Foundation Building Assessment Drawing – Refer to Appendix B

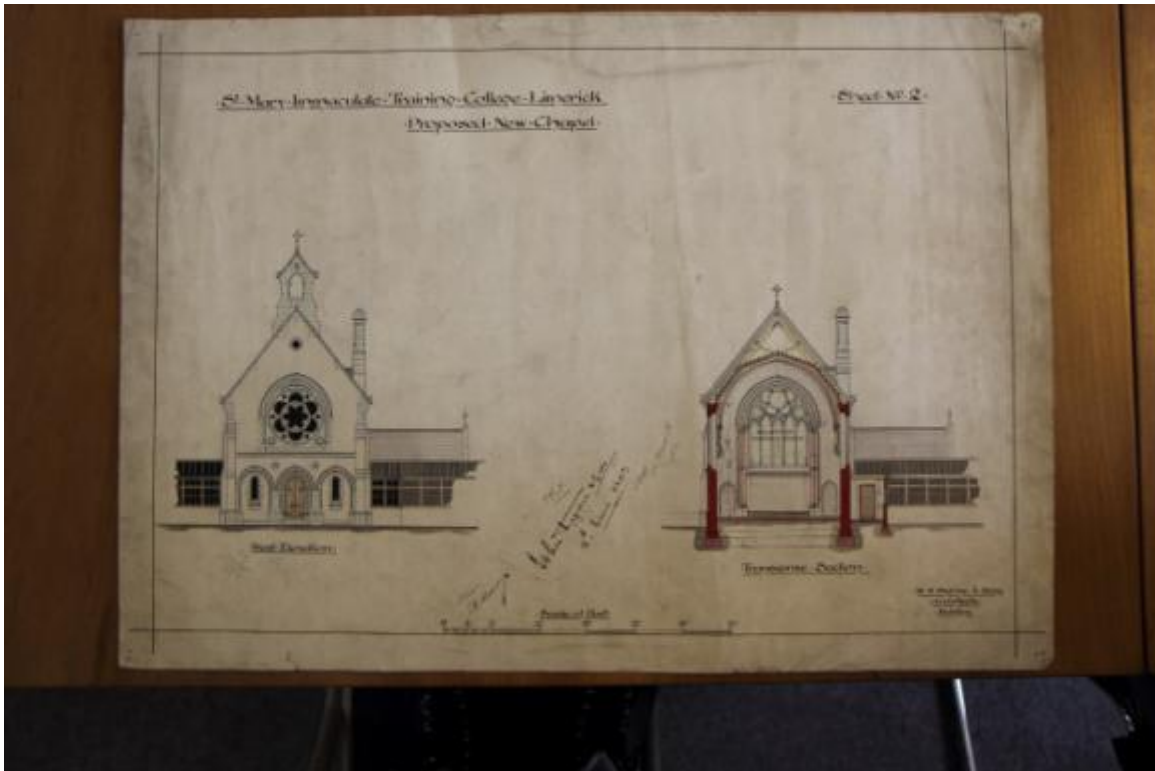
Figure 59 Proposed New Chapel - William Henry Byrne 1903 - Irish Architectural Archive

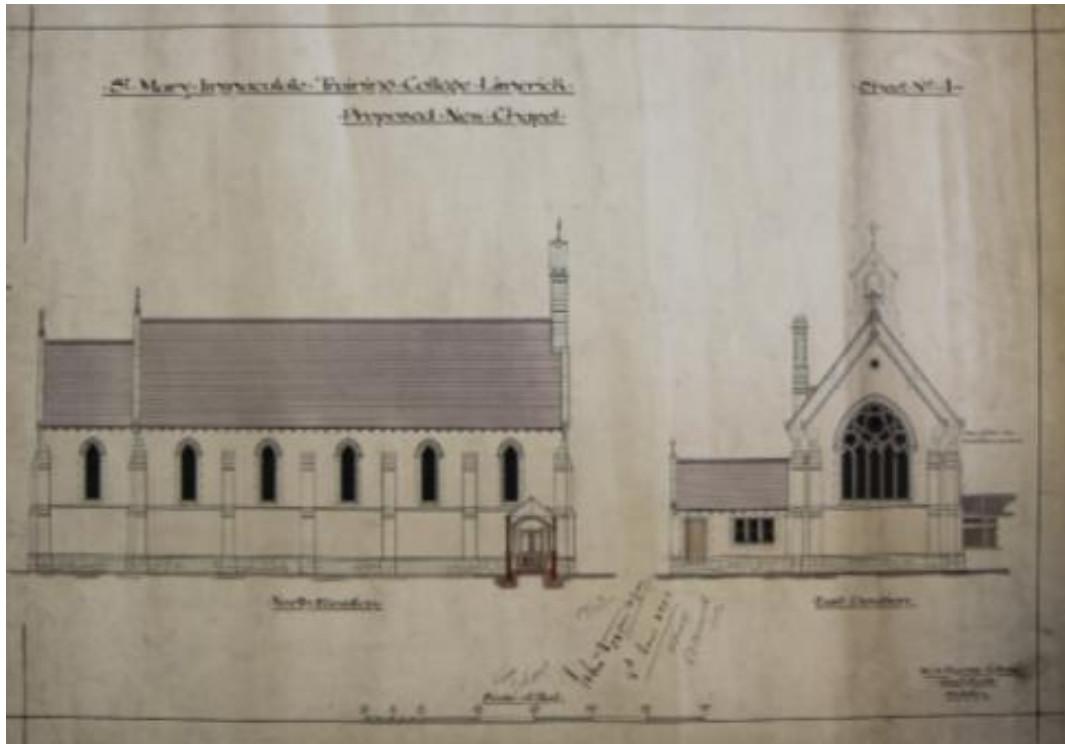
Figure 61 Proposed New Chapel - William Henry Byrne 1903 - Irish Architectural Archive

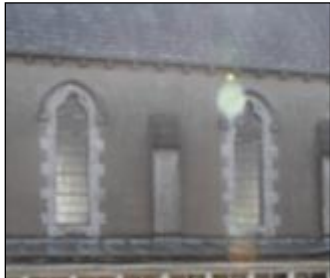
Original - 1903	☆☆☆
Large arch Window rear Elevation	Located above the alter, this Curvilinear tracery		Original - 1903	☆☆☆

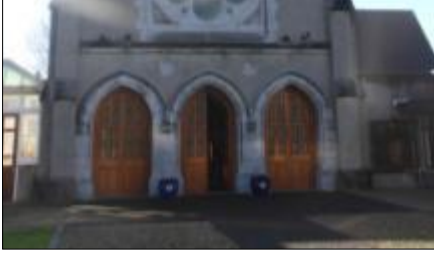
Doors on front facade	with cut stone arch surrounds and hood moldings above.

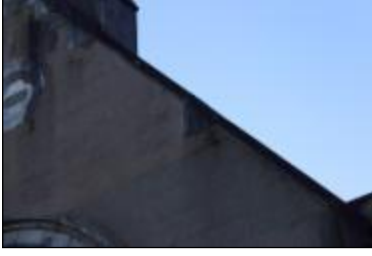
Original - 1903	★ ★ ★
Masonry walls	Cut limestone walls with limestone ashlar quoin stone detailing and detailing around windows and doors.

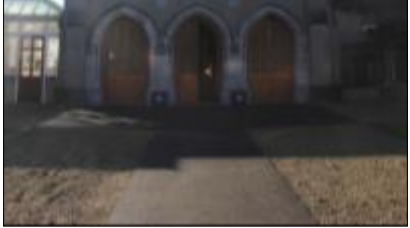
Modern - Installation date unknown	Not Significant
Paving	Stone paving located with the courtyard at the front of the chapel

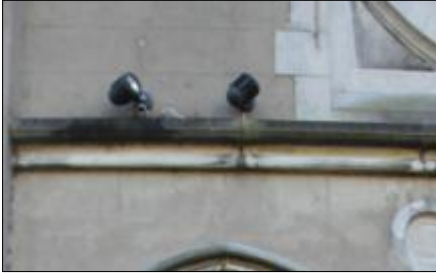
Modern - installation date unknown	Not Significant
Lighting	Modern external lighting on the side of the chapel

Modern - installation date unknown	No Significance and detracts from character of the building
Ground Lighting	Modern external lighting on ground in front of the chapel		Modern - installation date unknown	Not Significant

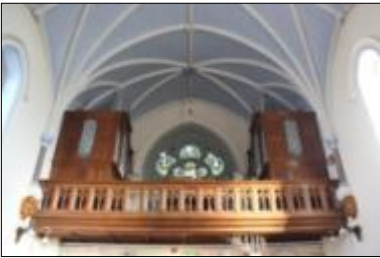
1950s	<p>★ ★ ★</p>
Choir Gallery	Located above the entrance, timber railing and timber ceiling and floor.

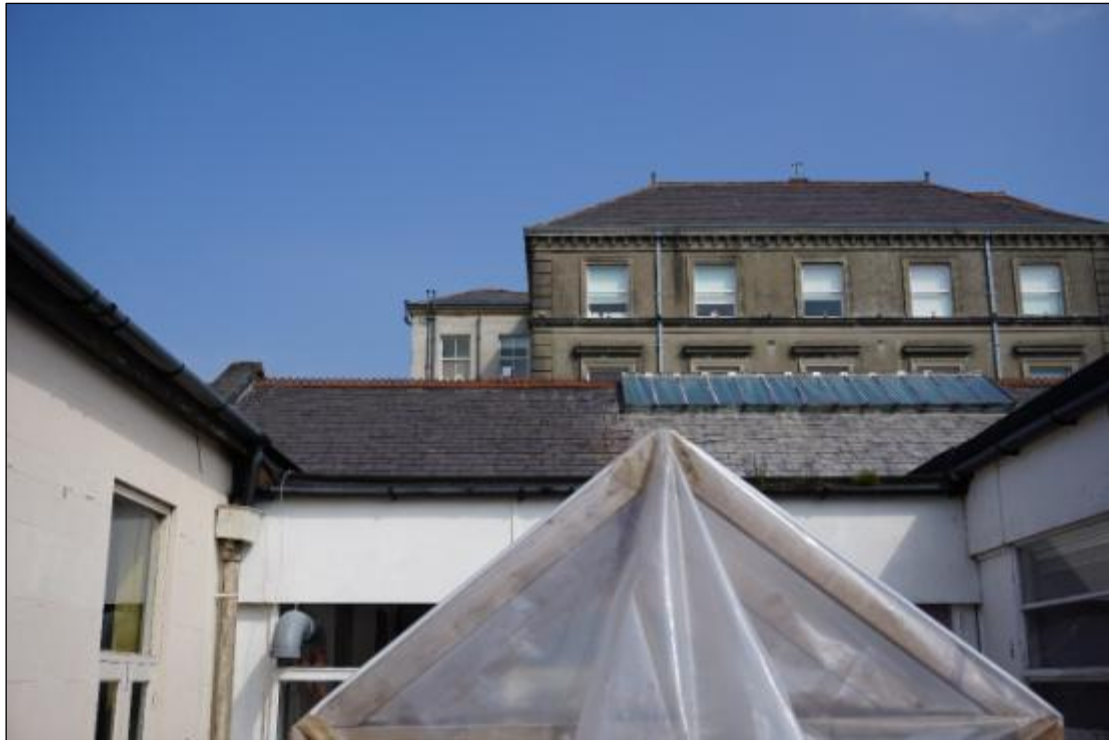
Photograph 77 External View of the recreational Hall showing natural slate roof.

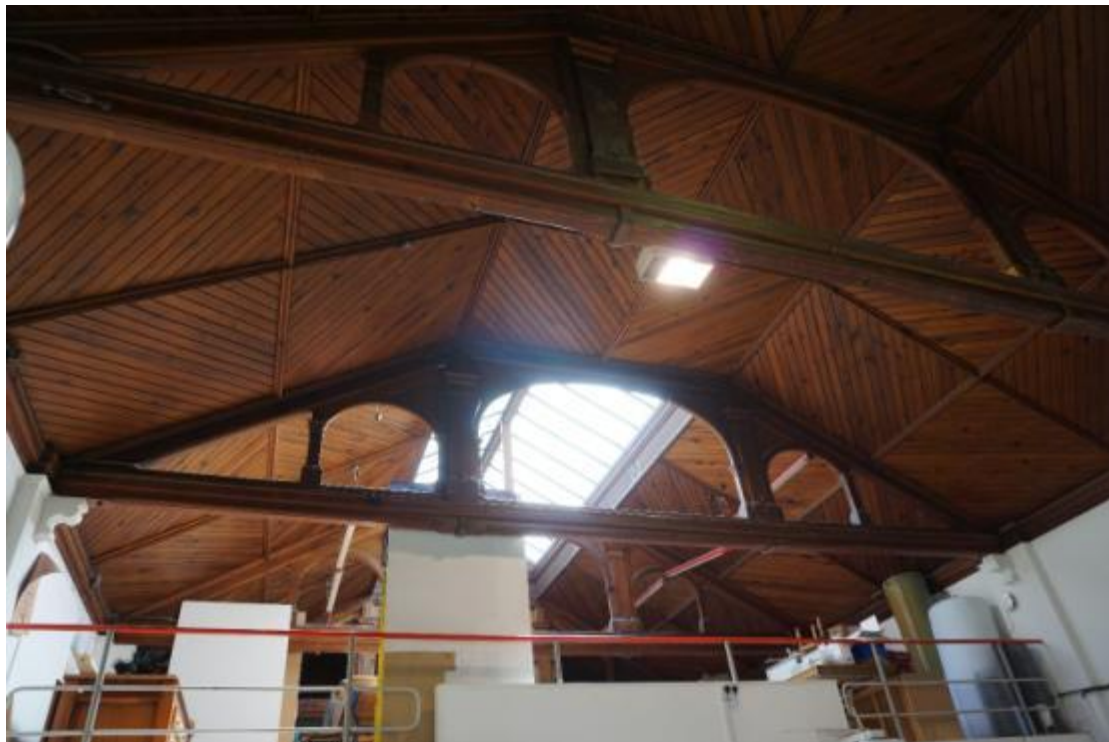
Photograph 78 Internal View of the recreational Hall showing Hammerbeam Roof and Mezzanine Level

The ceiling then has tongued and grooved paneling laid in diagonal pattern. The interior has been modified to house an art room with internal partitions in the centre of the room that hold a mezzanine level above. The original high ceiling allows for adequate space in the mezzanine above and a close up view to the detailing of the roof structure. The exquisite hammer beam trusses are still present within the structure and combined with the paneled tongue and grooved ceiling it provides an insight into the buildings original character and form. The roof light within the centre of the building is left much intact but the glazing has been replaced. Much of the other features of the building have long been replaced and modern fittings have been installed throughout.

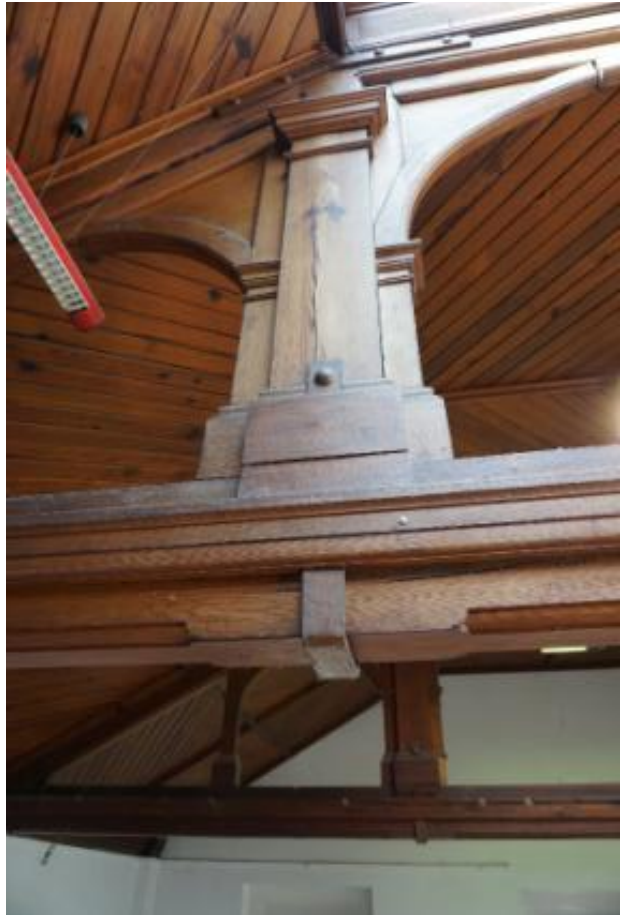
Photograph 79 Roof Structure Detail

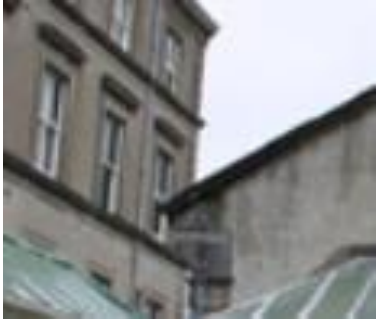
<p>Quoin stones</p>	<p>Exposed quoin stones on the gable ends of the building</p>

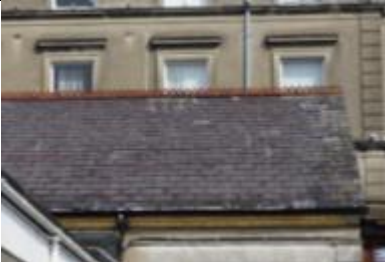
<p>1901</p>	<p>★ ★ ★</p>
<p>Eaves</p>	<p>Brick eaves detailing exposed on side elevation of building.</p>

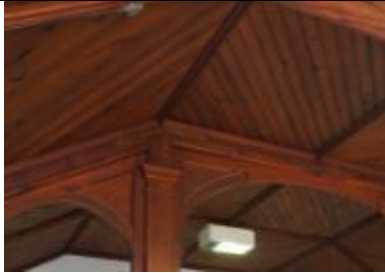
1901	☆☆☆
Ceiling	Tongue and grooved paneled ceiling that follows the slope before leveling off.

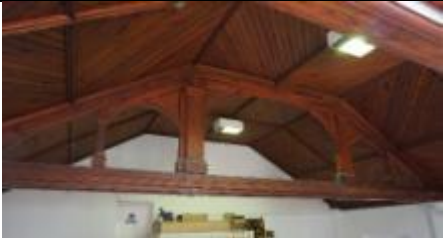
Roof Trusses	4 no. Hammerbeam Trusses

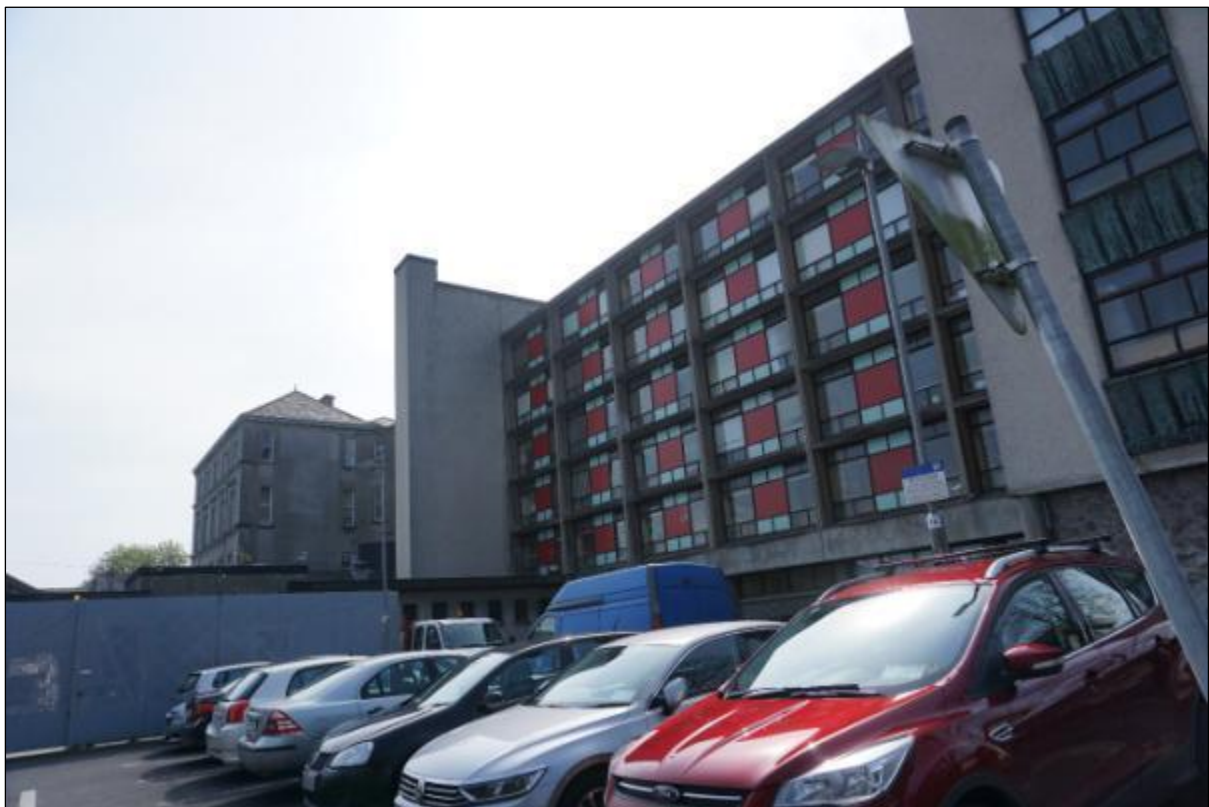
Photograph 80 Residential Block side elevation

The building is designed with a modular elevation forming a reinforced concrete grid framing timber-framed casement windows with coloured panels to north and south elevations. The smaller final elevation is made up of curved stair core and modular patterns.

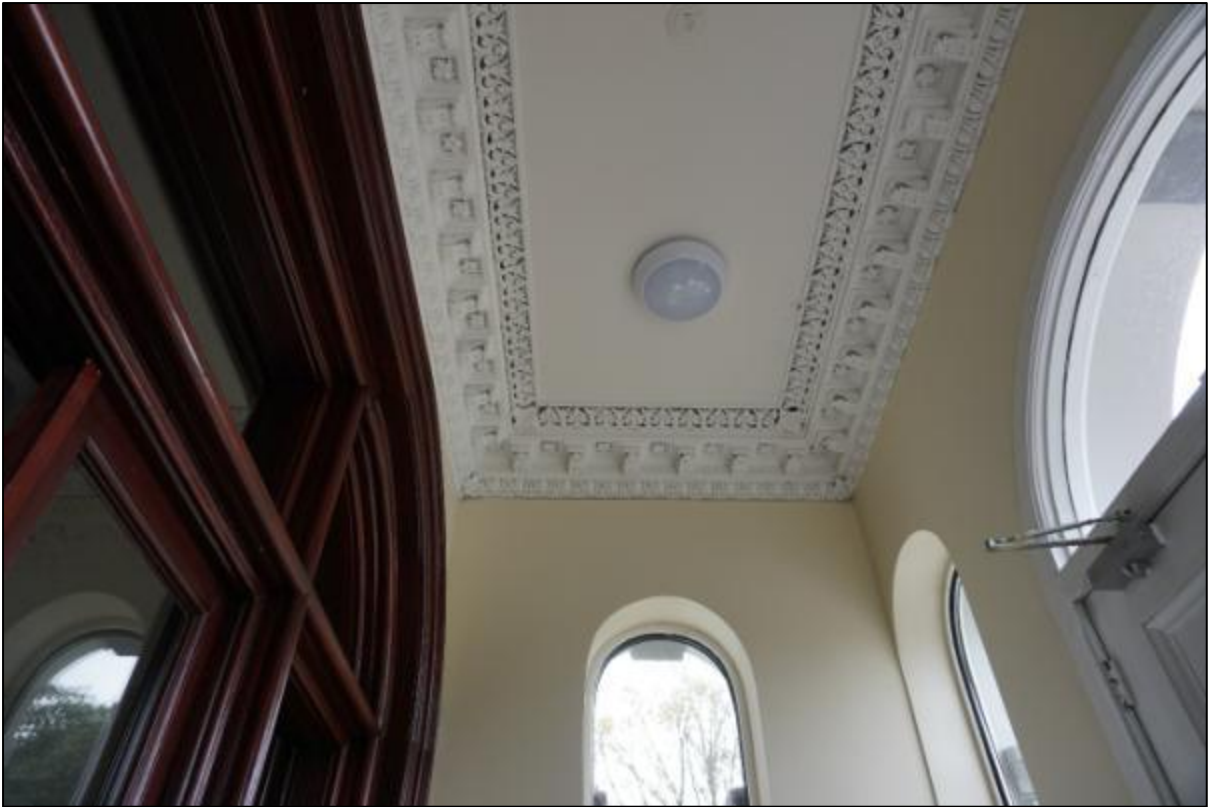
Photograph 91 Cornice detailing

Internally much of the intricate cornice detailing and moldings remain with the central staircase remaining much intact. Most of the rooms have been updated with modern fit out and finishes. There are modern stairs and a lift shaft installed within the building. The extensions to the rear houses lecture rooms and computer rooms. There are offices on the ground floor and lecture rooms in the larger spaces. The first floor houses more class rooms and offices with the final floor home to administration.

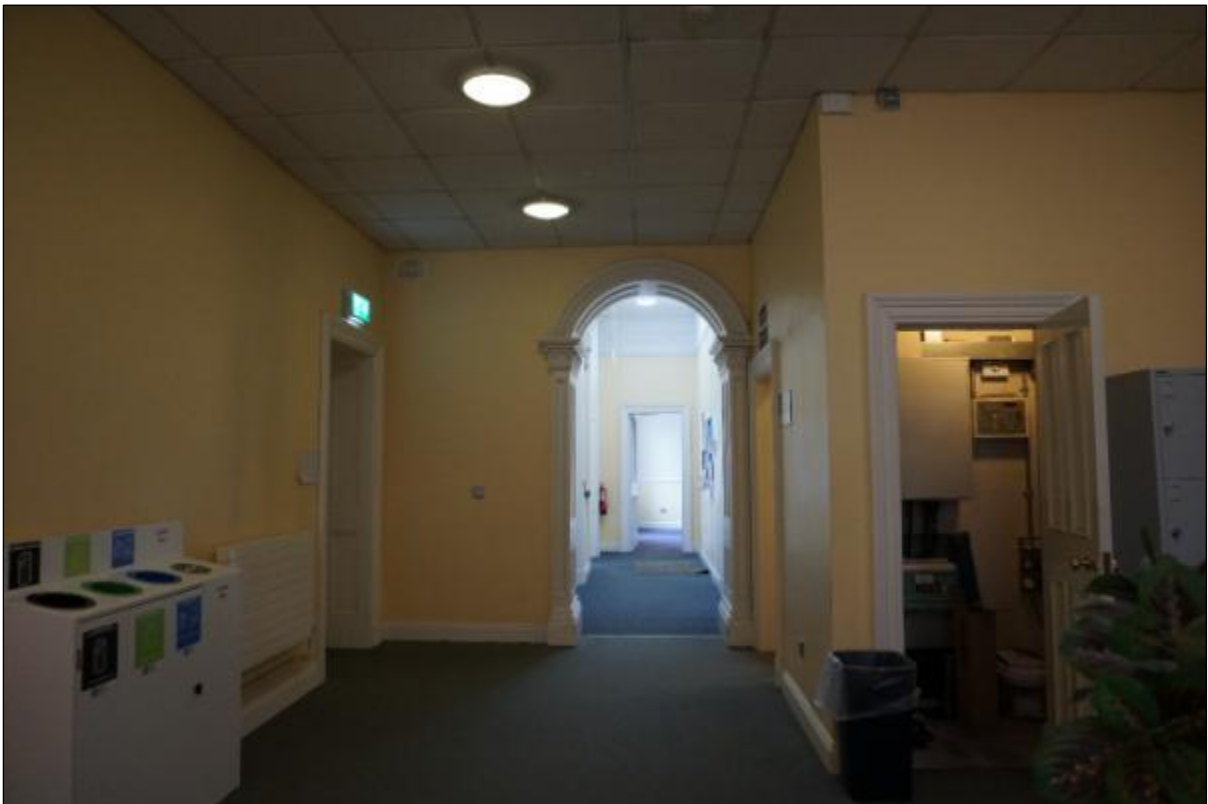
Photograph 92 Internal View showing architraves and modern fitout.

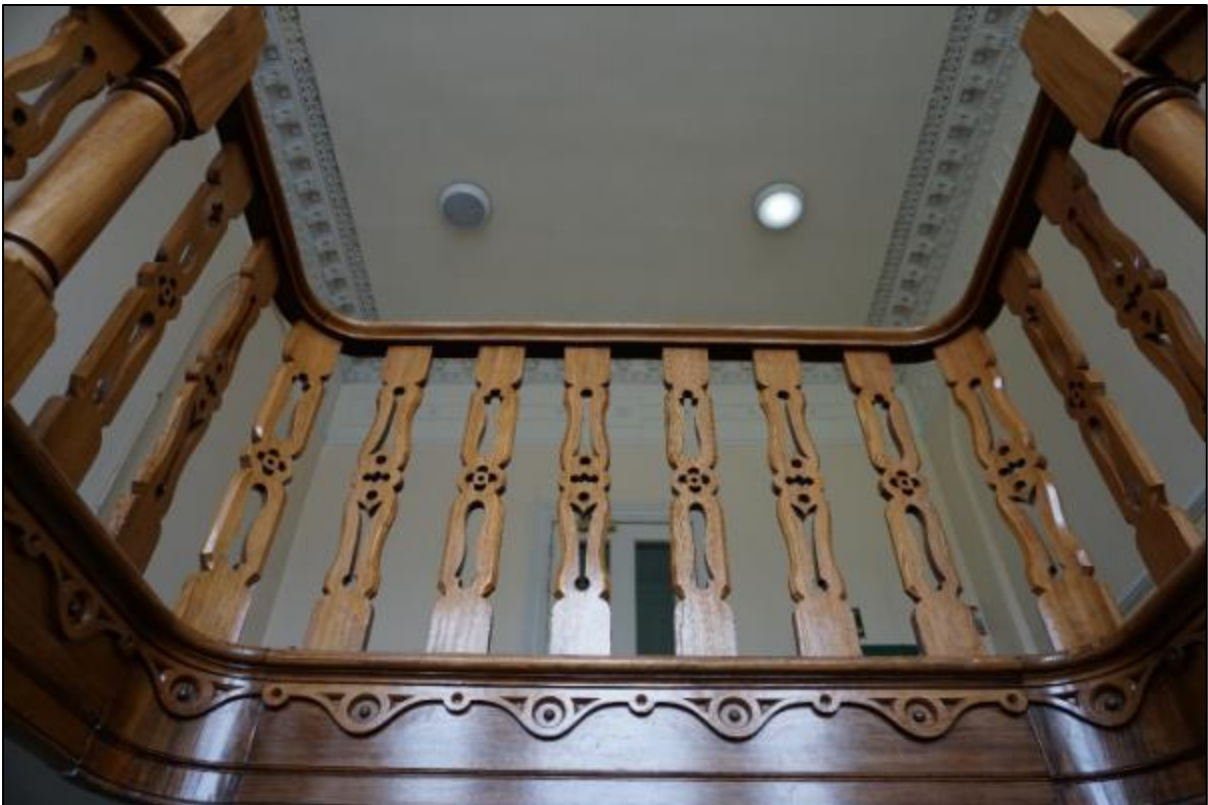
Photograph 94 Railing detailing on main stairs

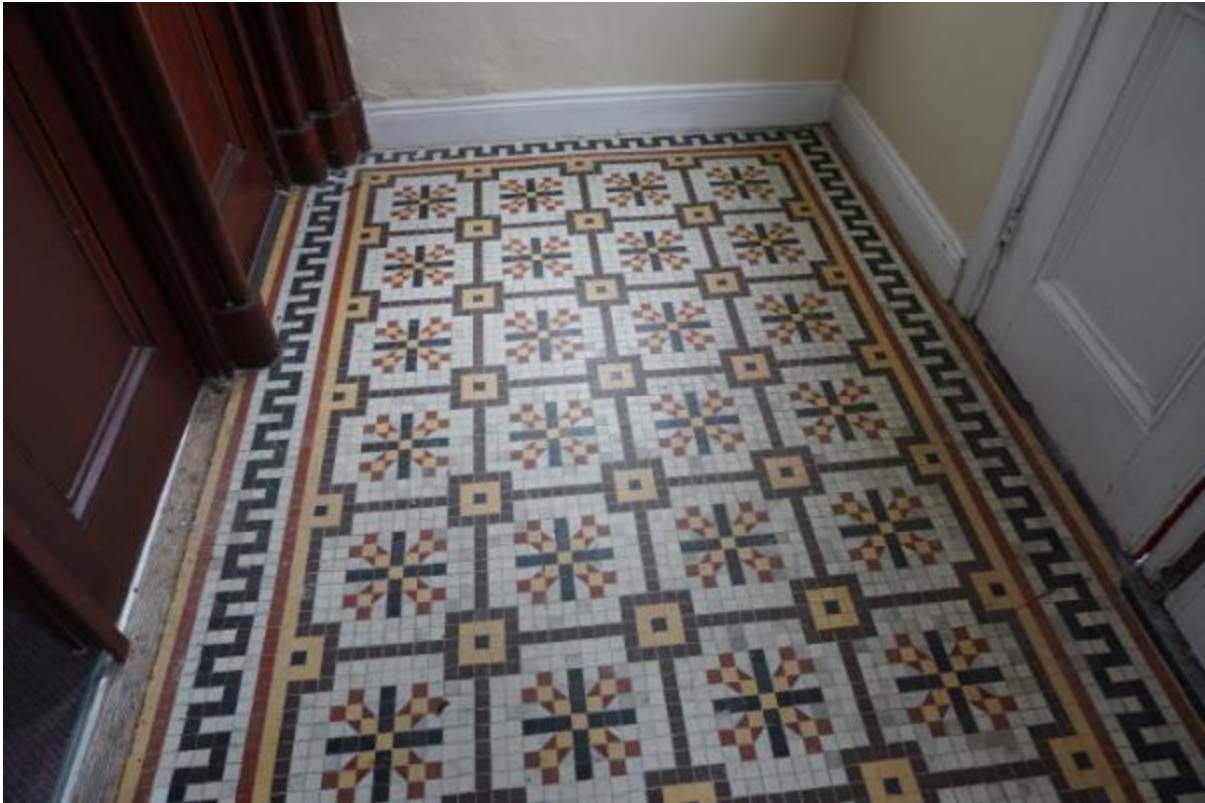
Photograph 95 Encaustic tile floor in Entrance Porch

Element	Description:	Photo	Period Built:	Level of Significance:
Entrance Porch	Entrance porch and hall with stylised Corinthian panelled pilasters and archivolt		1800s	☆☆☆
Flooring	Entrance porch with encaustic tiles

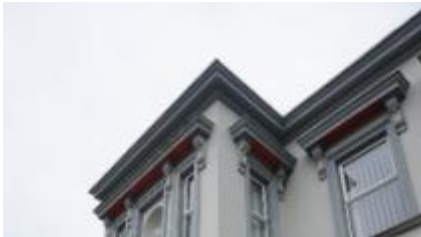
1786 +1800s	☆☆☆
Eaves	Parapet entablature around the original main building.

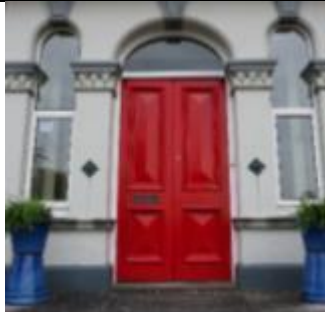
★ ★ ★
Form and Layout	Three-storey three-bay wing attached to northwest and extending south-eastwards with various neatly contained single-bay and two-storey ranges, and a multiple-bay single-storey wing to northeast breaking forward to front		1800/1900s additions	★ ★ ★
Windows	replacement uPVC windows		Modern

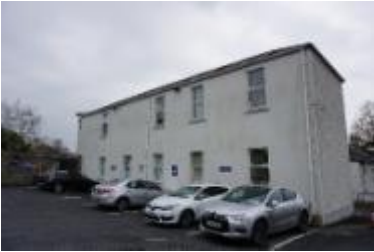
Rear extension	Two storey extension housing teaching spaces and computer rooms.

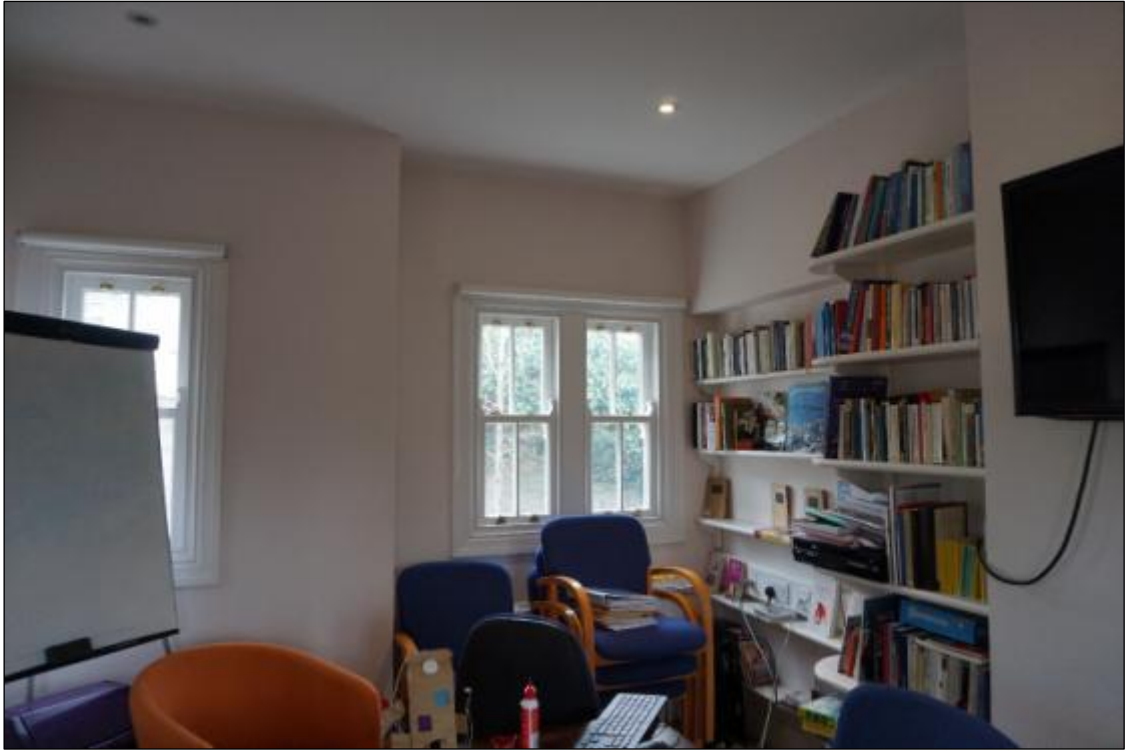
Photograph 98 Internal View showing modern fitout

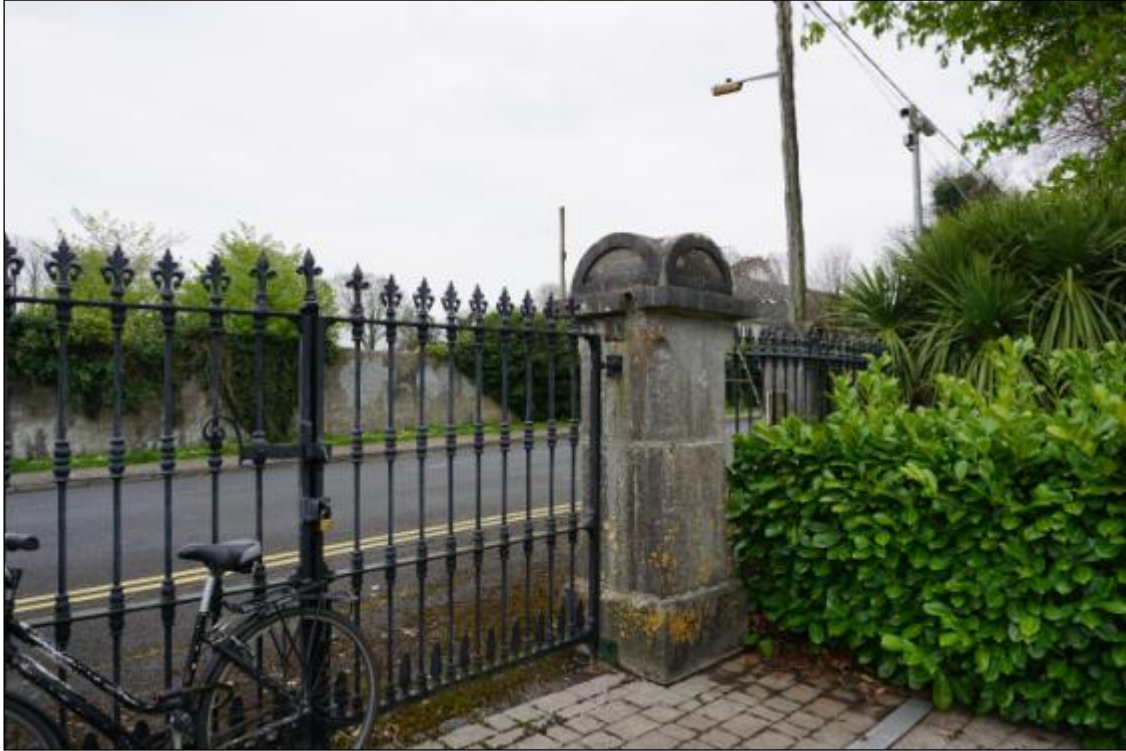
Photograph 100 Gates (not original) and limestone pillars adjacent to the Gate Lodge

<p>Original</p>	<p>★ ★ ★</p>
<p>Gateway – gates and railings</p>	<p>The original gates, railing and fixings were completely replaced in recent years with a modern mild steel substitute.</p>

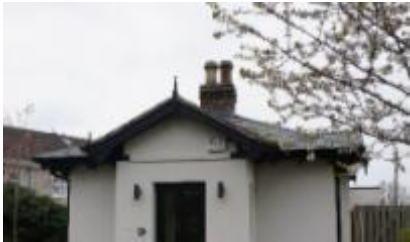
1870s	☆☆☆
Chimney	Red brick chimneystack with two octagonal clay pots.

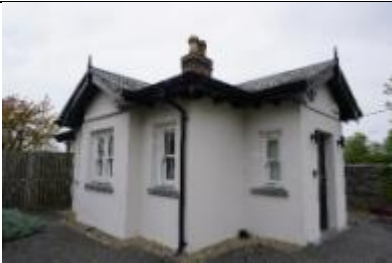
1870s	★ ★ ★
Window openings	Square-headed window openings, with splayed soffits and reveals, painted stone sills and replacement casement windows.

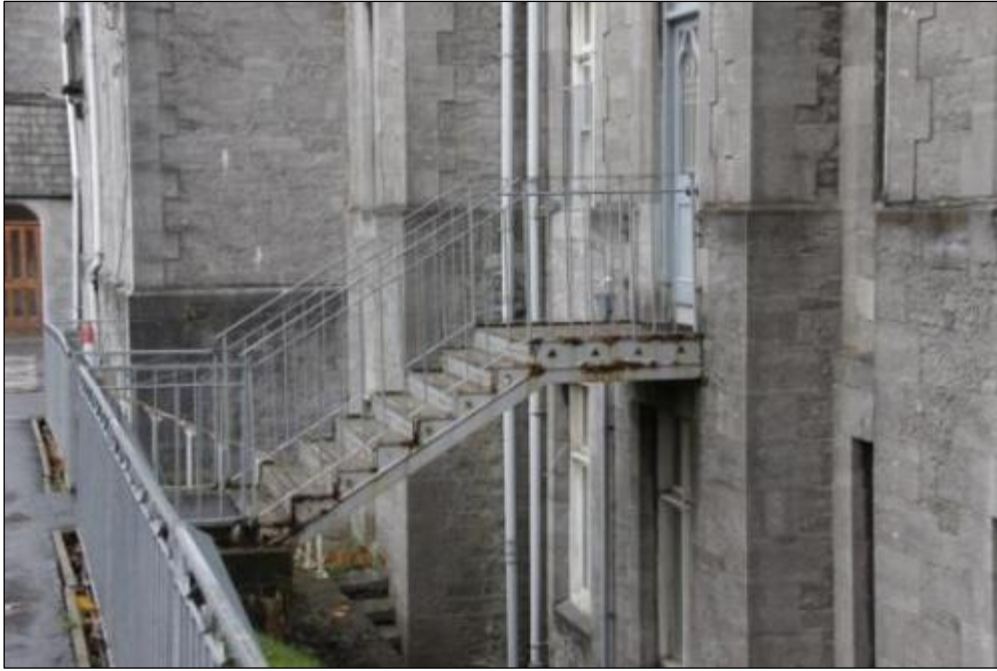
Photograph 105 The Nine Steps

Previous to the renovations of the 1950's and 1960's a local builder Mr. Ryan was employed for some alterations. In 1935 a bridge was constructed over the basement entrance to the convent to allow easier access to the playground. This became known as the 'nine steps'.

Not significant
External Stairs	Cast-iron Steps (known as “the 9 steps”) leading up to a square head door opening with replacement door and frame.		Original 1850 – 1870s	★ ★ ★

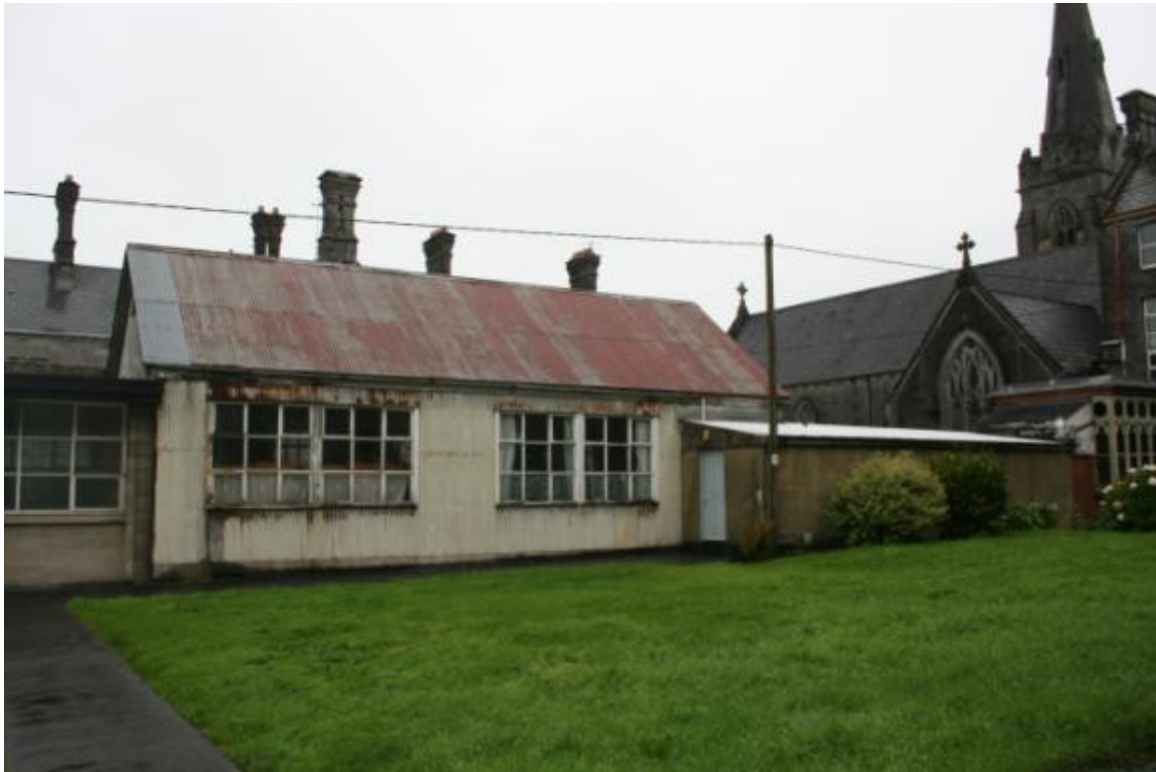
Photograph 106 The Iron House, purchased from England in 1898 Known as Mount St. Vincent Hall

In 1898 the novices who were until this time at St. Mary's Convent, were moved to the Mount Convent. To provide extra space an Iron House³⁶ was purchased from England and transported across the Irish Sea. It was placed as a separate unit on the Mount Garden and became known as Mount St. Vincent Hall. This was also used as a secondary school, as a chapel when the Mount St. Vincent Chapel was being renovated, and as a dining room for major celebrations.

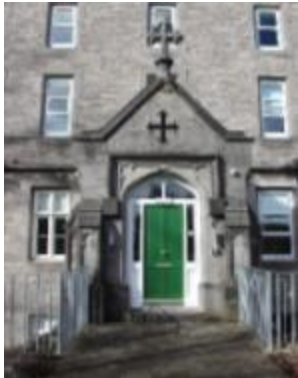
Original 1850	☆☆☆
Cruciform Finial	The cruciform finial is located at the apex of the pitched roof on the entrance porch.

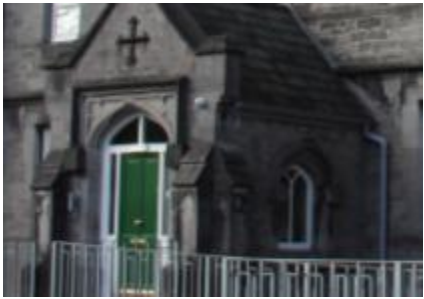
<p>Windows on side elevations of entrance porch.</p>	<p>Two pointed arch windows are located on the ground floor section of the entrance porch, one on each elevation. Both windows have cut stone surrounds and hood moldings.</p>

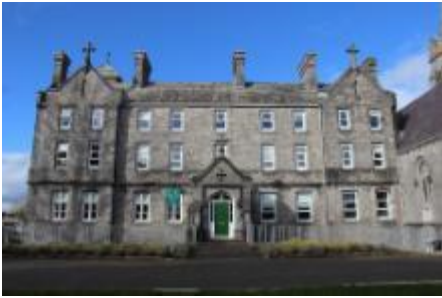
<p>Original 1850</p>	<p>★ ★ ★</p>
<p>Walls</p>	<p>The external walls of Mount st Vincent are made up of squared and snecked limestone with limestone ashlar dressing including a stringcourse indicating first floor level, quoining, and gable parapet copings.</p>

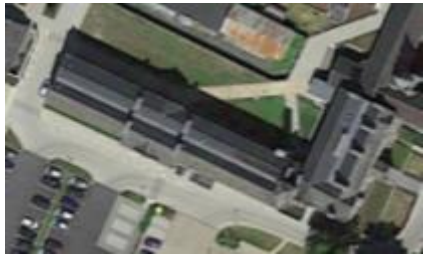
<p>Original 1850 – 1870s</p>	<p>★ ★ ★</p>
<p>Roof</p>	<p>The front elevation has a M profile natural slate roof with two two-bay gabled breakfront end bays. The seventeen-bay side elevation is linked to the front by the six-stage square plan campanile. The M profile roof on the side elevation runs perpendicular to the front roof and has intersecting gable end roof</p>

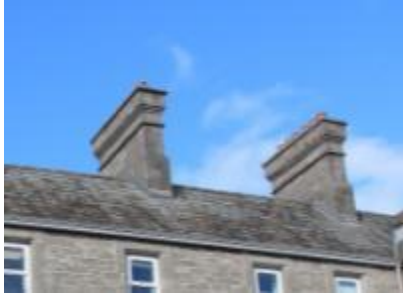
structures.			
Chimneys	There are 13 number Limestone ashlar chimneystacks with stringcourses. It contains emphatic stepped capping.

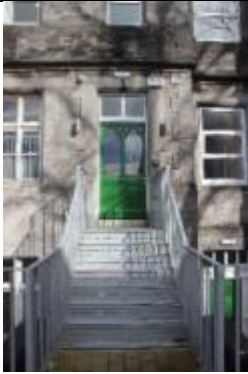
Windows– timber	Original timber sash windows on the side elevation. These sash windows have two fixed panels at the top then divided by a timber transom the two sash one over one sash window panels.

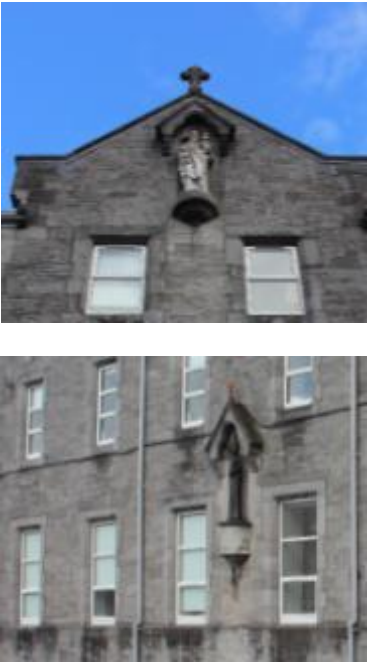
<p>Not significant</p>
<p>Statues on side elevation.</p>	<p>There are two statues on the side elevation located on protruding corbelled pedestals with a cut stone pitched hood molding directly above each statue. Behind the statues the limestone masonry is recessed in the wall, to accommodate the statue. One statue is located on near the apex of the gable of the building and the second is located on the extension to the building (circa 1870s) just between the ground and first floor level. It is centered on this extension.</p>

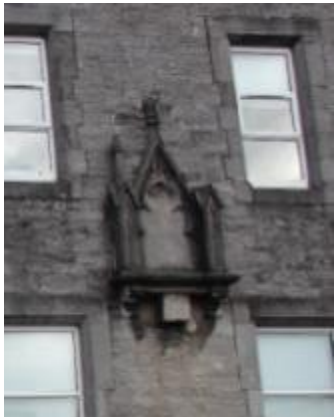
<p>Plaque on side elevation</p>	<p>Cut stone plaque located on the side elevation near the side entrance porch protruding from the building. This decorative cut stone plaque rests on a corbel.</p>

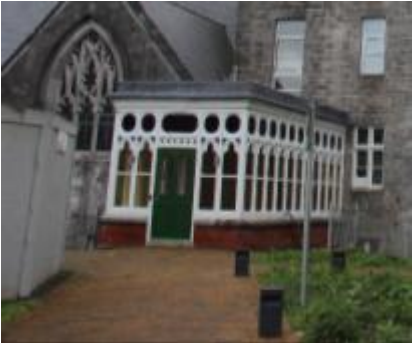
<p>Original 1850 – 1870s</p>	<p>★ ★ ★</p>
<p>Rear Conservatory</p>	<p>The Flat-roofed conservatory to northwest corner adjacent to chapel has a red brick plinth base and limestone coping with a timber framed glazed conservatory structure enriched by trefoil-arched panels.</p>

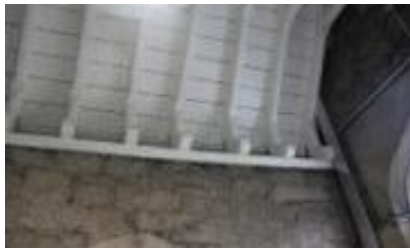
Original 1850 – 1870s	☆☆☆
Ceiling – Porch	Exposed ceiling with timber panels and joists.

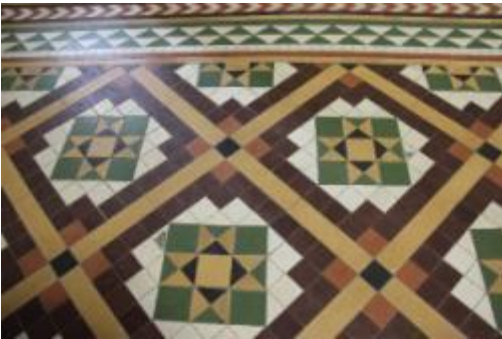
<p>Flooring – Entrance Porch</p>	<p>Encaustic tile floor</p>

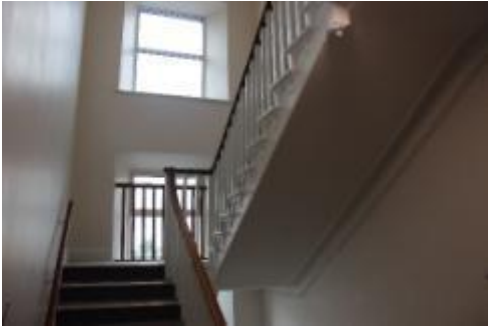
<p>Original 1850 – 1870s</p>	<p>★ ★ ★</p>
<p>Stairs</p>	<p>Open string timber staircase with Gothicised tread ends, stop-chamfered balustrade supporting timber handrail.</p>

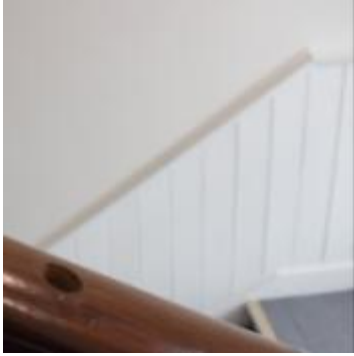
throughout the building.			
Doors	Several of the existing flat-panelled timber doors with arched upper panels doors have been upgraded for fire safety. Many of these contain Gothicised timber architraves.		Original 1850 – 1870s	★ ★ ★
Wainscoting	Timber paneled wainscoting in several areas of the building particularly by the stairs.

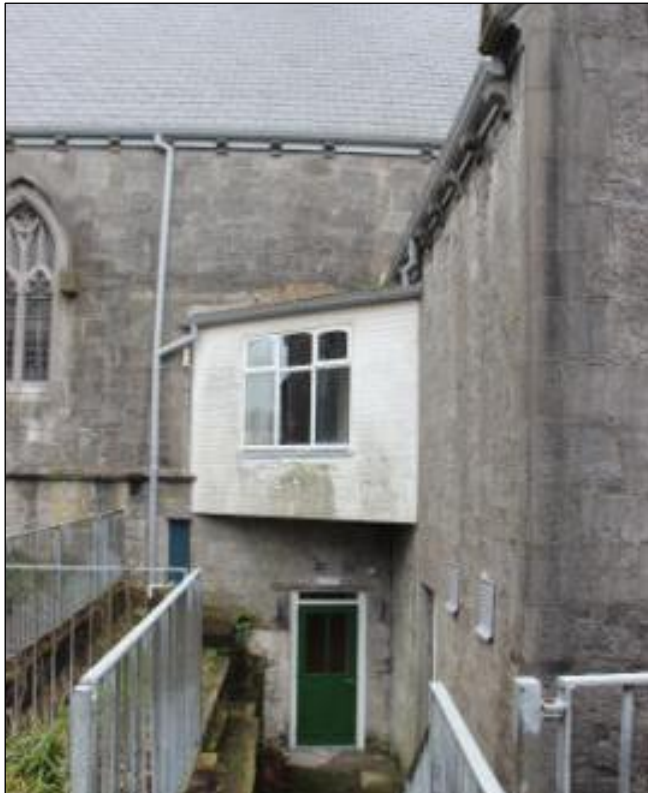
Photograph 109 Rear Elevation of Chapel showing timber extension

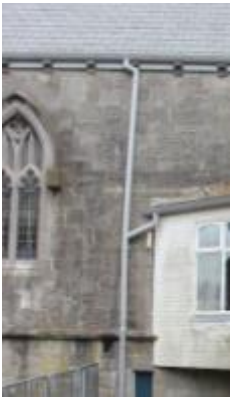
Modern	<div style="background-color: red; color: black; text-align: center; padding: 5px;">Not Significant</div>
Roof	Natural slate pitched roof with perpendicular pitched roof that intersects at the nave and pitched natural slate roof on the entrance porch.

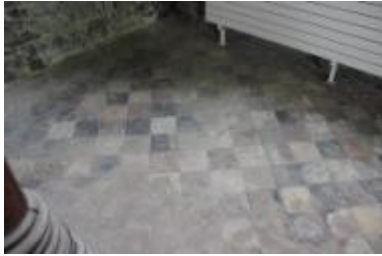
Original - 1861	☆☆☆
Floor	Encaustic tiled floor with a raised timber floor at alter level and into the transepts.

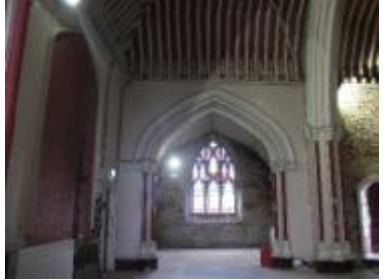
Original - 1861	★ ★ ★
Arches	Running mould pointed archivolt rising from cluster colonnettes, separates nave from altar and transepts.

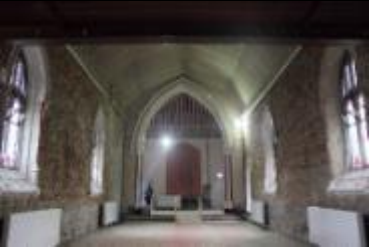
Original - 1861	★ ★ ★
Walls	Exposed masonry walls made up of brickwork and stone. Plaster work had been removed from the walls in recent times.		Original - 1861	★ ★ ★

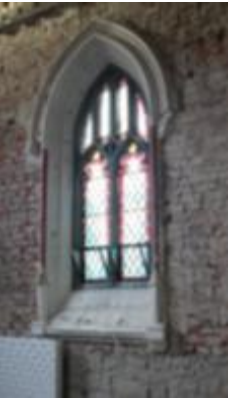
Modern - installation date unknown.	Not significant
Window surrounds	Each window opening articulated by a moulded sill with flanking pedestals supporting colonnettes from which a running mould archivolt rises. Outer architrave springing from plaster busts. NOTE: Plaster busts have been removed and are stored.

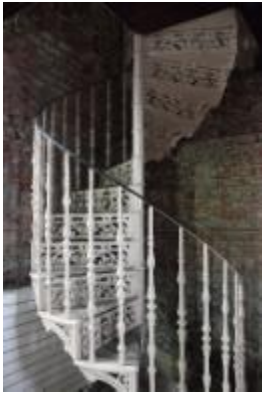
Spiral stairs	Located to left of the entrance porch and gives access the choir gallery above. The stairs has cast iron railings, steps and raisers with decorative patterns.
