Conservation & Management Plan

Mary Immaculate College, Limerick

Client: Mary Immaculate College

Date: April 2020

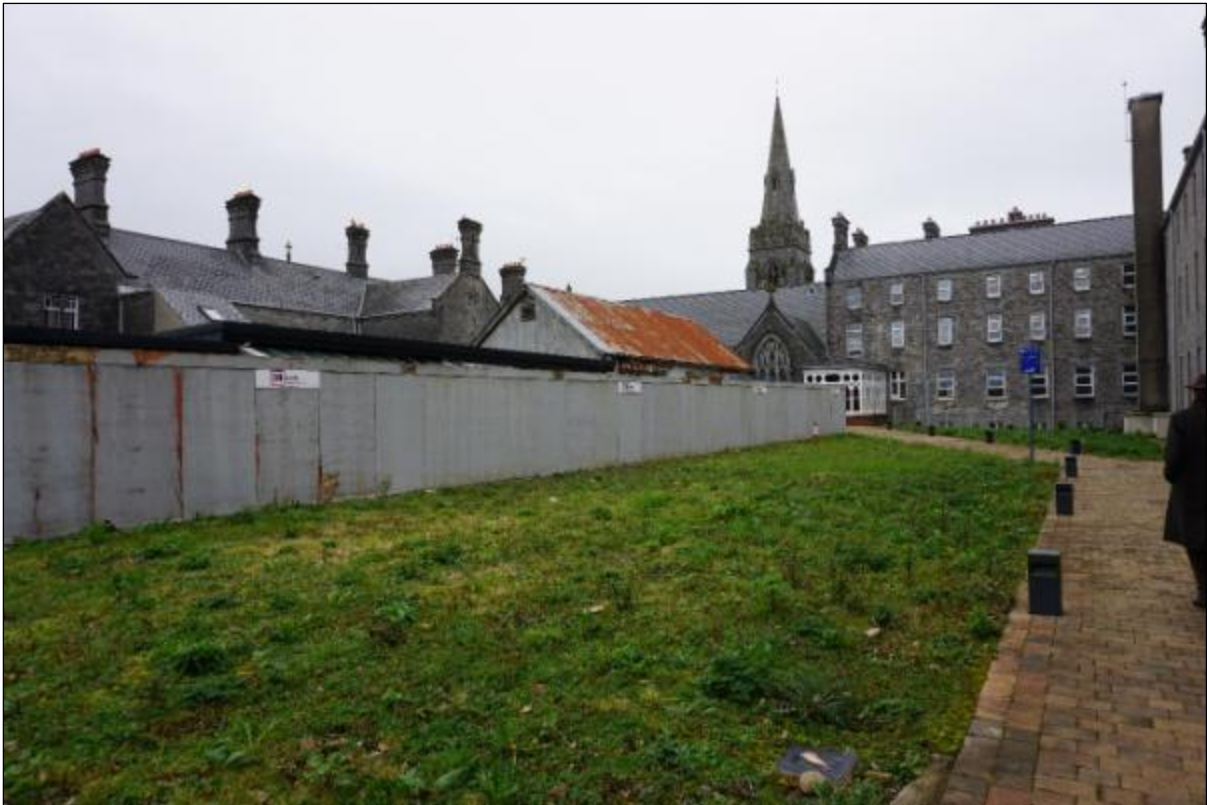
Much of the buildings original features remain intact however, the building is in need of repairs. The interior of the building is unused, but historical features are much intact. The hall is made up of corrugated metal sheeting with a pitched corrugated metal roof with timber barge and eaves. The windows are comprised of square-headed window openings with timber reveals, sills and mullioned four-paned casement lights with arched over lights. The larger window openings are made up of multiple-paned casement windows. Internally the walls are lined with tongued and grooved paneling that rises to the ceiling and continues across the ceiling. There are metal ties on the timber trusses. The interior is divided by a timber partition/ glazed screen which folds back.

Photograph 113 Mount St. Vincent Hall surrounded by hoarding

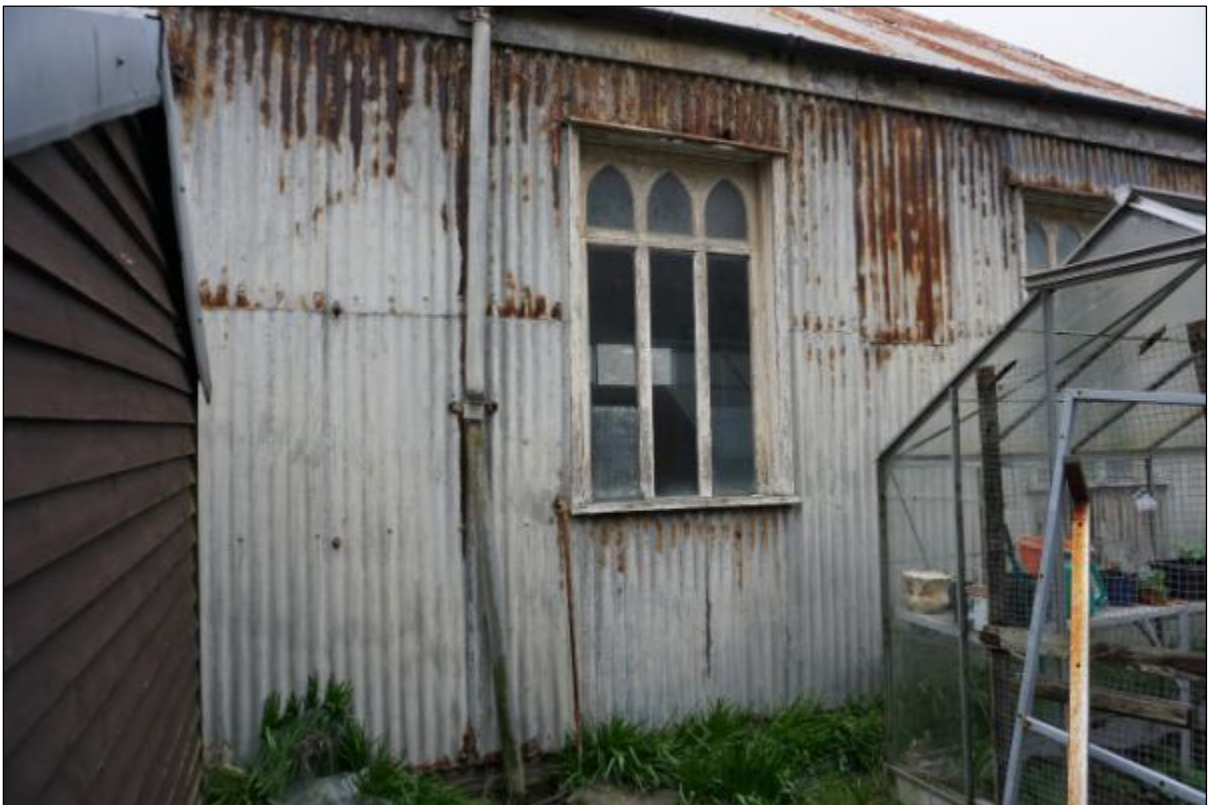
Photograph 116 Exterior View of window opening.

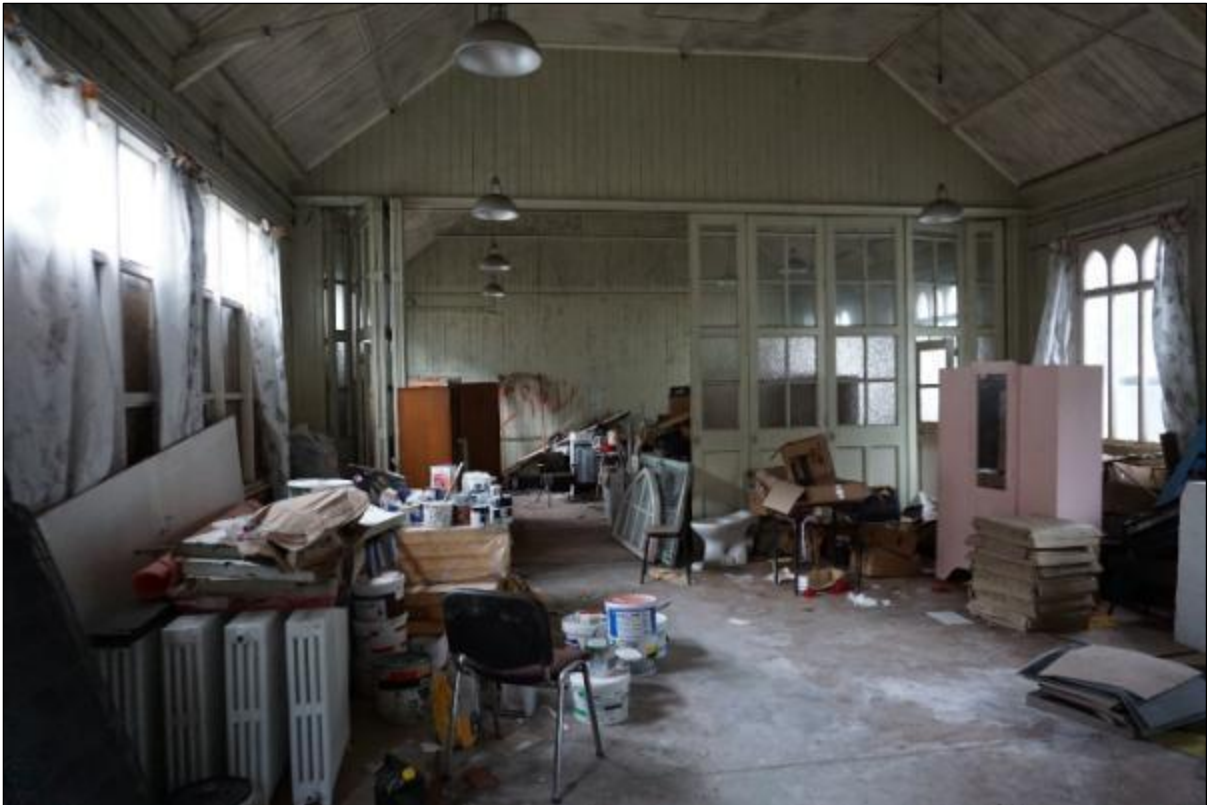
Photograph 117 Interior View showing folding doors

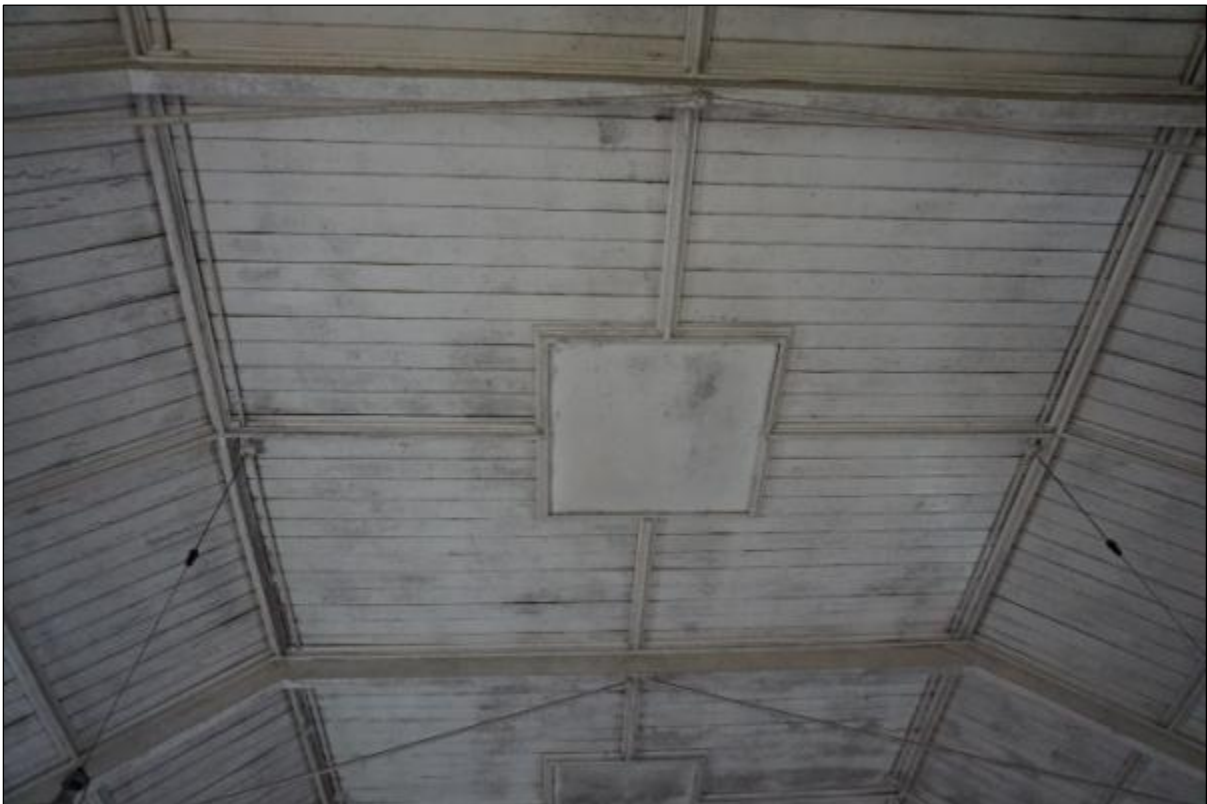
Photograph 118 View of boarded ceiling

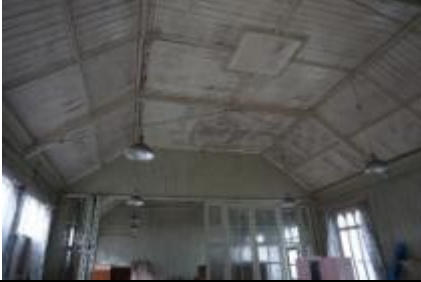
1890's	☆☆☆
Ceiling	Tongue and grooved paneled ceiling that follows the slope before leveling off. There are metal ties on the timber trusses.
